## **Yak-52, G-BWOD**

<b>AAIB Bulletin No: 4/2004</b>	<b>Ref: EW/G2003/10/16</b>	<b>Category: 1.3</b>
<b>Aircraft Type and Registration:</b>	<b>Yak-52, G-BWOD</b>	
<b>No &amp; Type of Engines:</b>	1 Ivchenko Vedeneyev M-14P piston engine	
<b>Year of Manufacture:</b>	1983	
<b>Date &amp; Time (UTC):</b>	30 October 2003 at 1450 hrs	
<b>Location:</b>	Field next to Conington Airfield, Cambridge	
<b>Type of Flight:</b>	Private	
<b>Persons on Board:</b>	Crew - 1	Passengers - 1
<b>Injuries:</b>	Crew - None	Passengers - None
<b>Nature of Damage:</b>	Damage to both wings and propeller. Fuel leak reported	
<b>Commander's Licence:</b>	Private Pilot's Licence	
<b>Commander's Age:</b>	42 years	
<b>Commander's Flying Experience:</b>	258 hours (of which 70 were on type)	
	Last 90 days - 16 hours	
	Last 28 days - 4 hours	
<b>Information Source:</b>	Aircraft Accident Report Form submitted by the pilot and AAIB follow-up inquiries to the repair agency

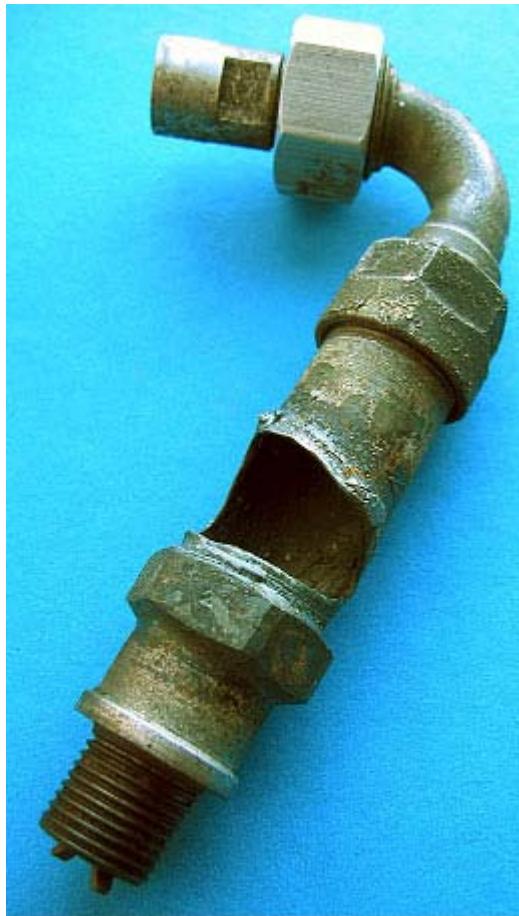
The aircraft was recovered by a major UK importer of Yak aircraft. His investigation established that the power reduction and vibration were caused by the break-up and subsequent blow-out of the insulator core of a spark plug in the No 4 cylinder. It was considered that the resulting loss of compression had caused rough running and that venting of combustion gases through the centre of the spark plug body, in close proximity to a cylinder head temperature sensor, would have produced the rising cylinder head temperature indications seen by the pilot. The damage sustained by the aircraft was significant: sufficient to render questionable the economic viability of repair.

Markings on the failed plug included the letters C-49 CM, which it is understood identify it as the standard type of Russian manufactured spark plug used in the Vedeneyev M-14P engine. The AAIB examination of this plug, Figure 1, showed that a large sector on the side of the casing had melted and been burnt away, and that the ceramic inner core and central electrode were missing. Because the origin of the failure was no longer present, the underlying cause could not be established with any degree of certainty. However, the periphery of the melted region was locally thickened and pitted in a manner consistent with melting by an electrical arc, and surface features inside the body of the plug in the immediate vicinity of the burnt region were also consistent with electrical arc damage. It could not be established whether this arcing was a primary cause of the failure *per se*, caused by a breakdown of the ceramic insulator core, or whether it was a secondary feature symptomatic of some other, non-identifiable, mechanical failure within the plug.

**Figure 1: View to damaged spark plug showing burn through and empty core**
