**INCIDENT**

<b>Aircraft Type and Registration:</b>	Aerospatale AS355F1, G-FFRI	
<b>No &amp; Type of Engines:</b>	2 Allison 250-C20F turboshaft engines	
<b>Category:</b>	2.2	
<b>Year of Manufacture:</b>	1982	
<b>Date &amp; Time (UTC):</b>	19 July 2004 at 0945 hrs	
<b>Location:</b>	Near Lasham Airfield, Hampshire	
<b>Type of Flight:</b>	Public Transport	
<b>Persons on Board:</b>	Crew - 1	Passengers - None
<b>Injuries:</b>	Crew - None	Passengers - N/A
<b>Nature of Damage:</b>	Damage to right engine drivetrain and coupling housing tube	
<b>Commander's Licence:</b>	Airline Transport Pilot's Licence	
<b>Commander's Age:</b>	59 years	
<b>Commander's Flying Experience:</b>	7,200 hours (of which 1,800 were on type) Last 90 days - 60 hours Last 28 days - 18 hours	
<b>Information Source:</b>	AAIB Field Investigation

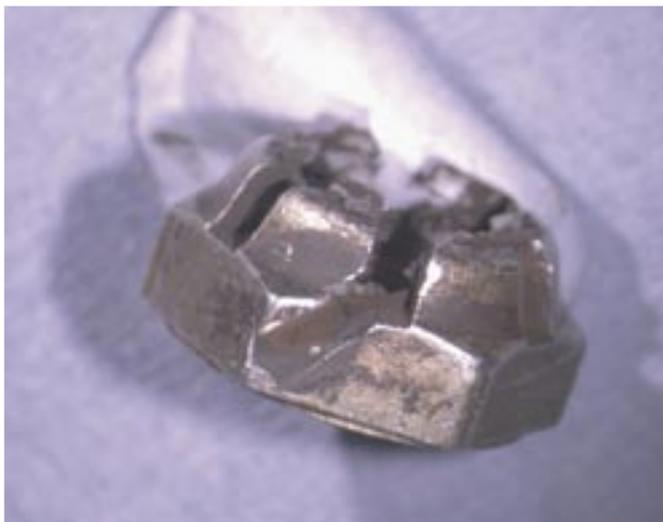
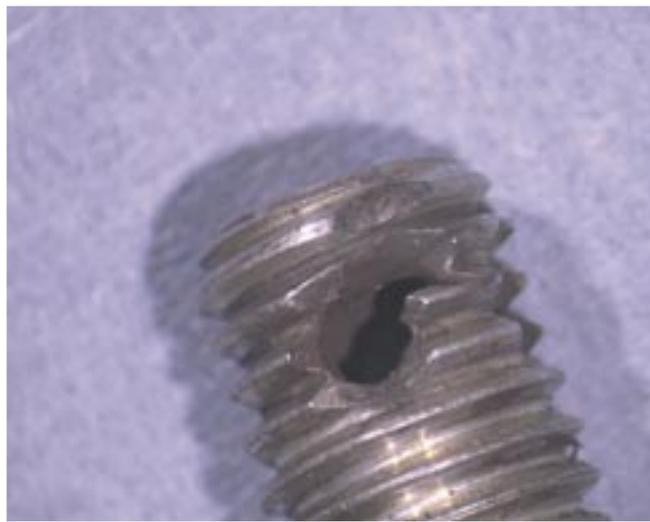
**Figure 2**

No evidence was found that either item No 1 or item No 3 above were responsible for the failure of the Thomas coupling of G-FFRI. It is regrettable that any evidence regarding the condition of the coupling flange bolts seems lost, particularly in the light of a discovery made by the same maintenance company in January 2005 and brought to the attention of the AAIB. During routine maintenance on an AS355F2 helicopter (not G-FFRI), it was necessary to dismantle the engine drive Thomas couplings. Four of the six nuts and bolts seemed quite normal but two showed signs of severe fretting of both the nut and the bolt, apparently caused by a loose-fitting split pin (Figure 2). The pins themselves were intact but, as can be seen from Figure 2, the loss of material from the nut is considerable. Informal contact with another maintenance company suggested that they, too, had experience of this phenomenon as did an AAIB consultant metallurgist who had observed it in applications other than helicopters. The helicopter had flown a total of 5,597 hours since new and the combining gearbox had a total of 1,072 hours since overhaul (overhauled gearboxes are supplied with new Thomas couplings and hence bolts).

A coupling flange nut and bolt removed from a Thomas coupling fitted to an AS355 helicopter showing severe fretting caused by a loose-fitting split-pin

**Safety Recommendation 2005-081**

It is recommended that Eurocopter review the design, or maintenance procedures adopted for the installation, of 'flector' couplings to ensure that the potential for fretting of the split-pin/nut/bolt assembly is eliminated.
