ACCIDENT

Aircraft Type and Registration:	Fokker 50, OO-VLQ
No & Type of Engines:	2 Pratt and Whitney 125B turboprop engines
Year of Manufacture:	1989
Date & Time (UTC):	25 August 2005 at 2058 hrs
Location:	Cardiff Airport, South Glamorgan
Type of Flight:	Public Transport (Passenger)
Persons on Board:	Crew - 3 Passengers - None
Injuries:	Crew - None Passengers - N/A
Nature of Damage:	Port wingtip and three feet of leading edge damaged
Commander's Licence:	Dutch Air Transports Pilot's Licence
Commander's Age:	39 years
Commander's Flying Experience:	9,000 hours (of which 5,500 were on type) Last 90 days - 180 hours Last 28 days - 50 hours
Information Source:	Aircraft Accident Report Form submitted by the pilot, reports submitted by the handling agent and further enquiries by the AAIB

Synopsis

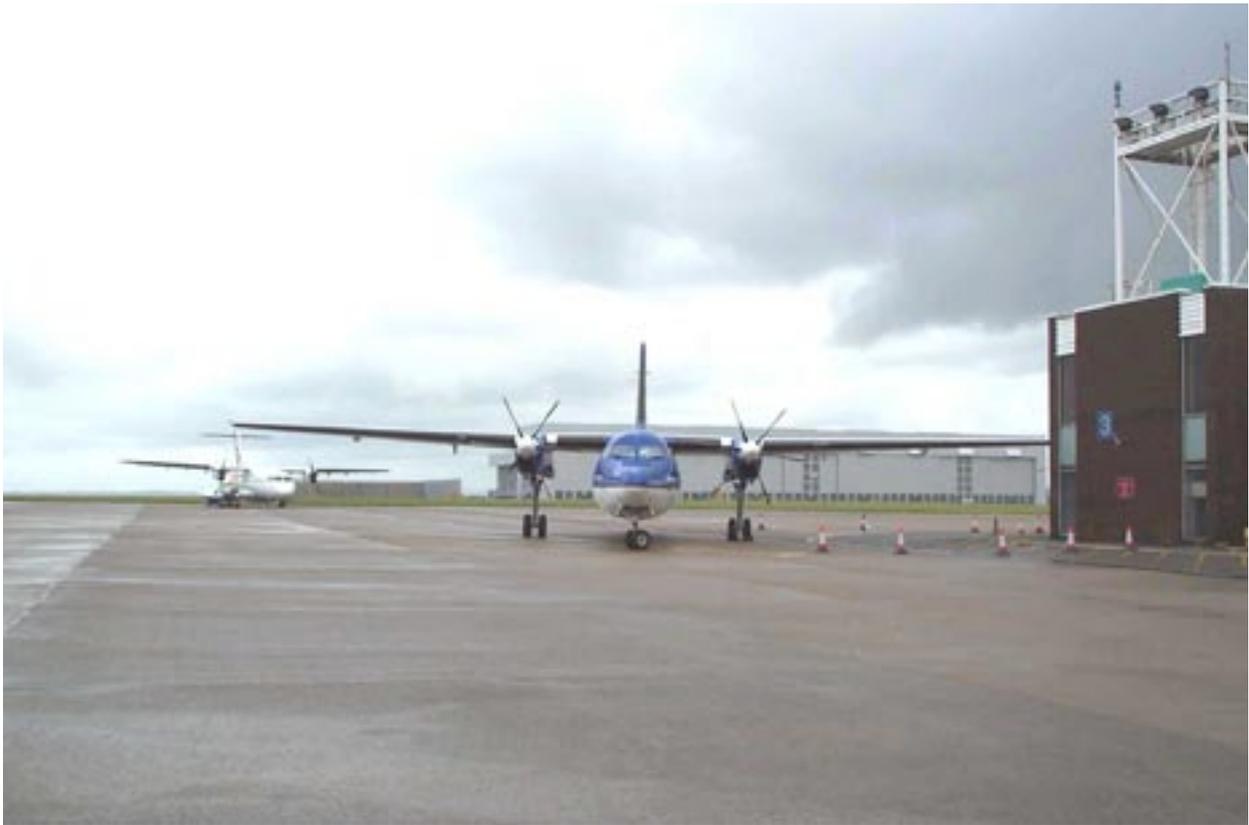
Figure 1

As the marshaller brought the aircraft towards the West Pier, in an easterly direction, he signalled to the aircraft to turn to the right in order to manoeuvre the aircraft onto the stand's yellow line. The aircraft then continued forward before starting the right turn and its right wing tip then hit the end of the West Pier (see Figure 1).

Aircraft position immediately after impact

about 10 ft away he realised that there was a problem. He shouted “Stop” and crossed his arms to indicate stop to the marshaller but the aircraft’s wing tip then hit the pier near to where he was standing. He was struck on the head by a small piece of plastic from the left wing tip navigation light covering, sustaining no injury.

The resulting damage was a broken wing tip light and a three foot long dent to the leading edge of the left wing.
