INCIDENT

| Aircraft Type and Registration: | Bombardier DHC-8-402, G-JECI | |
| Date & Time (UTC): | 9 January 2007 at 0728 hrs | |
| Location: | Manchester Airport | |

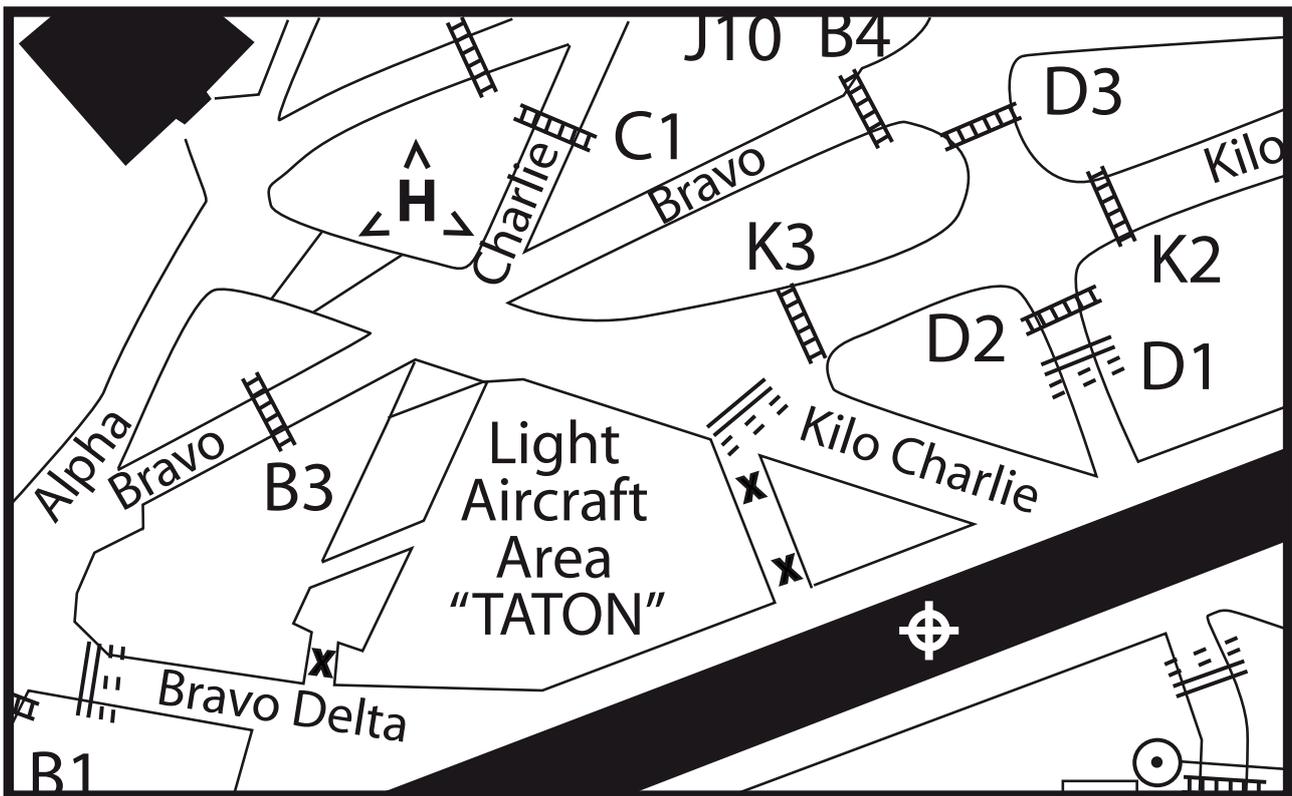
Figure 1

runway exit: KC, B (23m wide), C (23m wide), KC and B (See Figure 1).

Taxiway intersection KC,C,B

ATC now advised the crew that the aircraft had taken a wrong turn onto Taxiway B, so the commander brought the aircraft to a stop. ATC then instructed the aircraft to proceed but as the commander applied power he realised that the aircraft was stuck, the left main gear having sunk into the edge of the grass between Taxiway B and Taxiway C.

The intersection of Taxiways KC, C and B is complex and this creates a difficulty for the airport operator in

providing clear sign boards. Furthermore the runway exit taxiway, KC, is wider than a normal taxiway. Although the sign boards alongside are located at the recommended distance from the edge of the taxiway, they are further from the taxiway centreline than would be the case for a normal width taxiway. The airport is undertaking a trial of surface markings as a supplement to the existing signs and is also reviewing the positioning of the sign boards.
