INCIDENT

Aircraft Type and Registration: Boeing 757, 4X-EBR

Date & Time (UTC): 12 May 1994 at 0558 hrs

Location: Stand B23, London Heathrow Airport

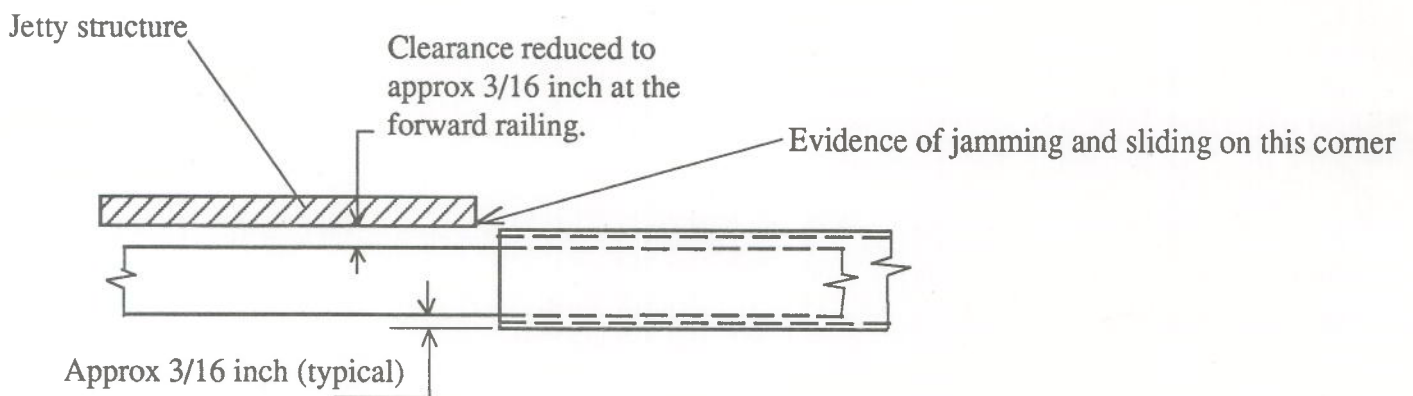
the forward railing (shown fully extended) on the subject jetty which damaged the aircraft and the rear railing in a typical position. The airline now use the jetty at Door 1L where the compound curvature of the nose precludes contact between the forward idle wheel and the aircraft. The idler wheel normally contacts the fuselage skin at window height and is held in contact by a telescopic actuator. The telescopic rail, made of rectangular section stainless steel, can be clearly seen in the photographs. The end of the larger telescopic tube is normally very close to the jetty structure. In plan view (see diagram), the clearance between the telescopic rail and the jetty structure was adequate on the rear railing, but marginal on the forward railing where the damage occurred. There was clear evidence on the jetty structure that the forward railing had jammed against the structure while trying to retract, and had been therefore unable to move away from the fuselage. There was also evidence that the railing had frequently rubbed against the structure. The accompanying diagram shows the clearances available.

The process by which the damage occurred was probably as follows: On initial contact between the jetty and the aircraft, the railings had moved out until the idler wheels contacted the skin, at which point the end of the larger rectangular section tube had passed beyond the structure. During disembarkation, the aircraft had moved upwards and the auto leveller had attempted to compensate, however the fuselage geometry required the railings to retract rapidly and during this process the forward railing jammed on the jetty structure. The upwards movement of the aircraft then pushed the window, with which the forward idler wheel was in contact, out of place.

PLAN VIEW OF FORWARD TELESCOPIC RAILING SHOWING REDUCTION OF CLEARANCE

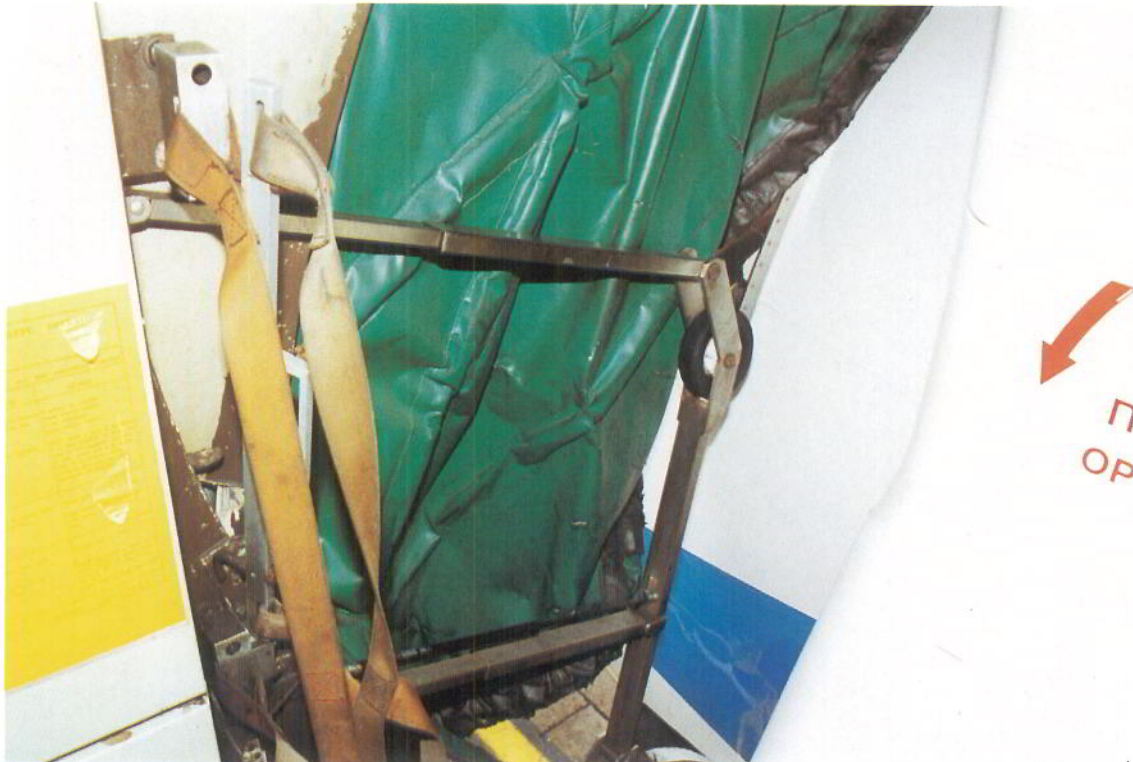
AAIB examination of the jetty showed that it had been modified by the fitting of telescopic railings which extended out to the aircraft skin. These were fitted to prevent persons falling between the aircraft and the jetty at each side, where the canopy provides a weather seal. The photographs show

Forwards railing and idler wheel at full extension (not in contact with skin).

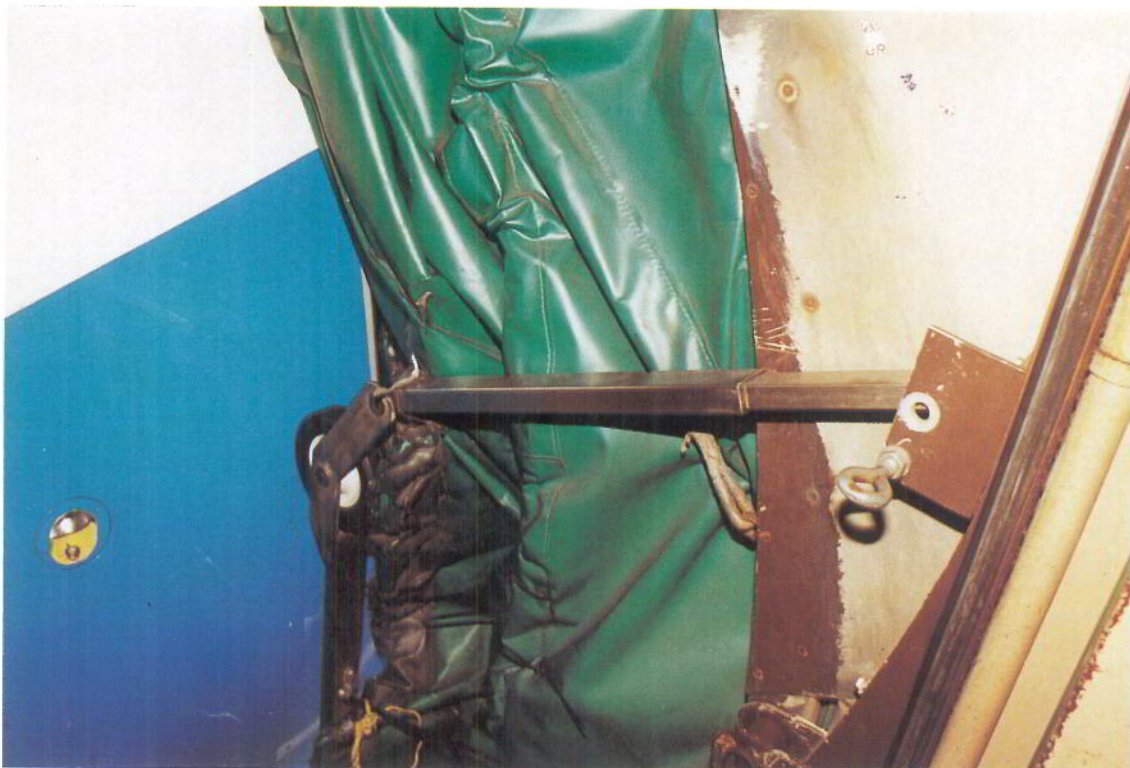
Rearwards railing and idler wheel contacting skin. Note telescopic rail and proximity of rectangular section outer tube end to adjacent structure.
