ACCIDENT

Aircraft Type and Registration:	Piper PA-28-161 Cadet, G-TLET	
No & Type of Engines:	1 Thielert TAE 125-02-99 diesel engine	
Year of Manufacture:	1989 (Serial no: 2841259)	
Date & Time (UTC):	21 July 2012 at 1458 hrs	
Location:	Field south of Shoreham Airport, West Sussex	
Type of Flight:	Training	
Persons on Board:	Crew - 2	Passengers - None
Injuries:	Crew - None	Passengers - N/A
Nature of Damage:	Damage to propeller, landing gear, and wing spar	
Commander's Licence:	Airline Transport Pilot's Licence	
Commander's Age:	26 years	
Commander's Flying Experience:	840 hours (of which 642 were on type) Last 90 days - 158 hours Last 28 days - 47 hours	
Information Source:	Aircraft Accident Report Form submitted by the pilot and further enquiries by the AAIB

Synopsis

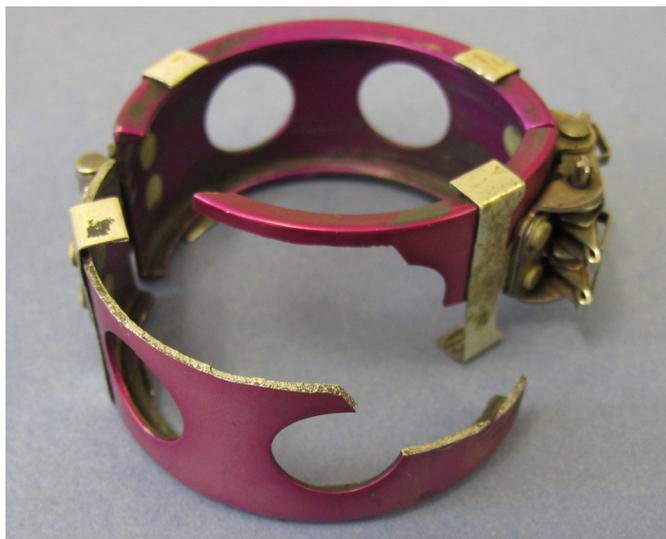
Figure 1

to as a Wiggins clamp, was later found in a field at the southern end of the runway, close to the extended runway centreline. The clamp had fractured and broken apart (Figure 1). A loss of this clamp in flight would result in a loss of compressed air from the turbocharger compressor to the intake manifold and a significant reduction in power.

Failed Wiggins clamp from G-TLET

The metallurgist concluded that the clamp from G-TLET had separated due to fatigue fracture under the influence of engine vibrations. It was not possible to estimate the duration of the fatigue crack growth.

The loss of power in G-TLET was caused by failure of the Wiggins clamp between the turbocharger compressor outlet and the turbo pipe assembly. The clamp had failed due to a fatigue crack that had initiated at multiple sites on the inner surface and then propagated through the thickness of the sidewall. No pre-existing material defects were identified and the clamp wall thickness was within specification. There was significant fretting wear on the inner surface so it was possible that loads due to vibration initiated the fatigue crack. These vibratory loads would have been superimposed on any loads from the compressed air passing through the angled turbo pipe assembly. It is also possible that a misalignment of the pipes during installation could have induced an additional pre-load on the clamp. It was not possible to determine when the crack had formed but the clamp had been in use for at least 793 hours and possibly as many as 1,647 hours – 447 hours in excess of the replacement requirement. The maintenance organisation had been unaware of both the 1,200-hour replacement requirement and the 300-hour ‘remove and inspect’ requirement. Had the clamp been removed for an inspection at the last 300-hour check the crack might have been detected, unless it had initiated after that inspection.

It is recommended that Technify Motors GmbH, as the STC holder, informs operators of Piper PA-28, Cessna 172 and Robin DR400 aircraft fitted with TAE 125-01 and 125-02 engines that the Wiggins clamp (P/N NM-0000-0024701) is susceptible to cracking, which can lead to clamp failure and significant power loss. Furthermore, as TC holder they should inform Diamond Aircraft Industries of the same.

It is recommended that Technify Motors GmbH establishes a consistent and suitable inspection and/or replacement interval for Wiggins clamp (P/N NM-0000-0024701) to be specified in the engine maintenance manuals and the aircraft maintenance manuals for which it holds the Supplemental Type Certificate, to maximise the likelihood that cracks in the clamp are detected before they propagate to failure.

It is recommended that Technify Motors GmbH re-assesses the vibration and loading conditions at the clamp and selects an alternate clamp design if necessary to ensure that it is not susceptible to cracking and failure during normal operations.

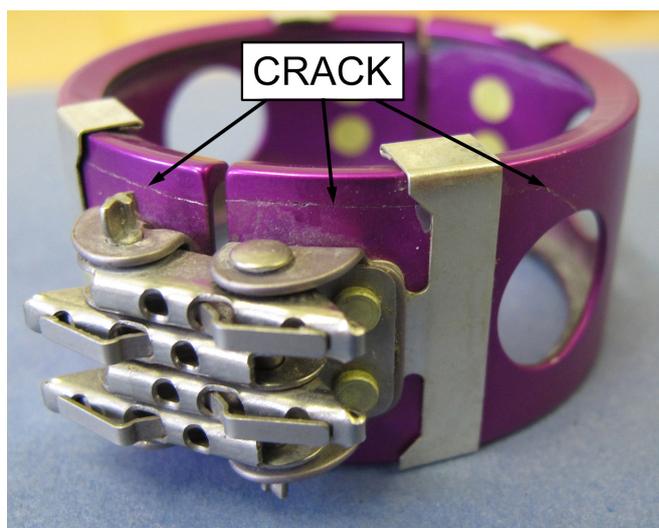
Figure 2

The maintenance organisation decided to carry out an inspection of their fleet of aircraft fitted with Thielert engines to check for cracks in the Wiggins clamps. They found that on another Piper PA-28-161(G-BZLH) the Wiggins clamp had started to crack in a similar location to the failed clamp from G-TLET (Figure 2).

Cracked Wiggins clamp from another PA-28-161 with TAE 125-02-99 engine (G-BZLH)

The evidence from the clamp from G-BZLH indicates that cracking can initiate in under 300 hours. This clamp had only accumulated 195 hours and it had started to crack in fatigue in the same manner as the clamp on G-TLET. If the crack had gone undetected the clamp probably would have failed with consequent loss of power. The maintenance organisation stated that they had detected the crack on the G-BZLH clamp only because they had removed it following the accident to G-TLET. There was no requirement to remove it

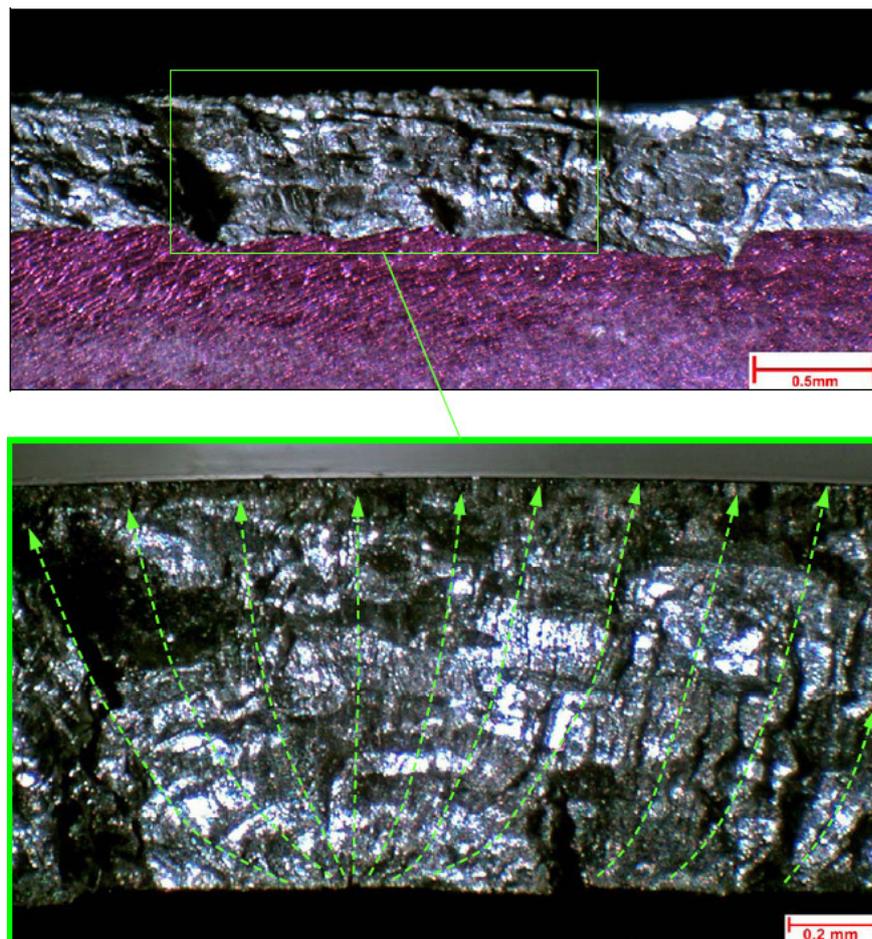
Figure 3

The clamp from G-BZLH was sectioned to reveal the fracture surfaces of the cracks. Microscopic examination of the fracture surfaces from both clamps revealed that the cracks had initiated at multiple sites on the inner surface and had propagated in fatigue through the thickness of the sidewall toward the outer surface (Figure 3). As they did so, these minor fatigue crack fronts coalesced, resulting in the formation and circumferential expansion of the fracture plane. It was concluded that the crack on the G-BZLH clamp, if it had gone undetected, would have eventually caused the clamp to fail in the same manner as the clamp from G-TLET.

Radial outward fatigue crack growth on the main fracture plane of the failed clamp from G-TLET

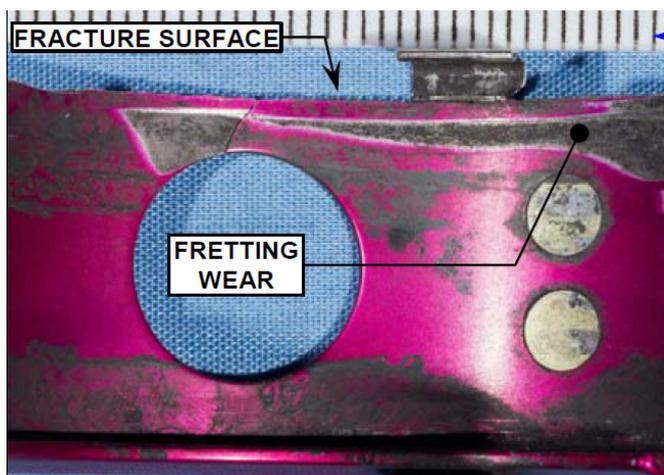
Figure 4

wall thickness was measured as between 0.864 mm and 0.889 mm, which was within specification. There was evidence of significant fretting on the inner surface of the G-TLET clamp (Figure 4). There was also fretting wear on the inner surface of the G-BZLH clamp (Figure 5), although less extensive than on G-TLET. This indicated that both clamps had been subject to vibrations during operation.

Fretting wear on the inner diameter of clamp from G-TLET

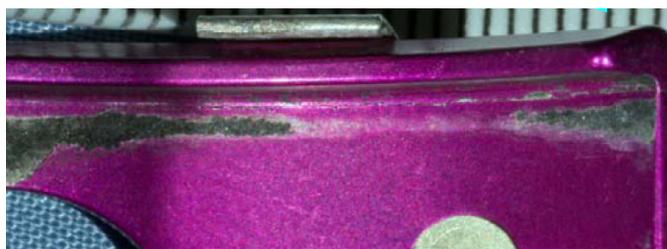
Figure 5

Fretting wear (dark areas) below crack line on clamp from G-BZLH

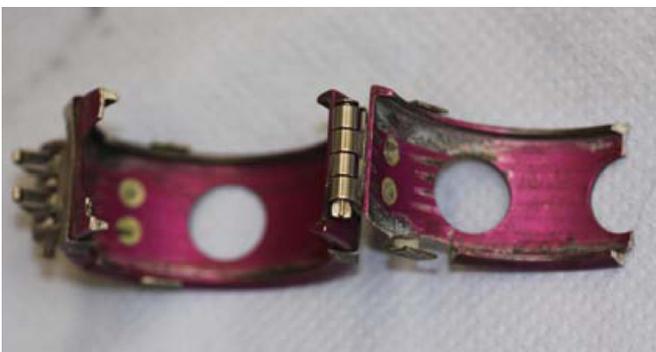
Figure 7

The engine manufacturer was aware of only one previous failure of a Wiggins clamp on a Centurion engine and that was on a Cessna 172R, registration SX-CCA, in 2010. During this incident the aircraft suffered a loss of power during the climb, but was able to turn back and land at the airfield. The clamp on SX-CCA was found to have cracked perpendicular to the main cracks found on the G-TLET and G-BZLH clamps (Figure 7). There was evidence of dark-coloured fretting damage on the inside of the clamp similar to G-TLET and G-BZLH. The engine manufacturer carried out an examination of the engine and noted that the mating section of the turbo charger compressor had a partially broken lip where the O-ring was fitted. Because the fracture surface was dirty they concluded

Failed Wiggins clamp from Cessna 172R (SX-CCA) fitted with Centurion 2.0 engine

that it was older than the clean fracture surface on the clamp. Loss of this mating section would result in tilting of the two interconnecting pipes which would result in a high load being transferred to the clamp and could cause it to fail. The manufacturer concluded that the clamp failure was caused by the mating surface failure, which may have been caused by use of improper tooling, based on surface damage witness marks near the failure. No metallurgical examination of the fracture surfaces was carried out.

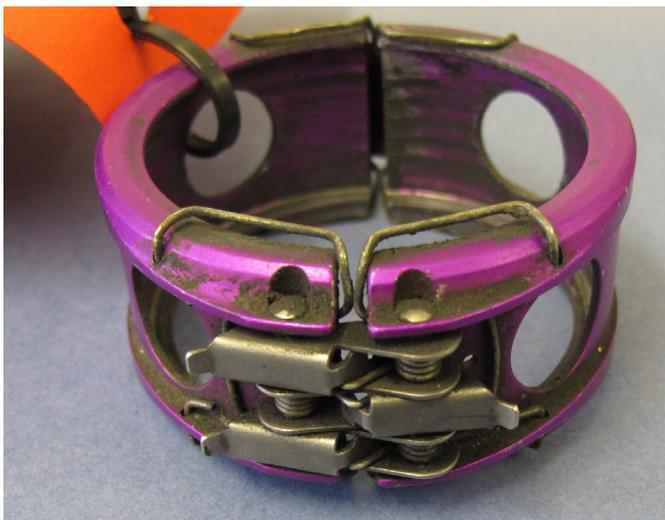
The TAE 125/Centurion engines were originally designed with a different type of clamp, part number 14C02-24A. An example of this clamp type is shown in Figure 8 – this clamp was removed from a Diamond DA40 D in 2012 due to excessive wear at the hinge. There was also evidence of fretting on the inner surface. This type of clamp is still in use today. The new clamp (P/N NM-0000-0024701), which was fitted to G-TLET, was approved in October 2003 and introduced into the field sometime thereafter but there was no requirement to retrofit, and therefore the total hours in service of the new clamp are not known. The engine manufacturer reported that the new clamp was introduced because of problems with excessive wear at the hinge of the old clamp and due to issues with its split-pin being out of position. There were, however, no reported occurrences of cracks and failures of the old clamp type. The wall thickness of the old clamp shown in Figure 8 was measured at 1.032 mm in the centre, with a region of thicker material at the edges of between 1.67 and 1.83 mm. This compares to a thickness of 0.864 to 0.889 mm for the newer clamp fitted to G-TLET.

Older style clamp (P/N 14C02-24A) which was removed from a Diamond DA40 D in 2012 due to excessive hinge wear

The old-style clamp, which is still in use, has not suffered any reported cracks or failures. It is possible that this is due to its thicker sidewall or it could be due to vibration loads being absorbed by the hinge, which results in a 'worn hinge' problem but alleviates stress that might otherwise initiate a crack.
