ACCIDENT

Aircraft Type and Registration:	Luton LA4A Minor, G-ATKH	
No & Type of Engines:	1 Lycoming O-145-A2 piston engine	
Category:	1.3	
Year of Manufacture:	1967	
Date & Time (UTC):	24 September 2005 at 1630 hrs	
Location:	Laddingford Airfield, Paddock Wood, Kent	
Type of Flight:	Private	
Persons on Board:	Crew - 1	Passengers - None
Injuries:	Crew - None	Passengers - N/A
Nature of Damage:	Broken wheel axle and subsequent damage to landing gear, propeller and cowling	
Commander's Licence:	Private Pilot's Licence with IMC rating	
Commander's Age:	60 years	
Commander's Flying Experience:	1,589 hours (of which none were on type) Last 90 days - 36 hours Last 28 days - 6 hours	
Information Source:	Aircraft Accident Report Form submitted by the pilot and a metallurgical examination of the wheel axle

Synopsis

The right stub axle failed in overload during a heavy landing made by a pilot who was making his first flight on type.

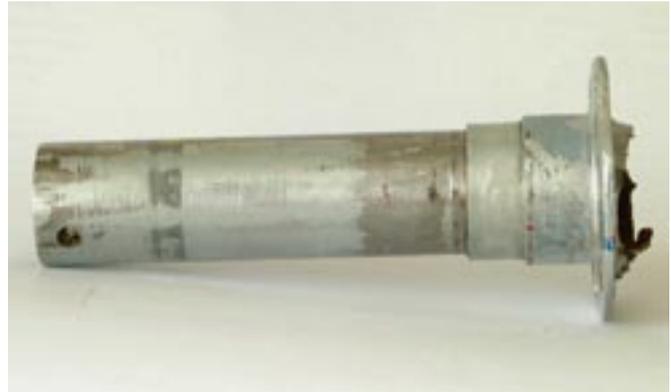
The right wheel stub axle had failed across its diameter just inboard of the inner face of the brake drum attachment plate. The stub axle was removed from the wheel and brake assembly and submitted to the AAIB for detailed examination. A photograph showing the stub axle is shown in Figure 1 (right).

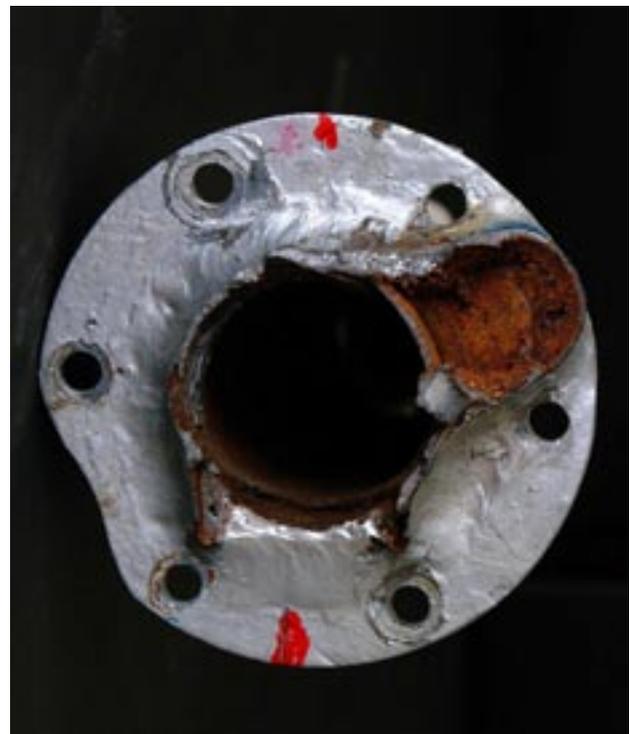
The right stub axle of G-ATKH was the subject of a dedicated metallurgical examination using visual and low magnification techniques. The view in Figure 2 (below) was taken from a view along the axle centre line in an outboard direction, with the landing load being in a direction vertically upwards as depicted.

- Poor welding had resulted in tube wall thinning and some weld burn through
- A region of gas porosity existed; however, this was present on the upper part of the weld in a region subject to compressive loads in the landing gear and would not therefore have adversely affected the strength of the joint, as this would have been the last to separate
- Some corrosion pitting had occurred but, considering the direction of the load that had caused the separation, the resultant reduction in strength was considered minimal
- The separation had resulted from overload bending conditions
- There was no evidence of separation by a progressive mechanism such as fatigue or stress corrosion.
