INCIDENCE OF COWLINGS, FAIRINGS AND DOORS OPENING IN FLIGHT

(A) AS 330 PUMA

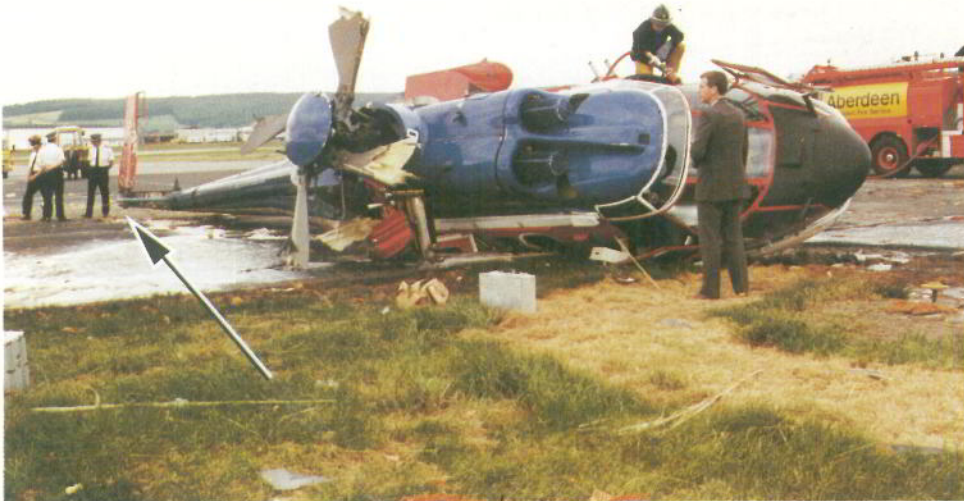
Photograph 1
Main wreckage site
(Note absence of tail rotor)

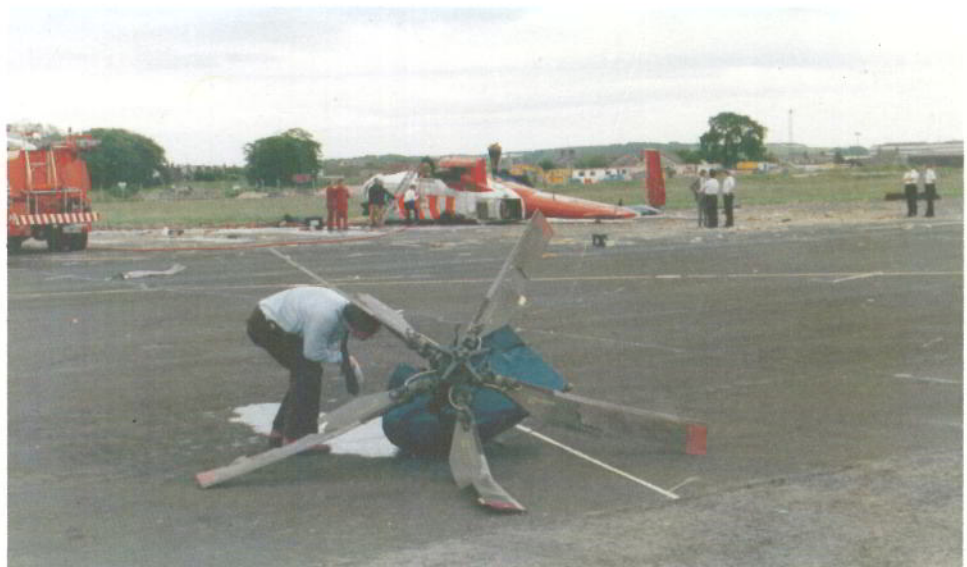
Photograph 2
Tail rotor and gearbox assembly
(Note sections missing from trailing edges of blades)

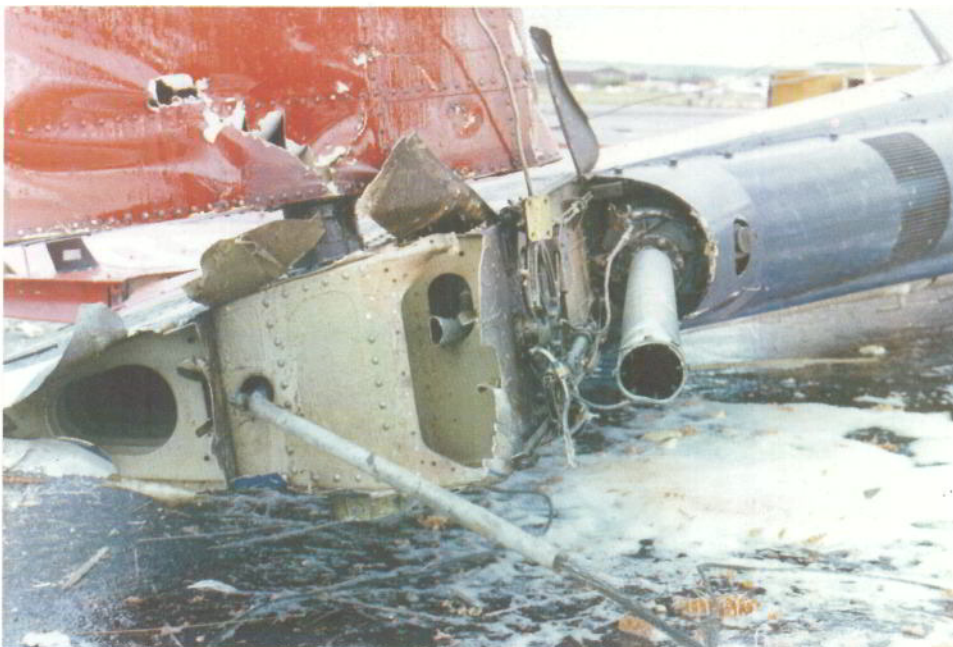
Photograph 3
Top of pylon assembly
(Showing detachment of upper pylon and tail rotor driveshaft)

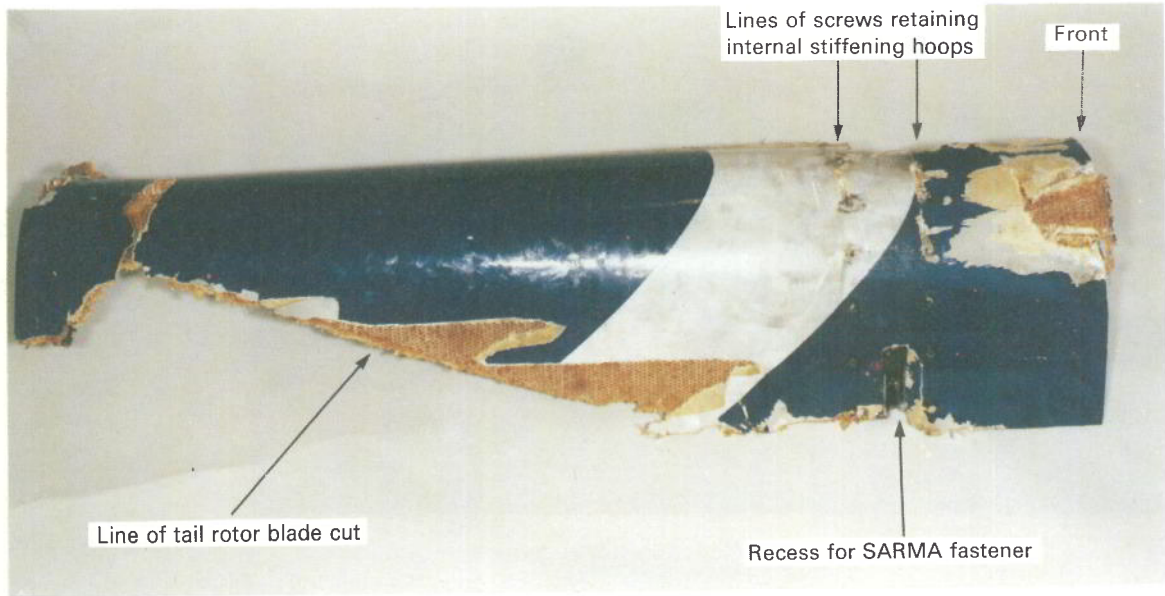
a) Right side

Views of damaged inclined driveshaft fairing

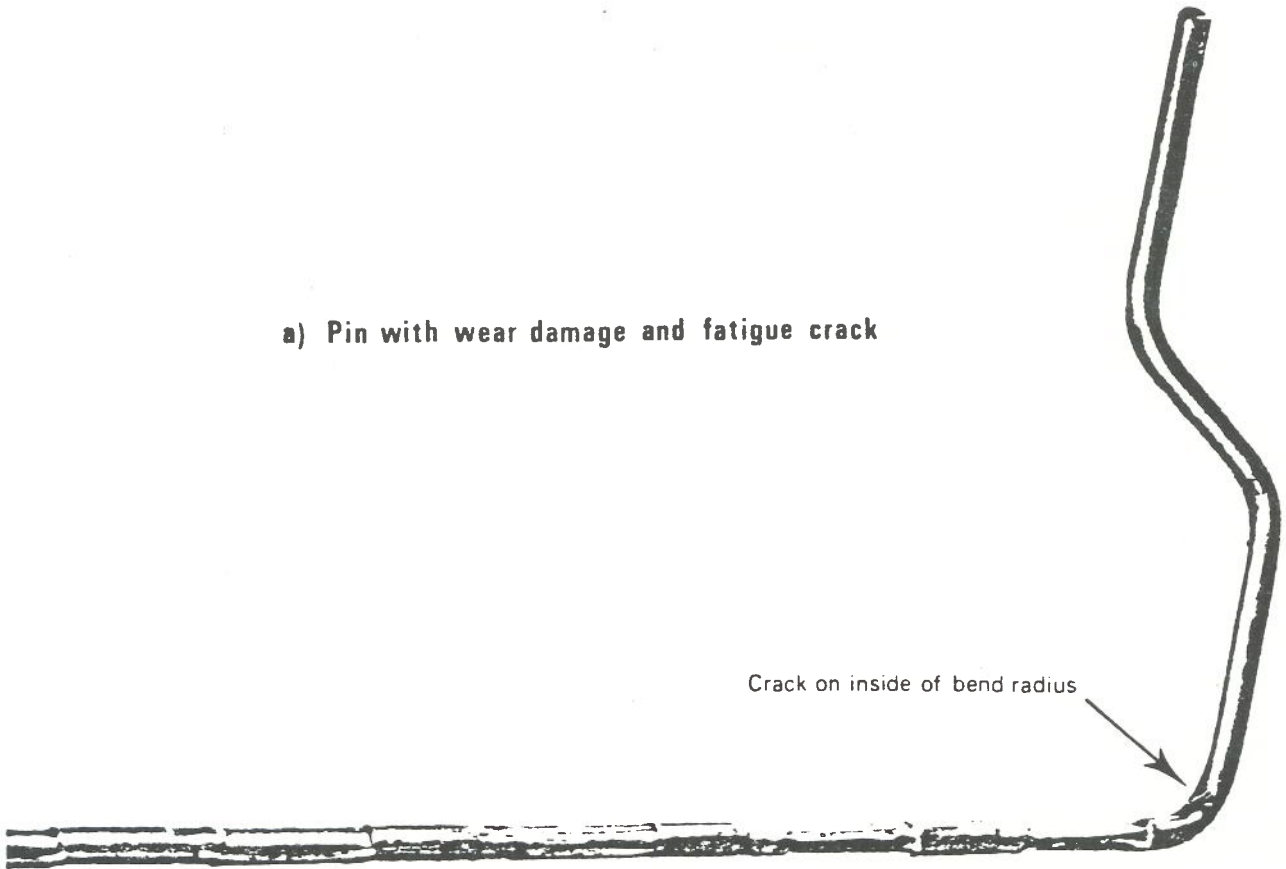
a) Pin with wear damage and fatigue crack

Stepped wear observed on hinge pins removed from two other aircraft of the Tiger fleet.

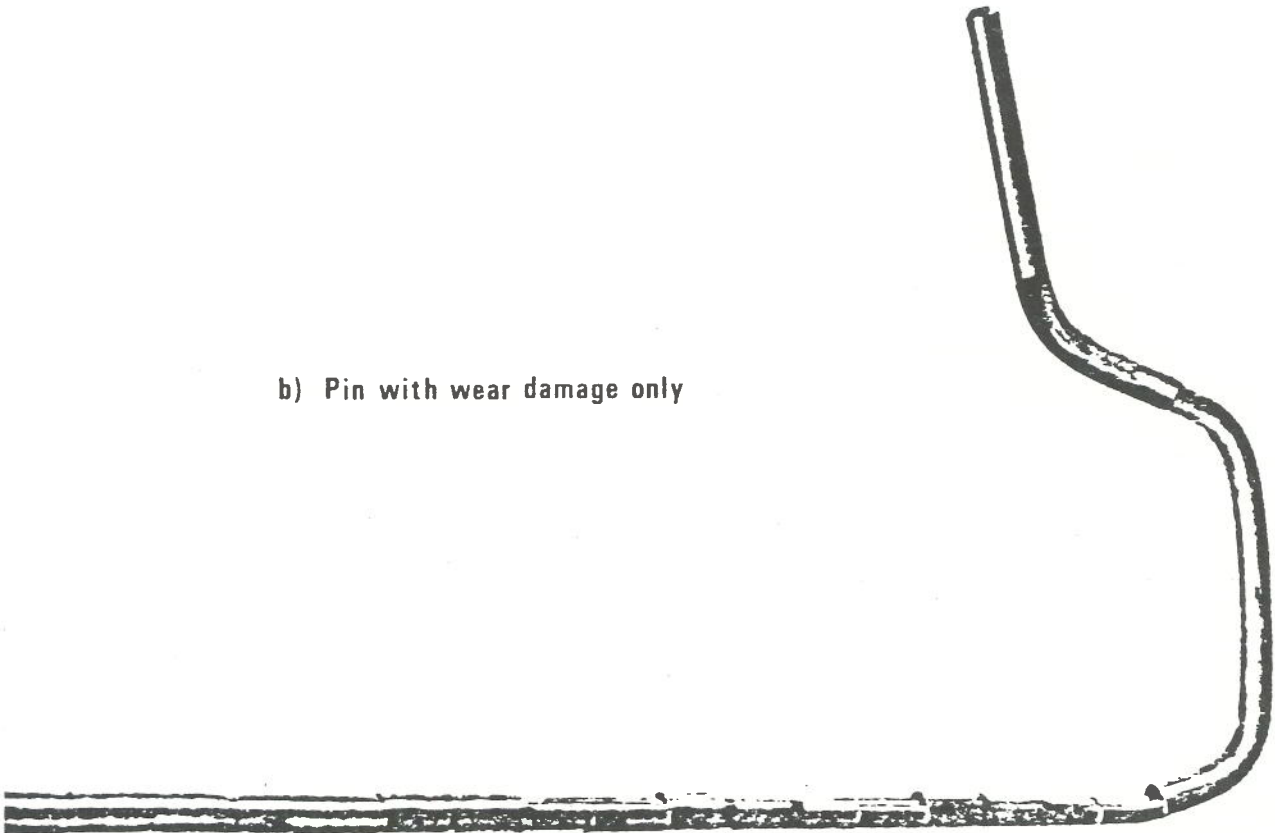
b) Pin with wear damage only
