AAIB Bulletin No: 3/95

Ref: EW/C94/12/3

Aircraft Type and Registration: Aerospatiale AS350B2 Ecureuil, G-PLMG

Location: Ballachulish, Scotland

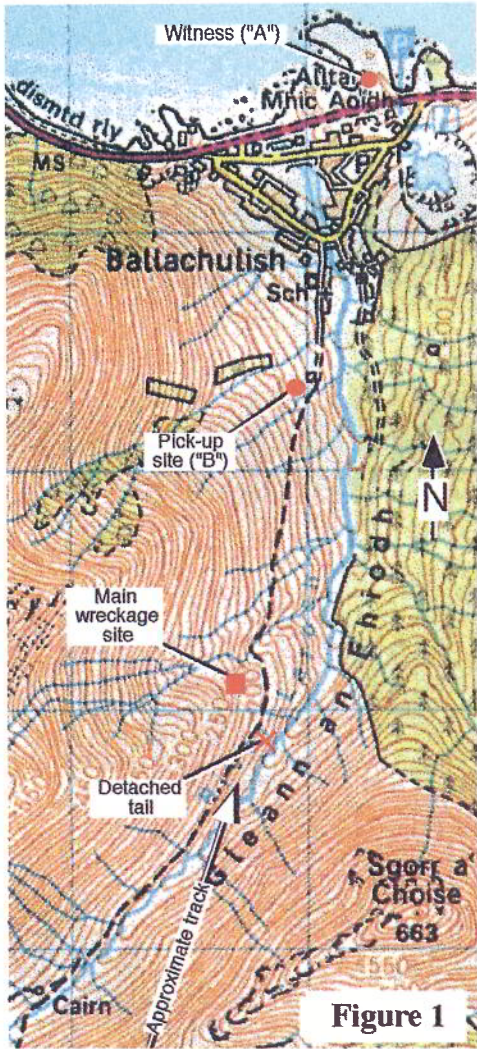
The approximate track which the pilot of G-PLMG would have been expected to take as he approached the pick up point at Ballachulish is shown on the map at Figure 1. Two witnesses saw the last few seconds of the flight of G-PLMG. The first witness was on the northern edge of Ballachulish (at position "A") looking south, and stated that he saw the helicopter for a maximum of 5 seconds. When he first saw it, the aircraft was flying towards Ballachulish but moving slightly from his right to left. He estimated that the helicopter was flying at 300 to 400 feet agl and he could see something black in colour suspended below it. He then saw the black object drop off, and almost immediately the aircraft noise stopped; the aircraft went into a vertical attitude with the nose down. There was a whisp of smoke from the tail end and the helicopter spiralled round until it went out of sight. The other witness was located near the pick up point ("B") south of Ballachulish and was waiting to assist the crew of G-PLMG who were tasked to do 12 agricultural feed lifts for a farming colleague of his. He had been waiting for the helicopter since 1400 hrs, which was the original planned meeting time, but did not hear the noise of the approaching helicopter until between 1445 hrs and 1500 hrs. When he heard it,

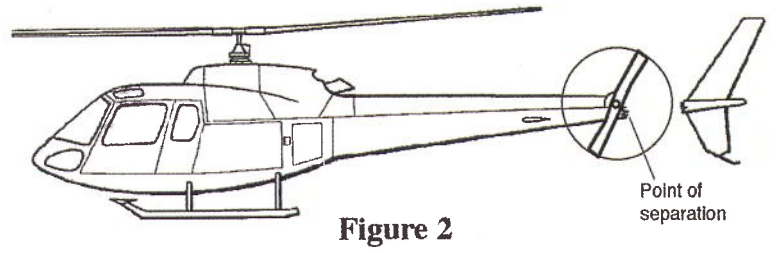
The rearmost part of the tail boom, with both vertical stabilisers still attached, was found separate from the main wreckage some 400 metres to the south. Figure 2 identifies the point of separation.

The extreme rear section of the tail boom, together with the still attached vertical stabilisers, had separated from the tail boom due to disruption of the tail boom structure at the tail rotor gearbox mount frame. The remote location of the detached parts was consistent with airborne break-up of the tail boom structure in this region, and separation of the rear section of tail boom and stabilisers at altitude. The structural damage associated with this break-up was consistent with heavy out-of-balance tail rotor forces following the blade strike, these forces being transmitted from the tail rotor gearbox casing into the thin tail boom shell structure via the heavy gearbox mount frame. The resulting disruption of the tail boom shell structure, combined with aerodynamic loading on the vertical stabilisers (which are mounted aft of the gearbox mount frame), evidently resulted in separation of the stabilisers and the rearmost part of the tail boom. Evidence of rotational rubs and scores were found on the tail boom structure adjacent to the tail rotor gearbox input coupling, which could not have occurred in the absence of gross movement of the gearbox in relation to the tail boom structure. A characteristic cut in the tail boom structure in the area of separation showed that, following structural separation, the tail section and vertical stabilisers had remained briefly attached to the aircraft by electrical cables before finally separating and falling free. (This is a possible explanation of the dark object seen by one of the witnesses suspended from the aircraft, then dropping away.)

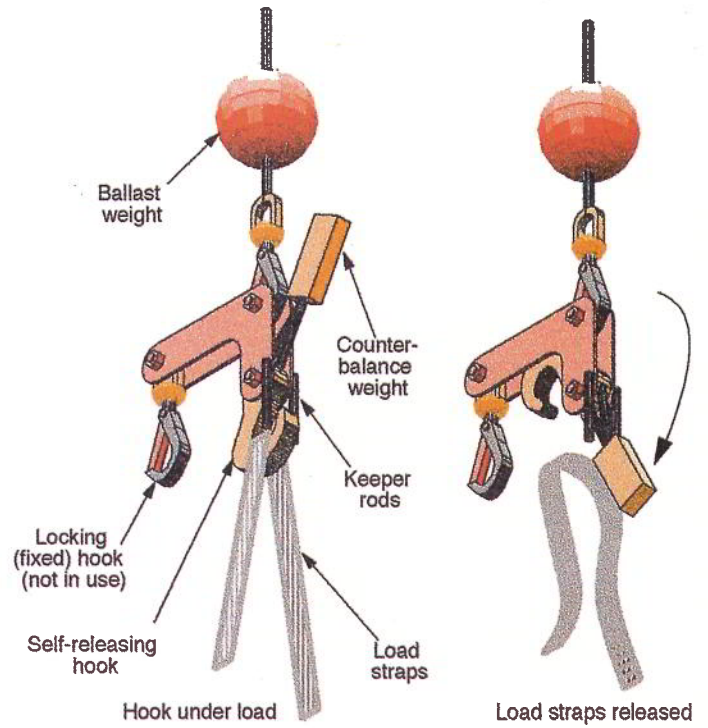
The diagram at Figure 3 shows the general arrangement of the self-releasing hook and its attachment to the main lifting strop. The hook assembly comprised a pair of separate hooks attached to the ends of an "L" shaped *chassis* frame formed from a pair of steel plates bolted back-to-back, with the hooks interposed between. The attachment point, to which the hook on the main strop was connected, comprised a spacing pillar bolted between the two plates at the *corner* of the "L". One of the two hooks was fitted with a steel counterweight on the end of an arm attached to the top of the hook, arranged in such a way that without a moderate load attached to the hook the counterbalance weight would fall to the lowest point, thereby swinging the hook into the inverted (release) position. The other hook was a standard self-locking type. In use, a ground handler would manually attach the load by lifting the counterweight so as to bring the hook into the lower position, placing the load straps over the hook and holding them in place until the aircraft started to pick up the load. Once the load started to lift, its weight maintained the hook in the *bottom* position where it remained throughout the flight until the drop off point was reached and the pilot lowered the load onto the ground. As weight came off the hook, the counterweight was sufficient to overcome the weight of any webbing or other straps attached to the load itself, thereby swinging the hook up into the vertical position and disconnecting the load straps without any need for a ground handler to be present. (The *fixed* hook was used to facilitate certain types of lifting operation in which the load was suspended from a strap looped from the fixed to the self-releasing hooks; only the self-releasing hook was being used on the day of the accident.)

Examination of the (red painted) self-releasing hook revealed fragments of tail rotor blade leading edge material jammed tightly into the gap between the secondary (fixed) hook and the side-plate members, indicating beyond all doubt that the hook had struck the tail rotor, resulting in the separation of the outer part of the blade. The direction of rotation of the tail rotor is such that the lowermost blade arcs forwards and upwards, and it was evident that the strop and hook had trailed rearwards and upwards into the tail rotor disc, the resulting strike throwing the hook, and the attached strop and ballast weight, up and over the trailing edge of the right-hand horizontal stabiliser. The energy associated with this process caused the strop to cut forward through the trailing edge of the right stabiliser, and the hook-

More detailed examination of what initially appeared to be accident damage to the self-releasing hook revealed that this damage was in fact not consistent with the impact, and consequently must have occurred between the point of last departure, when the hook had been used successfully (and must therefore have been serviceable) and the accident. The lower corner of the counterbalance weight was heavily bruised and its mounting arm was bent (in the same direction as the bruise); both of the two keeper rods adjacent to the self-releasing hook were bent and bruised at their ends (the bruising and bending being in the same direction as that of the counterbalance), and there was a bruise and gouge at the *tip* end of the hook. A deep bruise was also visible on the counterbalance arm, where the bent keeper rod had been driven forcibly back against it. Figure 4 shows the deformation of the hook and identifies the sites of the damage. The surface textures of the bruises to the counterbalance weight and the ends of the keeper rods, in particular, were rough and irregular, and not typical of bruises caused by metal-to-metal impacts. Taken overall, the damage formed a pattern consistent with the hook having struck a rock whilst suspended from the aircraft in flight, presumably as the aircraft crested the ridge upon entering the valley in which it crashed. There is little doubt that a strike against a rock in these circumstances would have been capable of knocking the hook back with sufficient energy to cause it to swing rearwards and upwards into the tail rotor disc.
