**WIRES REMOVED FROM N653UA FOR EXAMINATION**

## N653UA - REPAIRED WIRE LIST

AAIB Bulletin No: 10/97

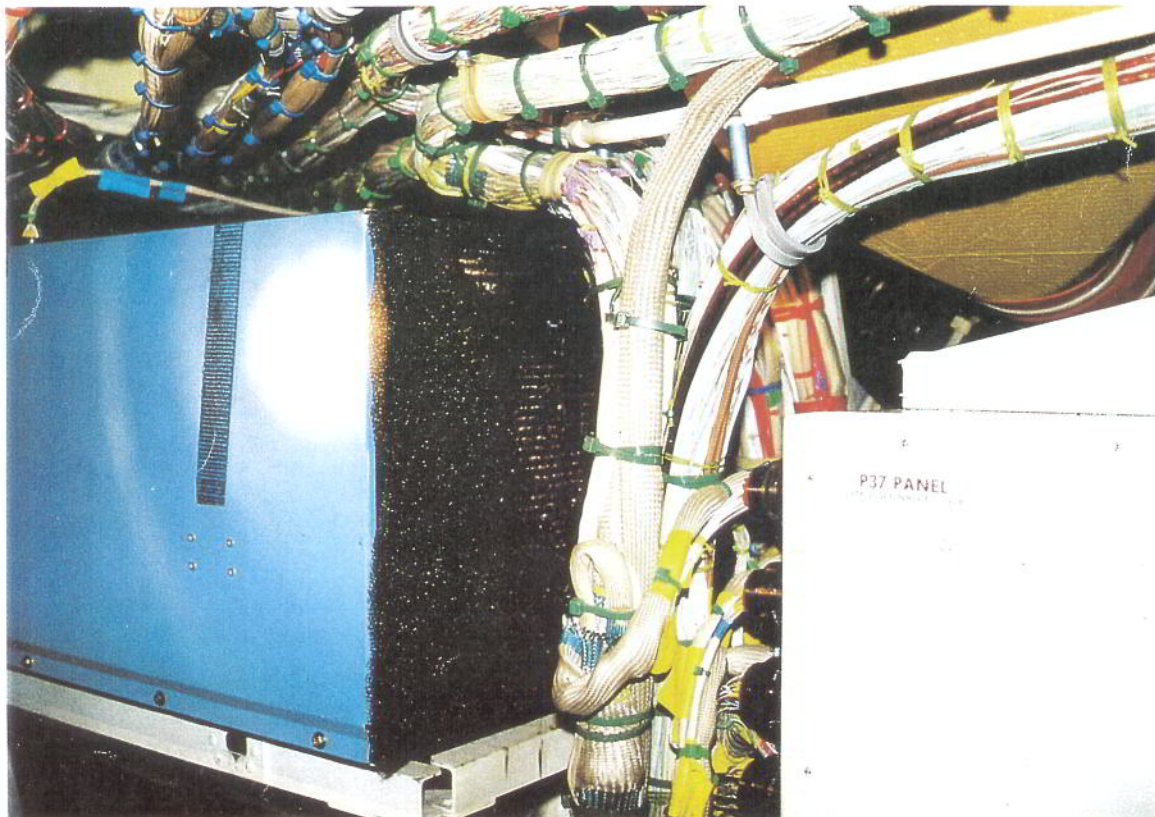
General view, looking forward and outboard, of the aft inboard corner of the galley chiller unit (blue) in relation to the wiring looms. Crew emergency oxygen bottle is located beneath chiller.

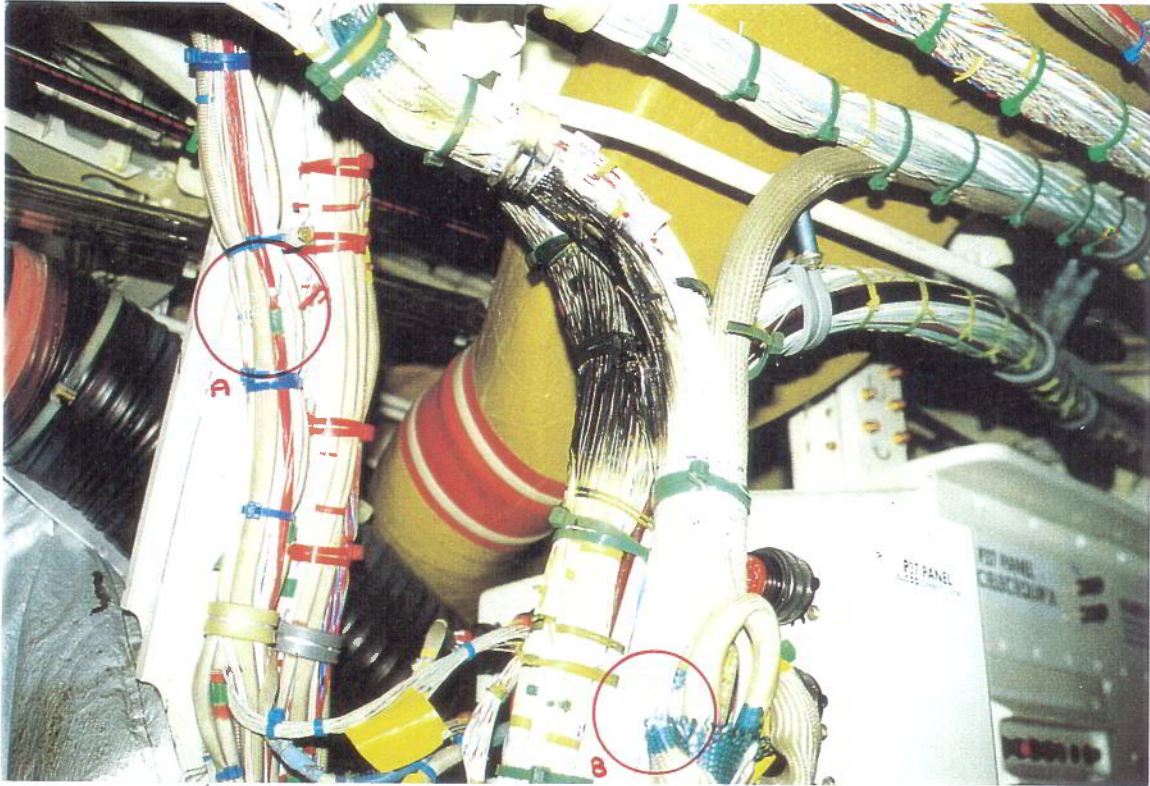
General view of damaged wires after chiller removal, with partially failed loom nearest the camera. Areas identified A and B exhibit wire damage not directly related to the loom failure (see Figure B-3). Of significance, damage at A is approximately at the same height as the failed section of loom.

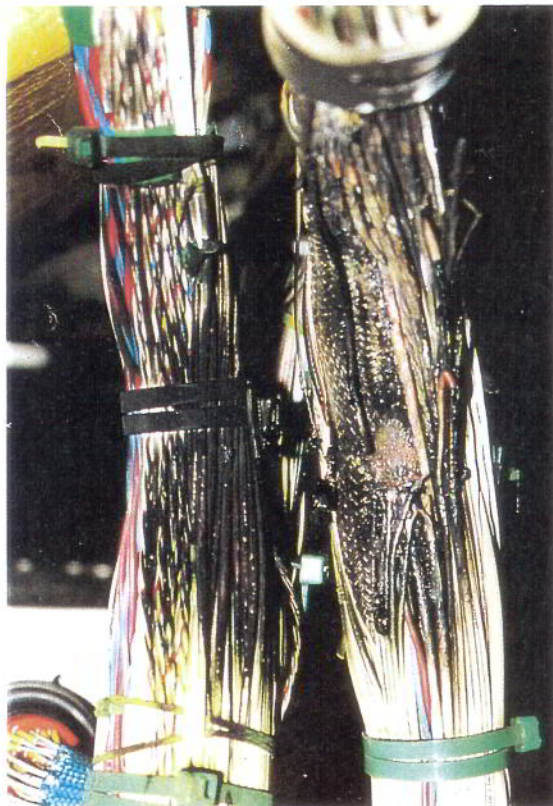
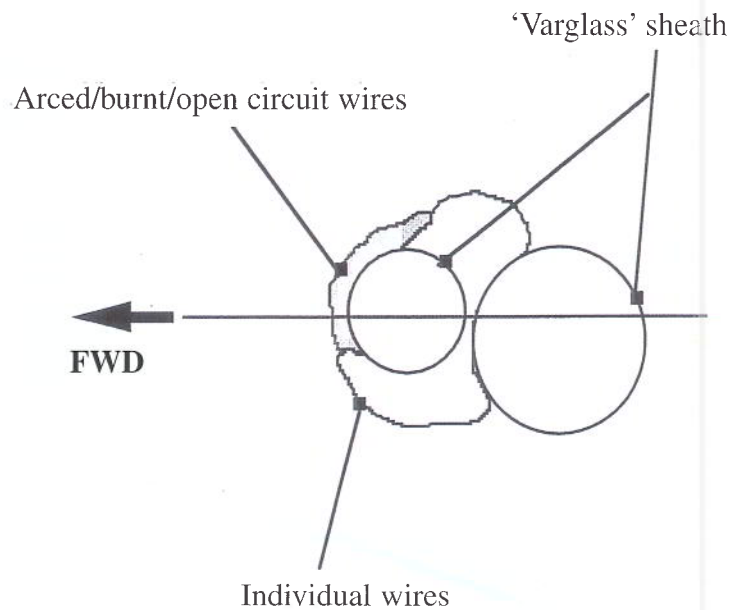
Detail view of failed areas of loom, and the adjacent heat affected loom. Above is a sketch of a cross section of the failed loom at the identified position.

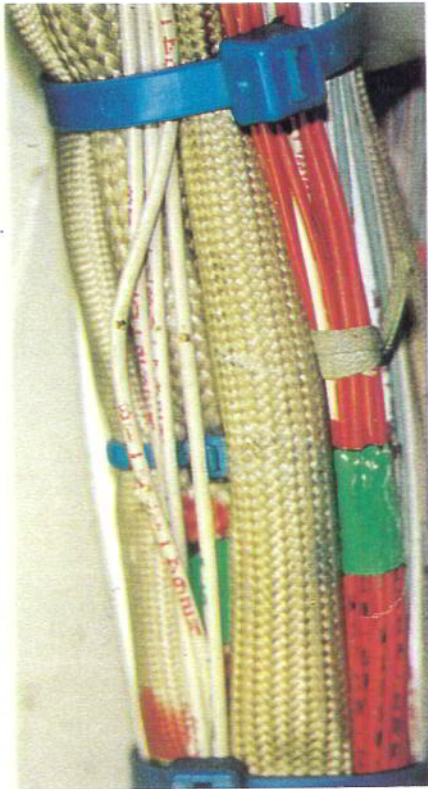
Wire damage at location A in figure B-2. Three wires affected in addition to scuffing of braided sheath.

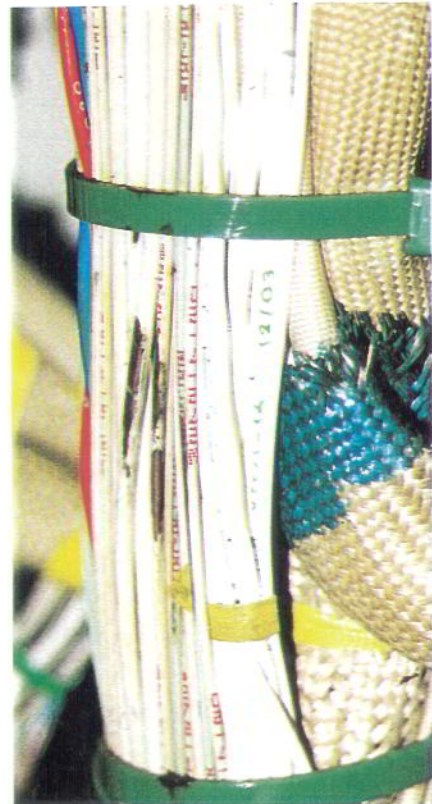
Abrasion of insulation topcoat at location B in figure B-2.

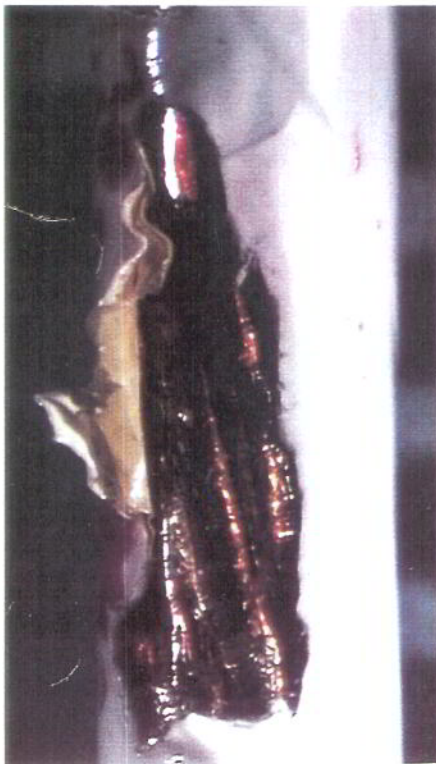
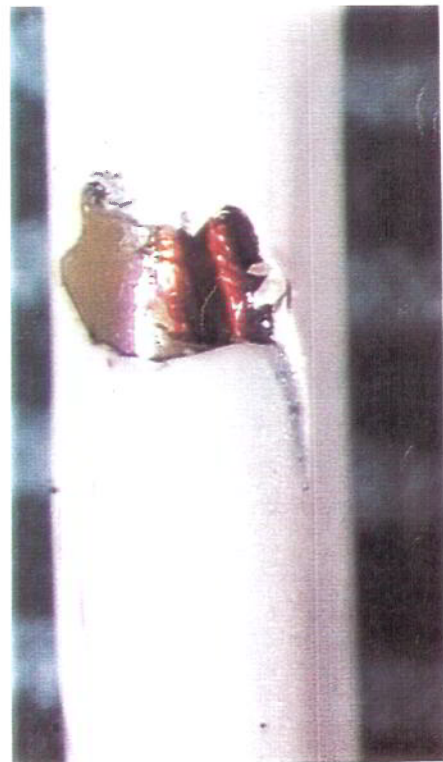
Details of 'cutting/slicing' damage to the outer insulation of two of the wires shown above left, leading to exposure of the polyimide insulation.

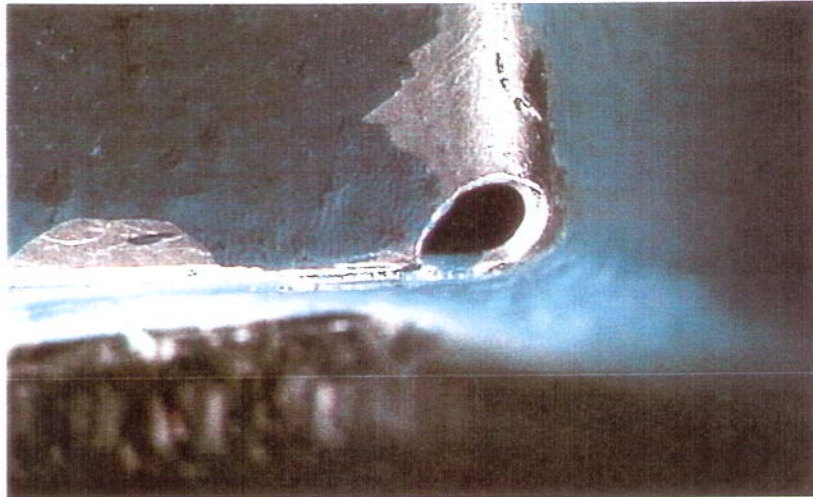
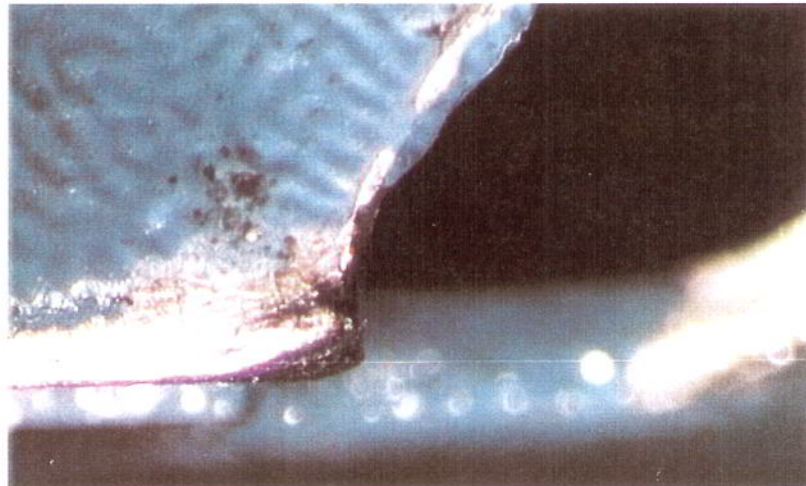
General view, above, of the top aft outboard corner of the chiller box showing the chipped paint, nature of construction and general bruising and, below, a detail of the burred 'sharp' edge.

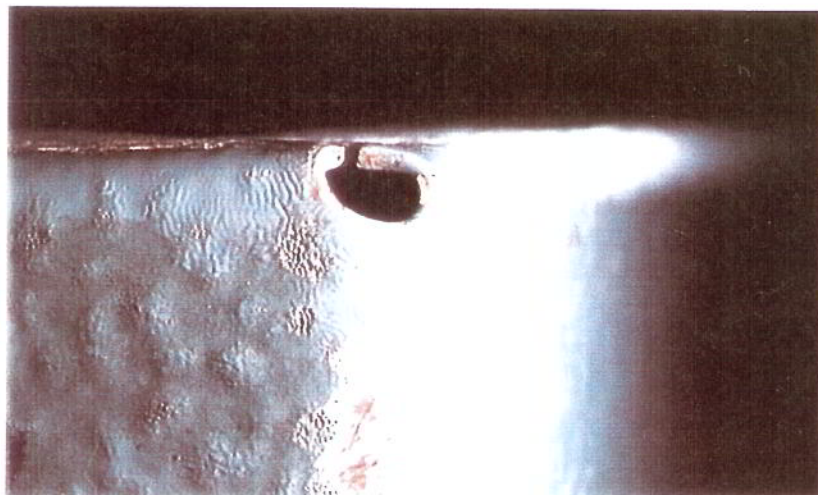
c

For comparison, below, a view of a top corner from the front of the chiller where three folds intersect. No exposed sharp edges were apparent.

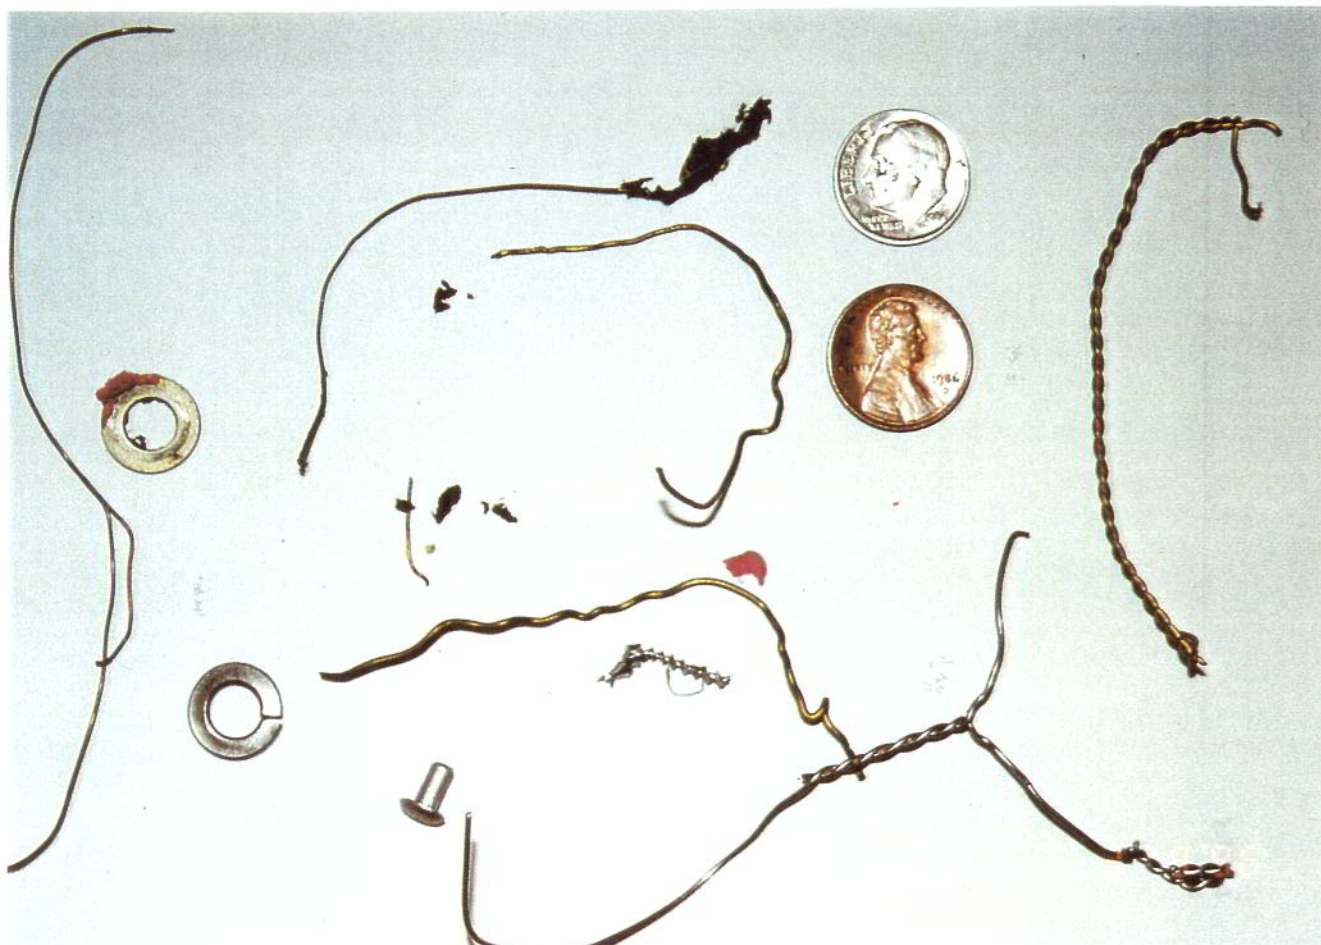
Above; Sample of conductive debris remove from immediate environment of chiller in the E&E bay of N653UA. Below: SEM analysis of typical swarf found in this region. (See also Figure D-1)

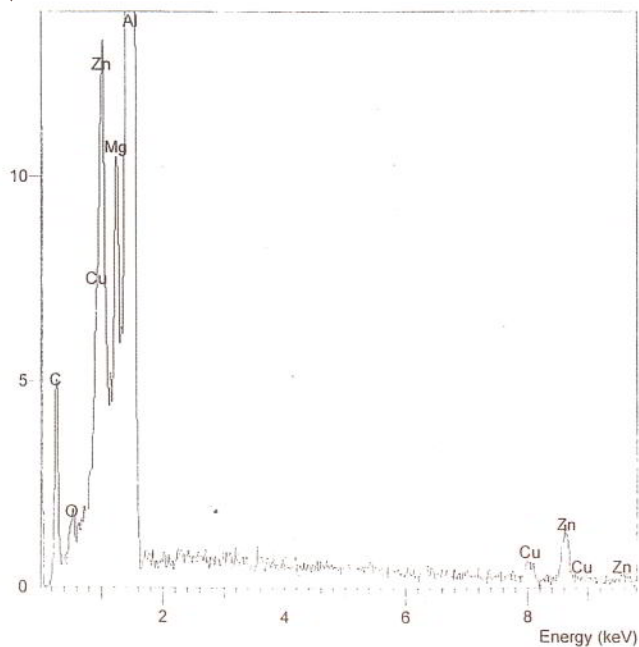
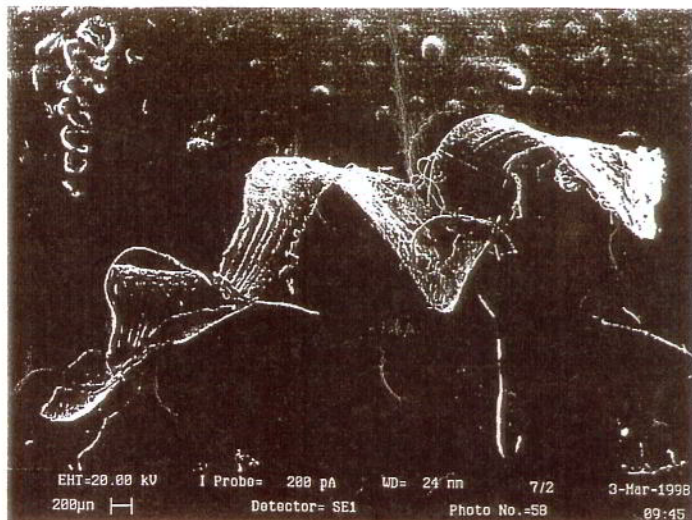
Debris from floor below damaged harness - micrograph and EDX spectrum of aluminium swarf 7/2

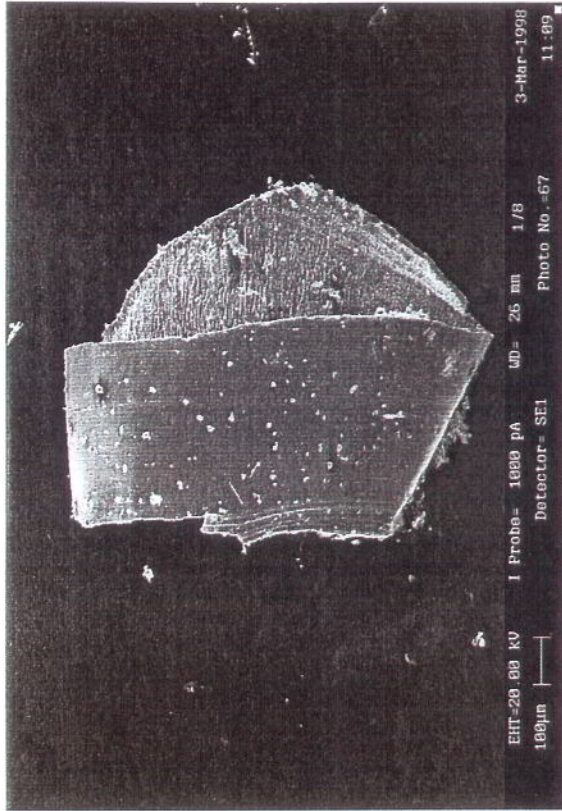
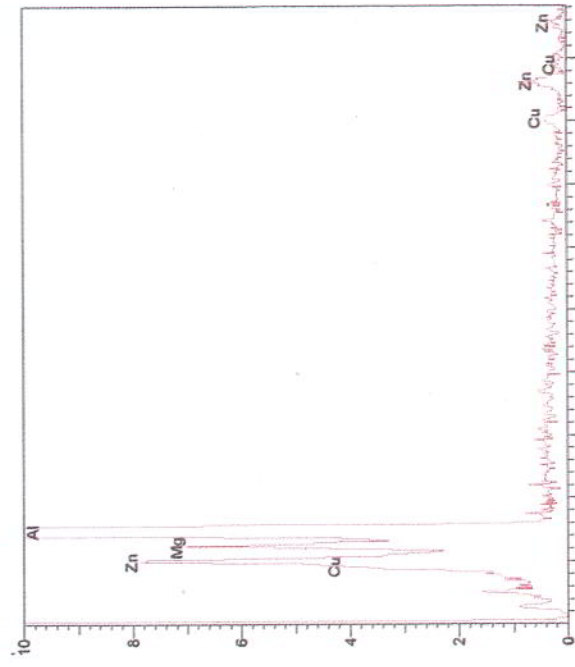
Debris from vacuum box - micrograph and EDX spectrum of aluminium swarf particle 1/8

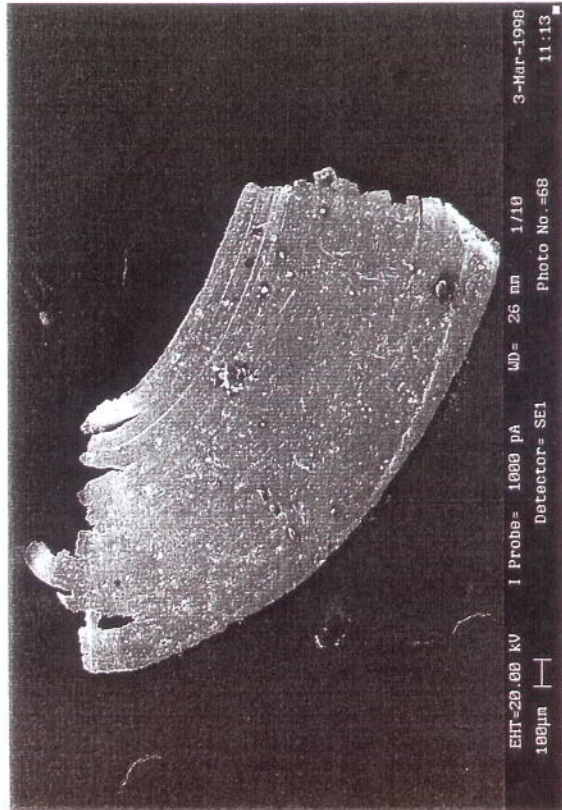
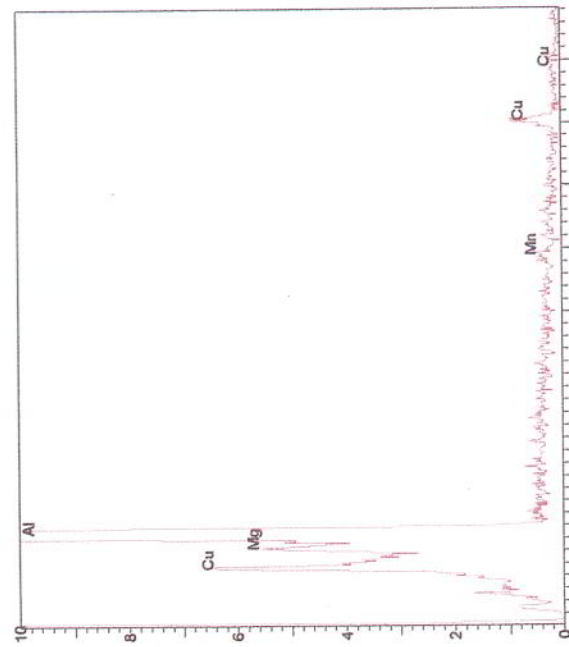
Debris from vacuum box - micrograph and EDX spectrum of aluminium swarf particle 1/10

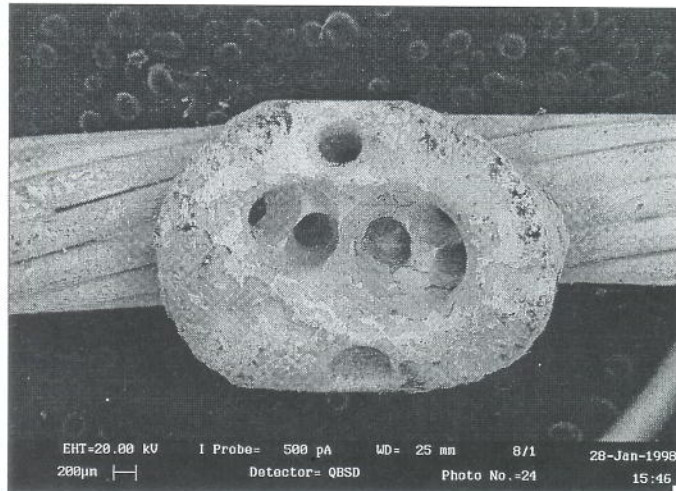
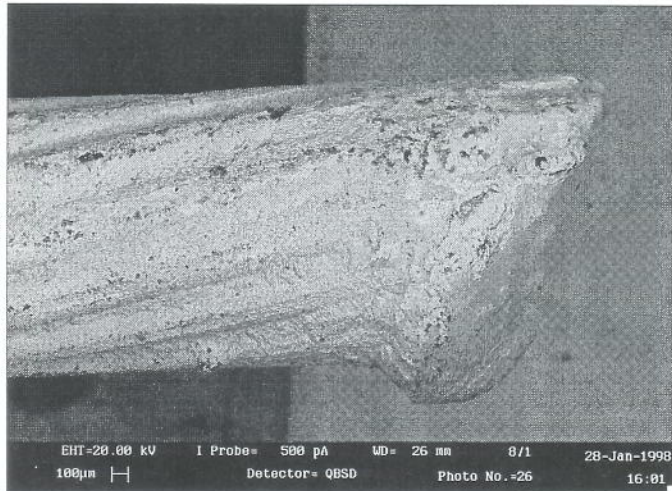
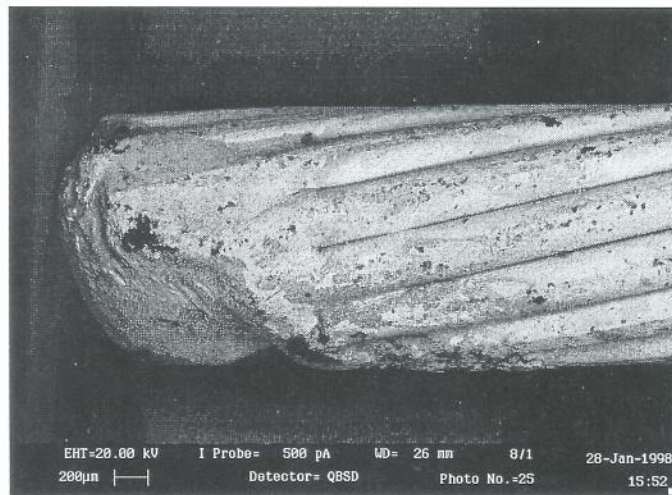
Debris from shelf below damaged harness - copper conductor

Upper micrograph - central globular attachment to conductor  
 Central micrograph - one end; Lower micrograph - other end

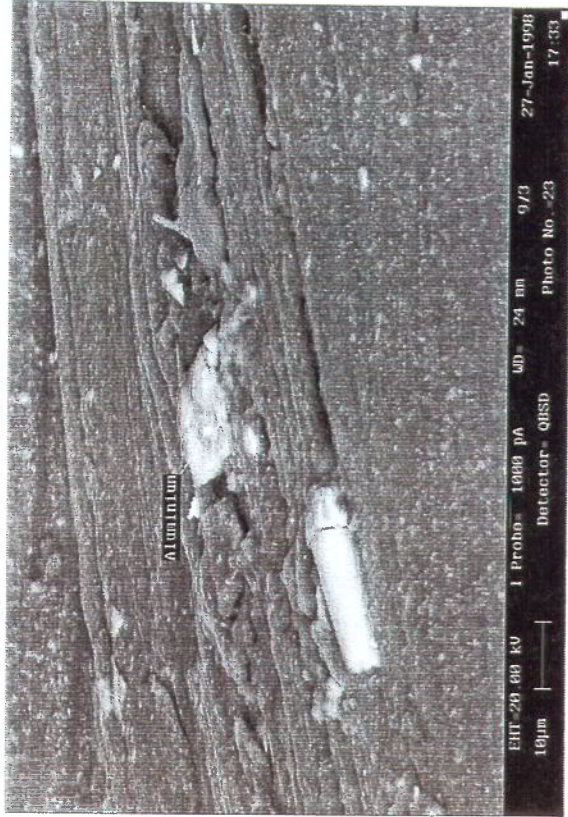
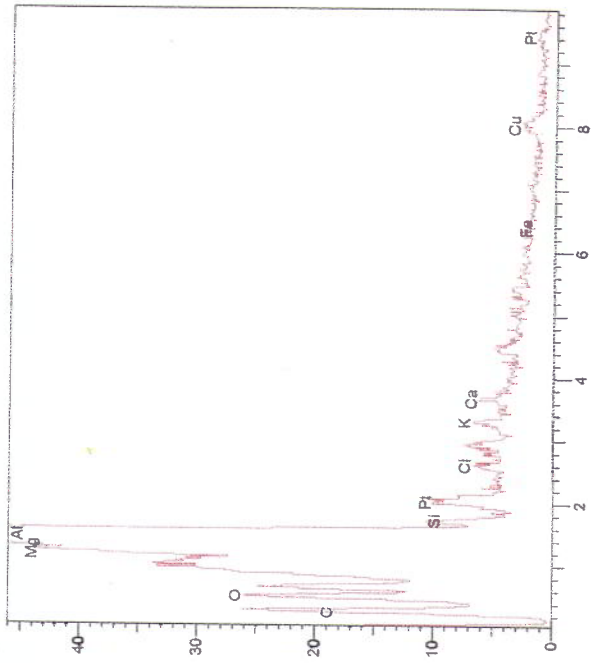
Wire from outboard harness - micrograph and EDX spectrum  
 of embedded aluminium in insulation of wire, 9/3

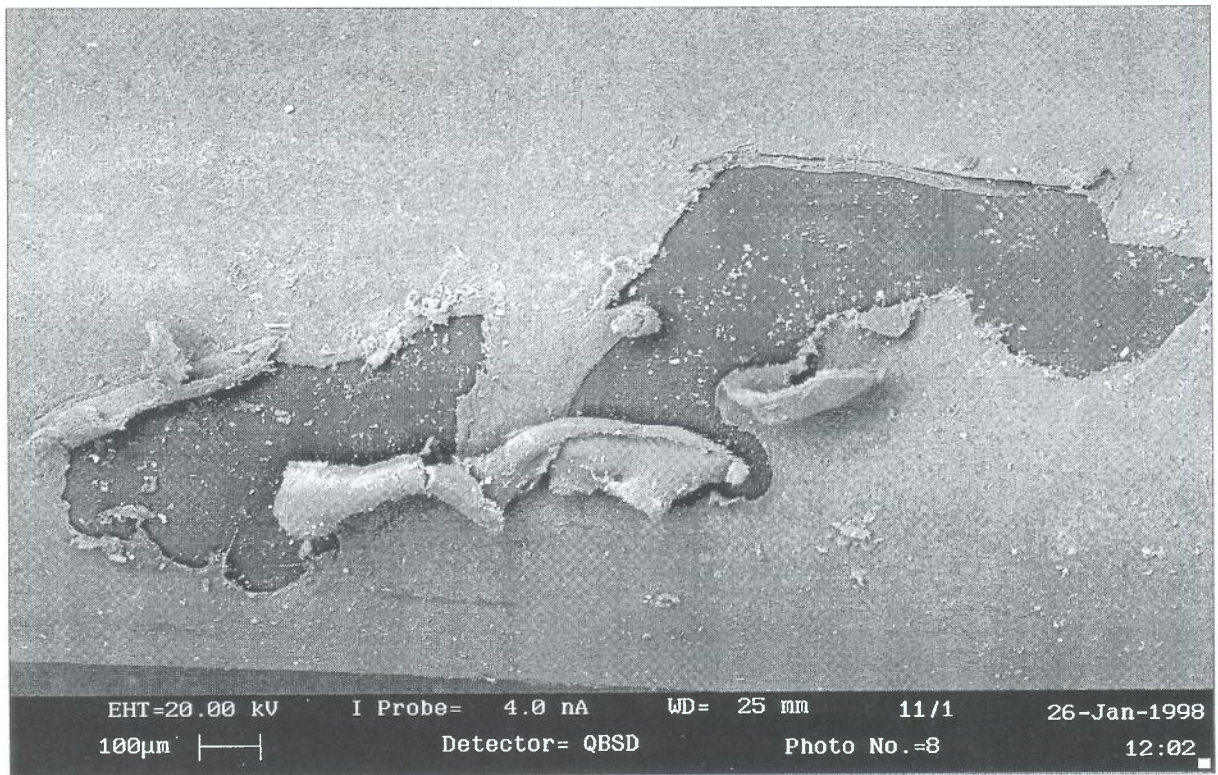
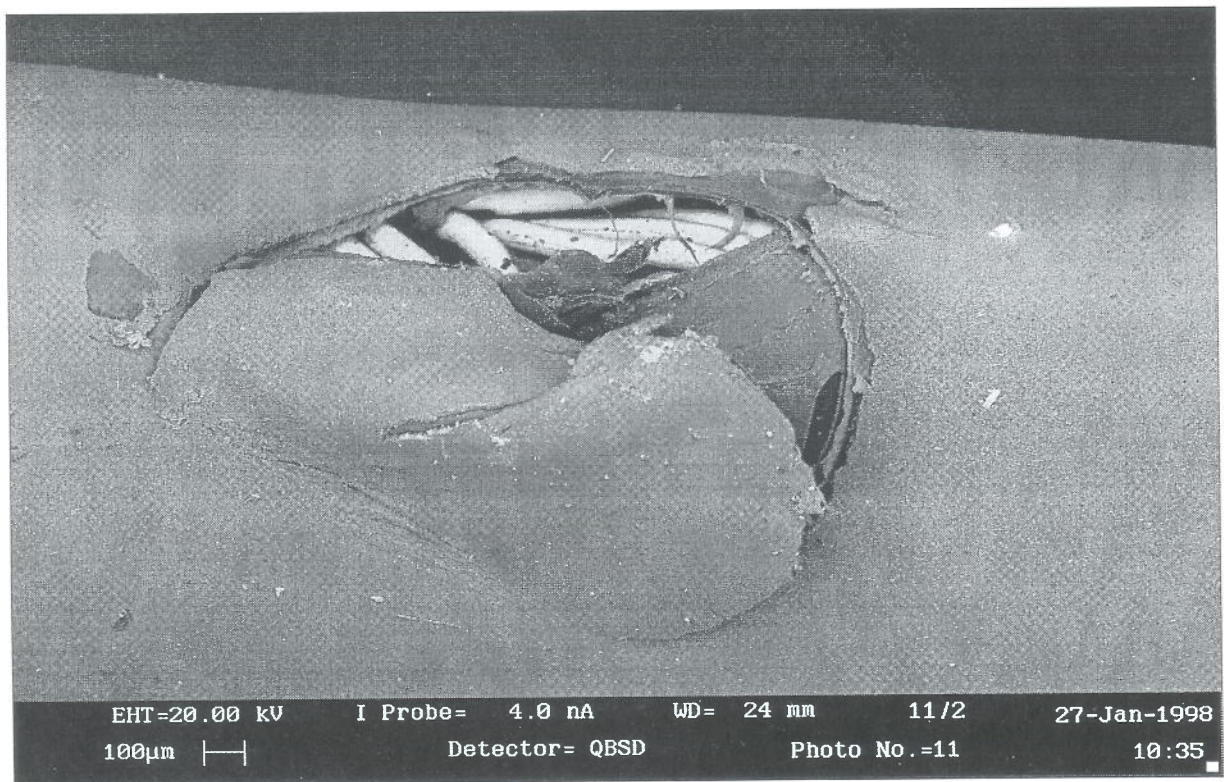
Wire from harness which suffered electrical failure  
Mechanical damage at a distance of ~ 10 mm from blackened area

Upper micrograph - wire 11/1; Lower micrograph - wire 11/2

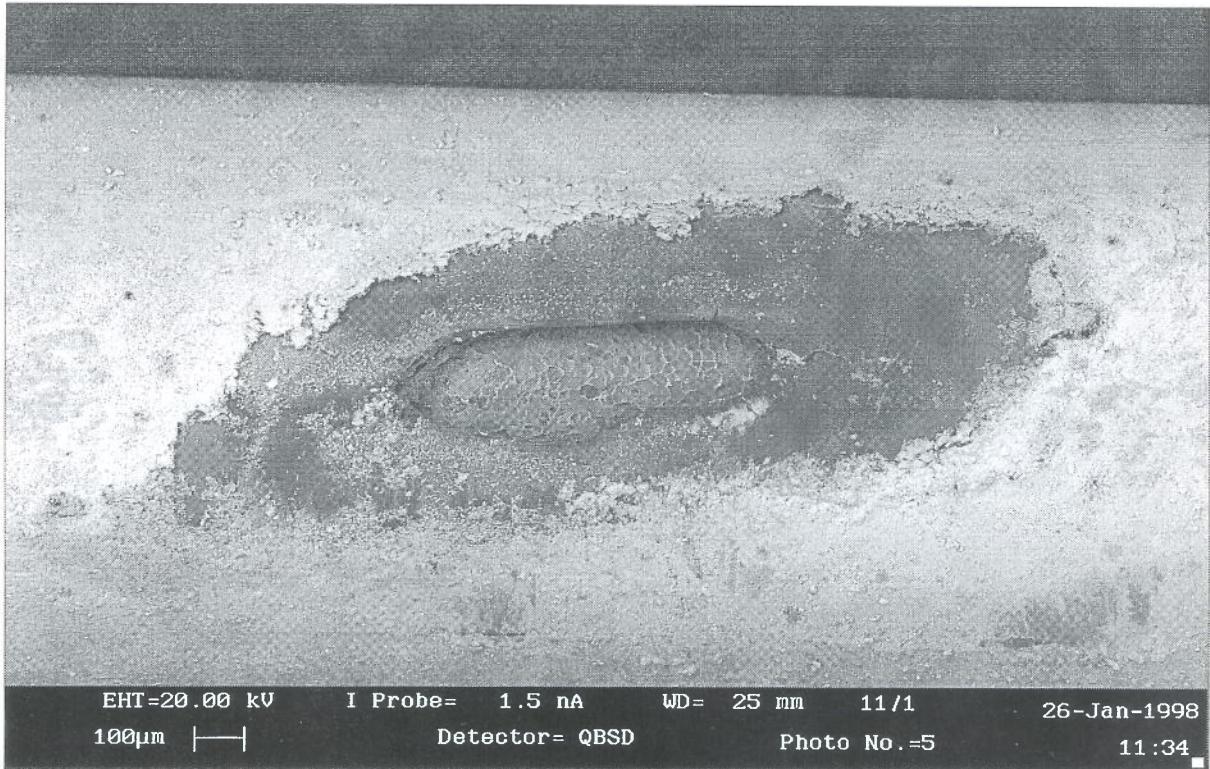
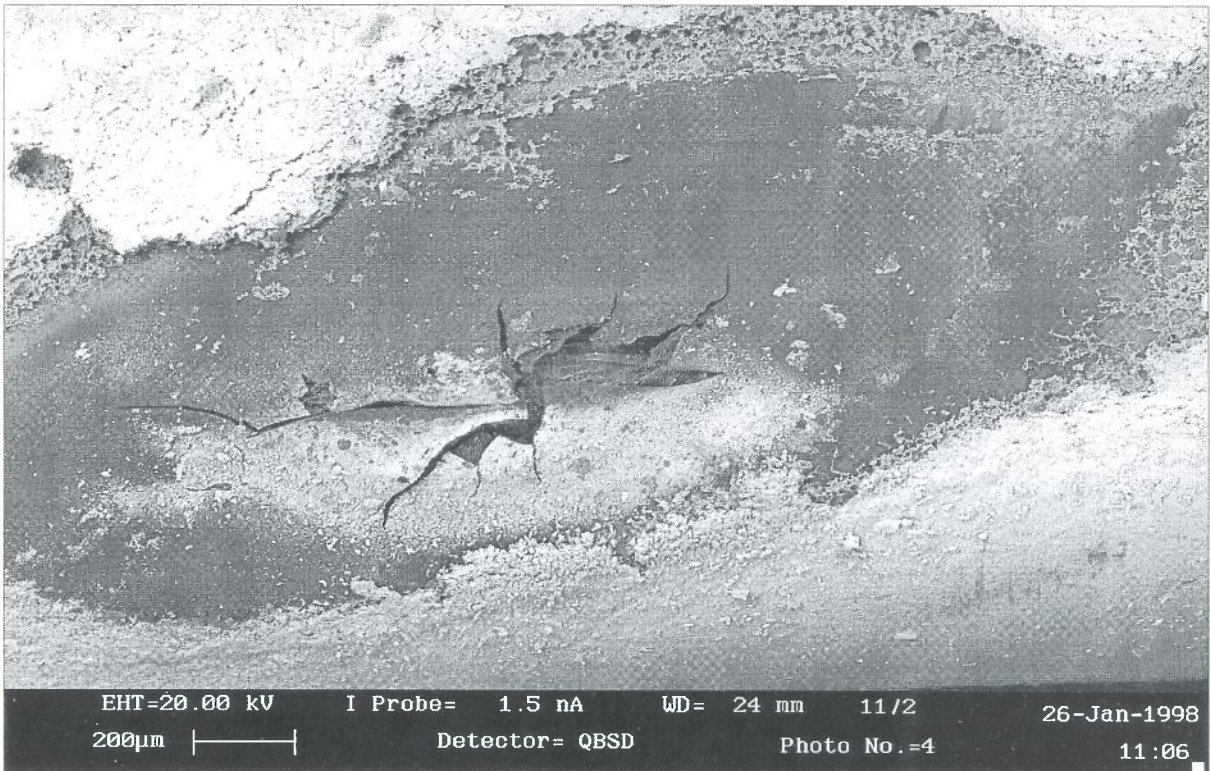
Wire from harness which suffered electrical failure  
Heat damage at a distance of ~ 10 mm from blackened area

Upper micrograph - wire 11/1; Lower micrograph - wire 11/2

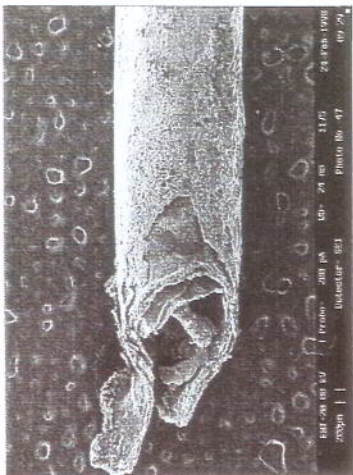
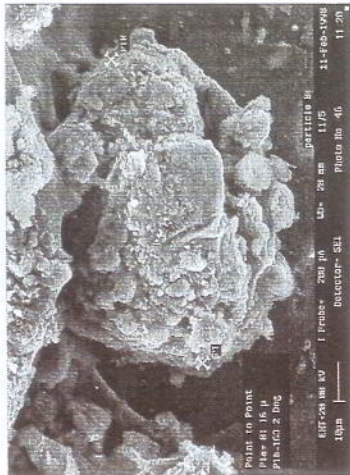
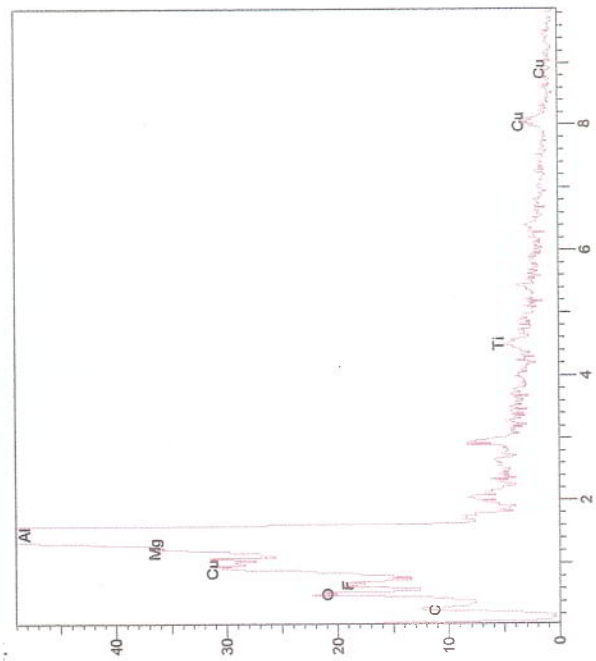
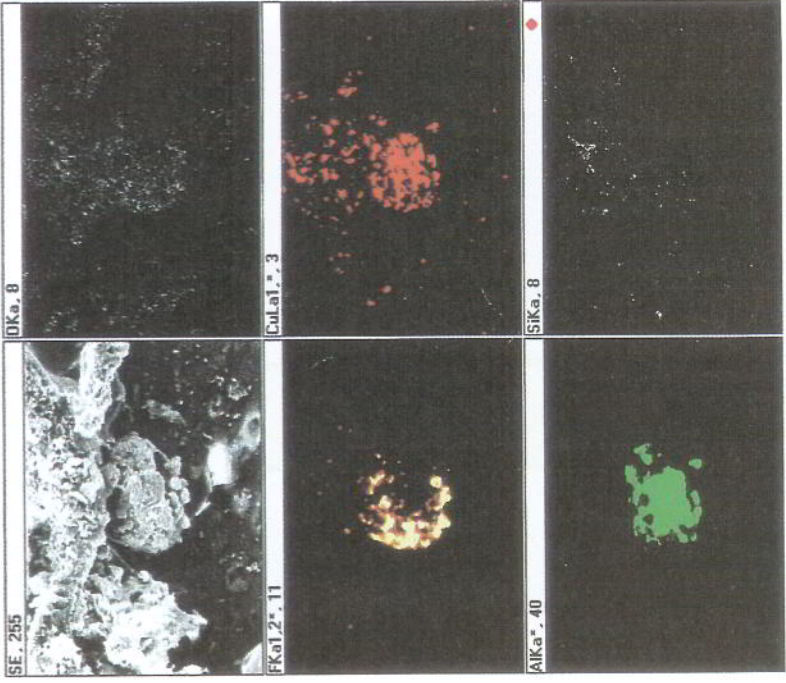
Wires from harness which suffered electrical failure

LHS: micrographs and EDX spectrum of aluminium sphere on insulation of wire 11/5

RHS: Element maps of aluminium sphere on wire 11/5

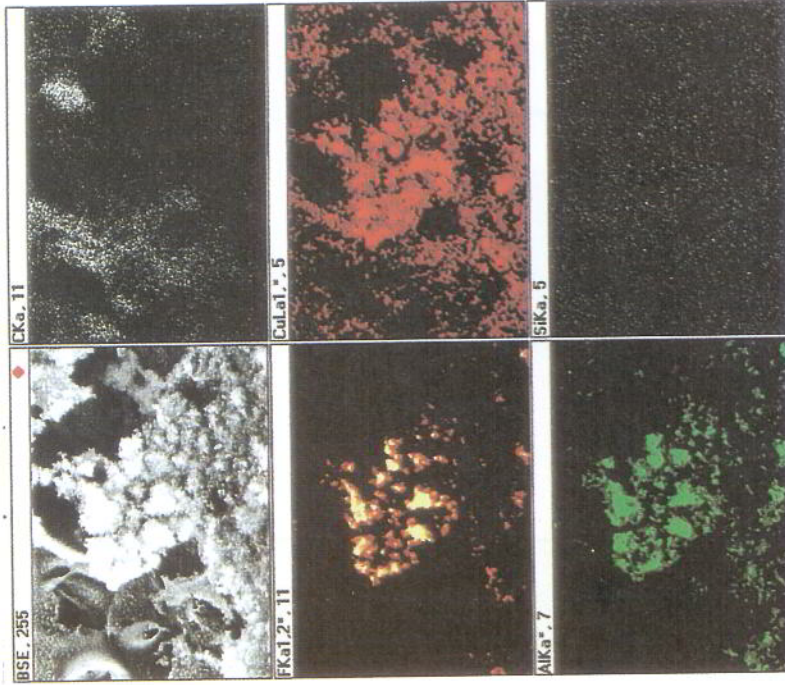
Wires from harness which suffered electrical failure

LHS: micrographs and EDX spectrum of aluminum and copper 'dust' on insulation of wire 11/7

RHS: Element maps of aluminum nodules on wire 11/8

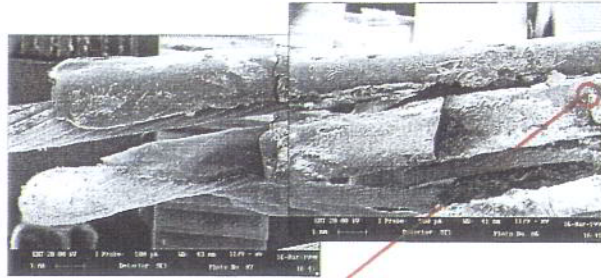
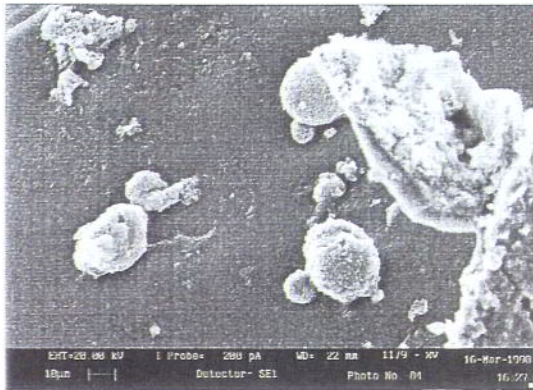
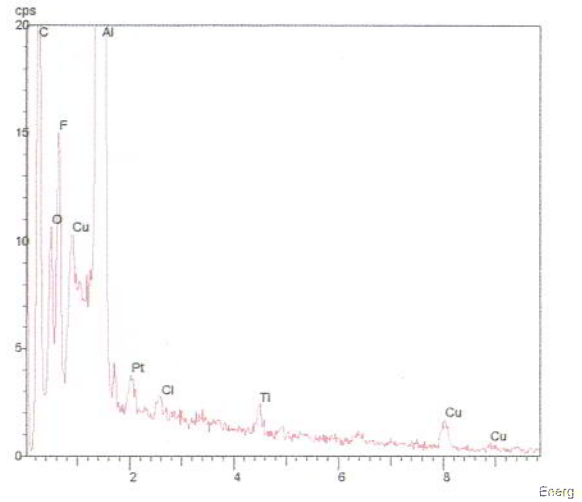
Wire from harness which suffered electrical failure

Micrographs and EDX spectrum of aluminium spheres on insulation of wire 11/9  
Upper micrograph - location @ O; lower micrograph - detail

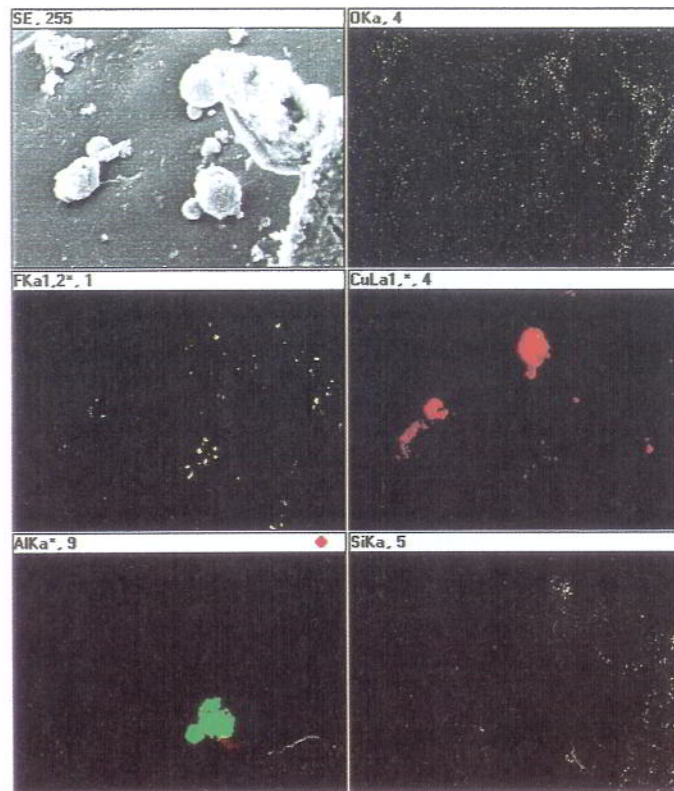
Element maps of aluminium and copper spheres on wire 11/9

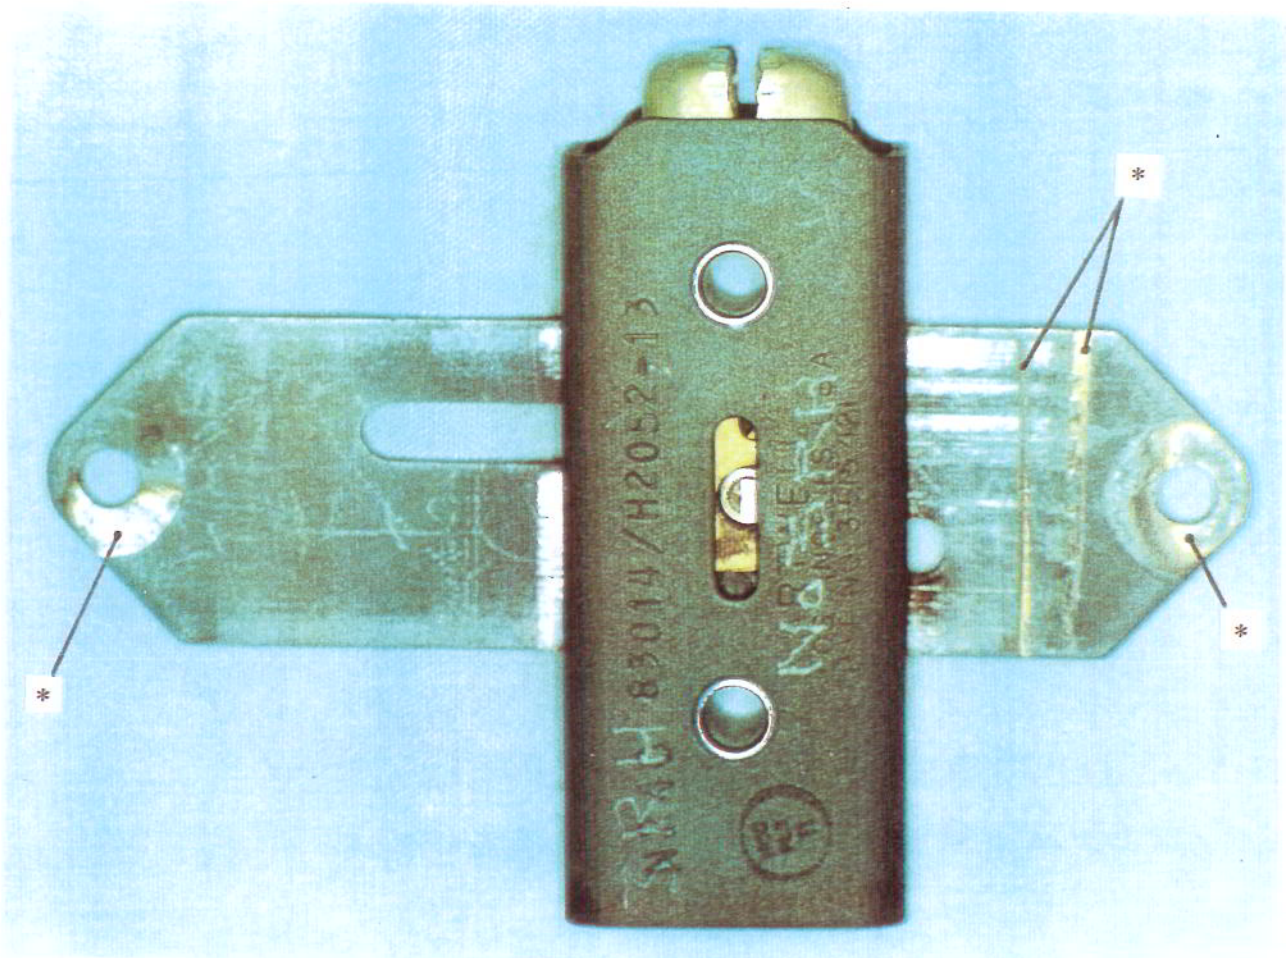
Latch No 3 from left side of aircraft, as found, and jammed mid-travel. Note evidence of fretting around operating rod attachment holes and on cam plate (\*), and displaced pivot pin.

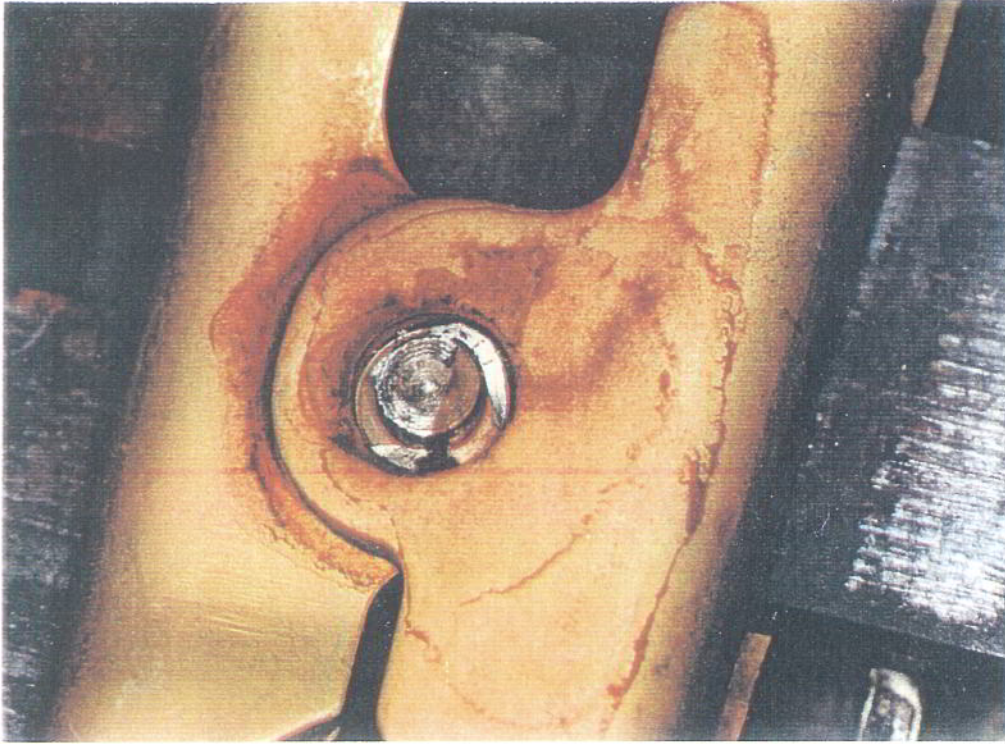
Detail of damage to top of stepped pivot pin, No 3 right side latch.

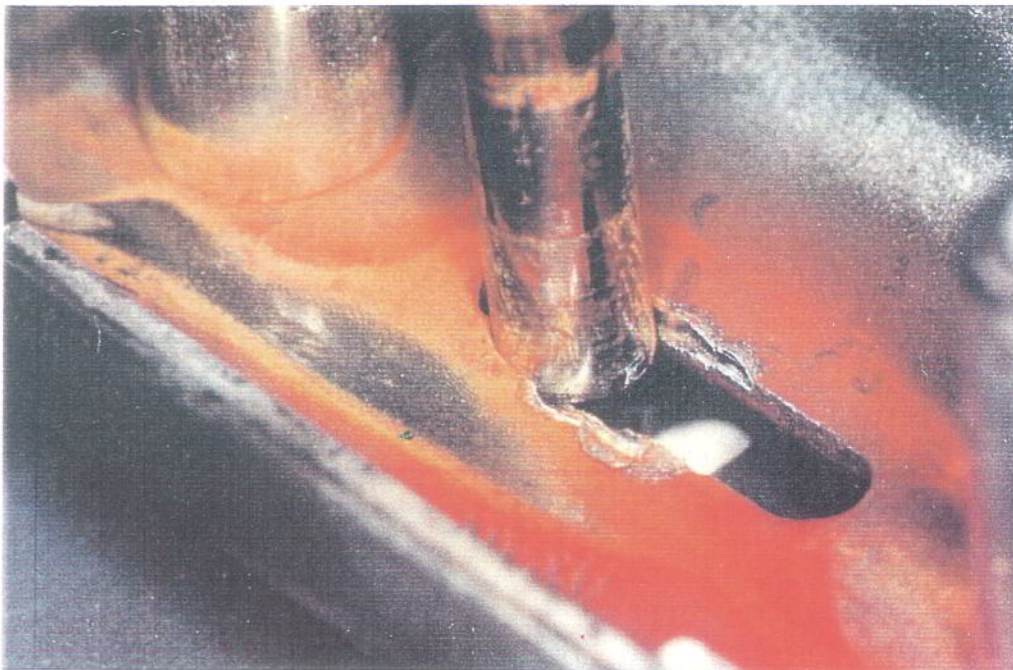
Detail of lower part of stepped pivot pin, located in area of fretting/wear on the inside face of the lower latch housing. The damage to the right of the pin along the slot edge was caused during the attempted operation and forced opening of the door. Orange deposits resulted from wear between jaws and housing.

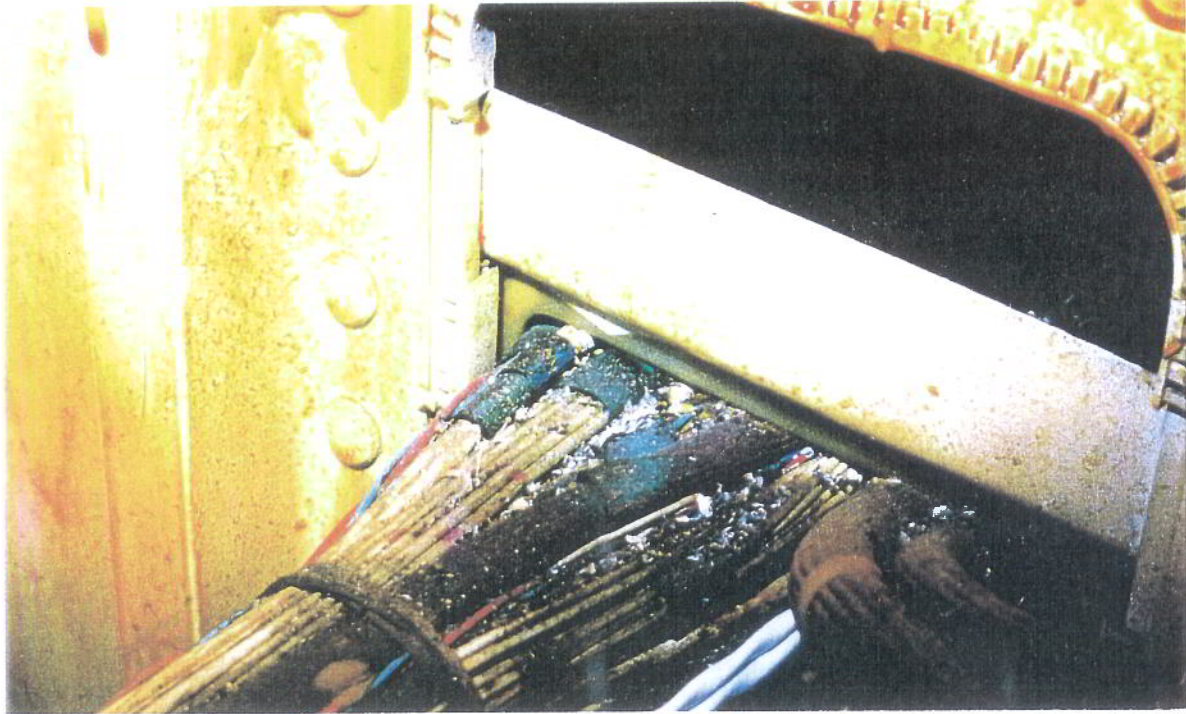
Contamination of wiring looms by drilling swarf, found in a retired B747, above, and an A300, below.
