**No: 3/92**

**Ref: EW/G91/11/08**

**Aircraft Type and Registration:** Piper PA-34-200-2, G-FLYI

**Location:** Elstree Airfield, Hertfordshire

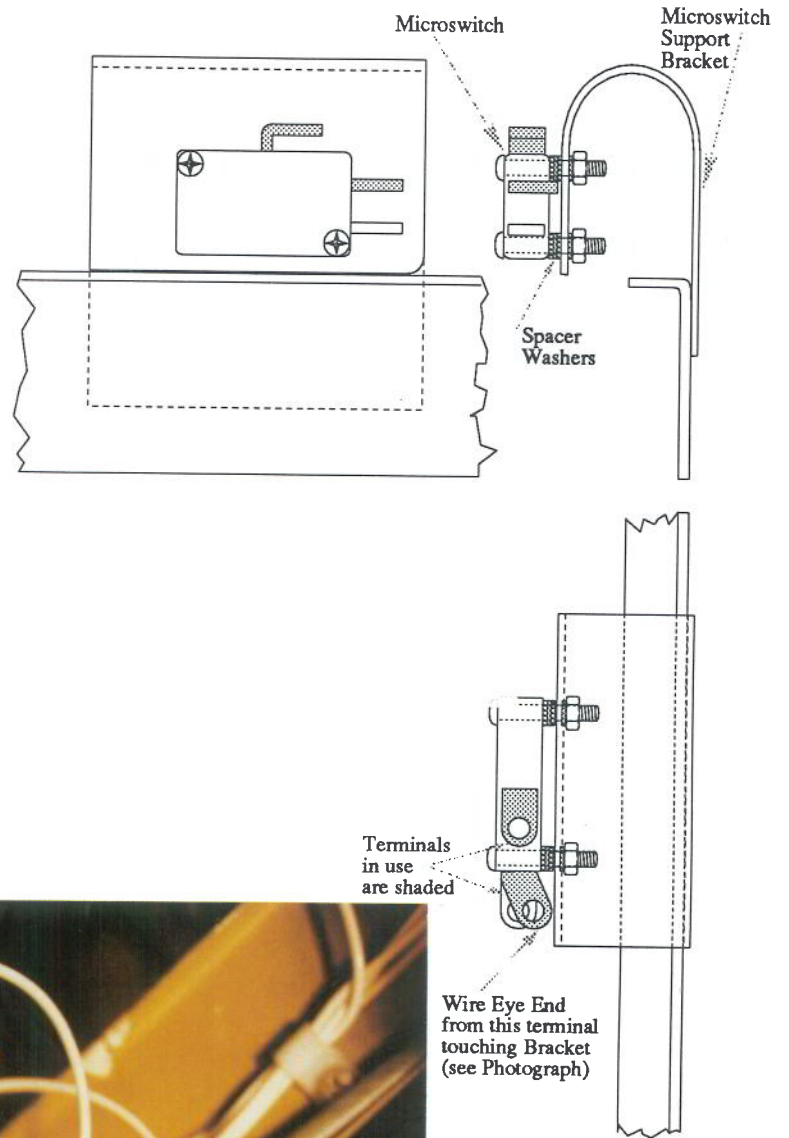
Fig 1  
Scrap views of  
Landing gear warning  
Microswitch installation  
on Throttle System

During hangar checks the first attempt to retract the landing gear was unsuccessful and it was noticed that the 5 amp circuit breaker in the electrical supply to the landing gear control and indication circuits had 'tripped', although the 10 amp supply circuit breaker to the gear motor had not. The 5 amp breaker was reset, but 'tripped' again immediately. Electrical checks then revealed that there was a permanent 'short' to earth at the throttle microswitch where one of the wire terminal tags had come into hard contact with the microswitch support bracket. (See photograph and diagrams) The microswitch was separated from the metal bracket by a stack of washers but one of its terminals was found bent towards the bracket. It was noted that the microswitch terminals, (even in a new microswitch) were able to move a little, relative to the body. There was no insulation between this terminal and the bracket.
