**ACCIDENT**

<b>Aircraft Type and Registration:</b>	Socata TB10 Tobago, G-BOIU	
<b>No &amp; Type of Engines:</b>	1 Lycoming O-360-A1AD piston engine	
<b>Category:</b>	1.3	
<b>Year of Manufacture:</b>	1988	
<b>Date &amp; Time (UTC):</b>	28 August 2004 at 1056 hrs	
<b>Location:</b>	Bournemouth International Airport, Dorset	
<b>Type of Flight:</b>	Private	
<b>Persons on Board:</b>	Crew - 1	Passengers - 2
<b>Injuries:</b>	Crew - 1	Passengers - 2 (1 Fatal)
<b>Nature of Damage:</b>	Aircraft destroyed	
<b>Commander's Licence:</b>	Private Pilot's Licence	
<b>Commander's Age:</b>	54 years	
<b>Commander's Flying Experience:</b>	1,456 hours (of which 1,310 hours were on type) Last 90 days - 50 hours Last 28 days - 27 hours	
<b>Information Source:</b>	AAIB Field Investigation

**Synopsis**

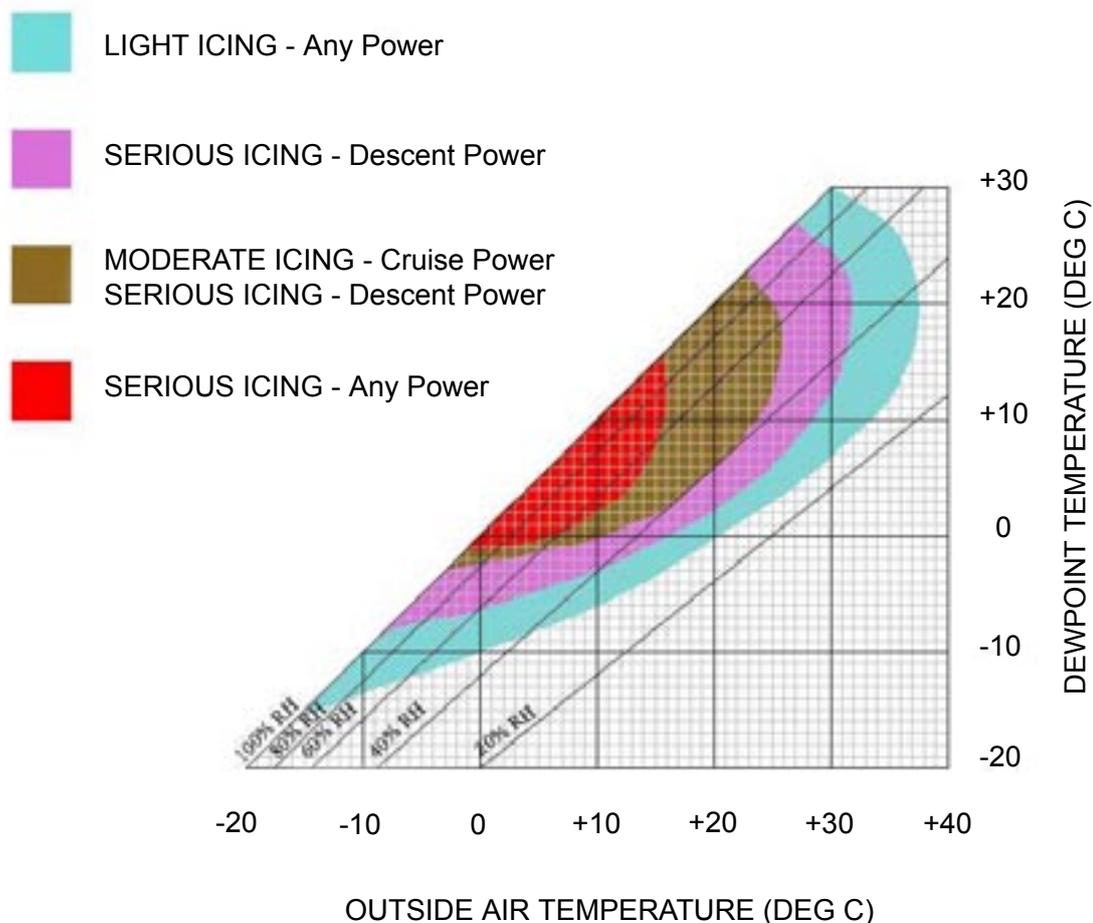
at 3,200 ft, scattered cloud at 5,000 ft, temperature 17°C, dewpoint 12°C and QNH 1012 mb. The chart reproduced at Figure 1 below shows that the temperature/dewpoint spread would have put the aircraft in the moderate risk of carburettor icing range.

In summary, detailed examination of the aircraft wreckage failed to identify any significant pre-accident defect or abnormality. No explanation could be found for the apparently low-power output of the engine at the time of the crash. The atmospheric conditions were conducive to carburettor icing, but evidence of such a

condition would not have survived after the crash and consequently no definitive conclusion could be reached as to its possible relevance to this accident.
