ACCIDENT

Aircraft Type and Registration:	Minicab (JB01 Standard), G-AWEP	
No & Type of Engines:	1 Continental Motors Corp C90-8F piston engine	
Year of Manufacture:	1969 (Serial no: PFA 1801)	
Date & Time (UTC):	6 July 2013 at 1230 hrs	
Location:	Sittles Farm Airstrip, Lichfield, Staffordshire	
Type of Flight:	Private	
Persons on Board:	Crew - 1	Passengers - 1
Injuries:	Crew - None	Passengers - None
Nature of Damage:	Damage to propeller, cowling, canopy, cabin front and roof	
Commander's Licence:	Private Pilot's Licence	
Commander's Age:	55 years	
Commander's Flying Experience:	144 hours (of which 44 were on type) Last 90 days - 14 hours Last 28 days - 4 hours	
Information Source:	Aircraft Accident Report Form submitted by the pilot and additional enquiries by the AAIB

Synopsis

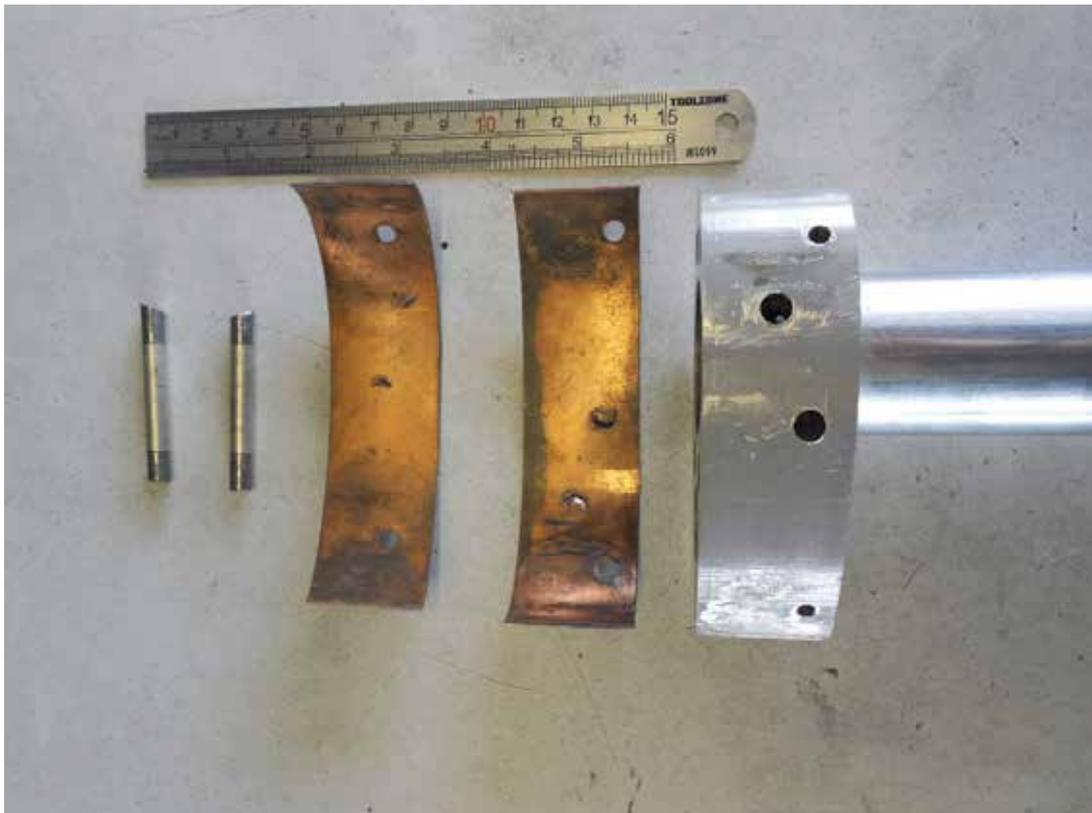
Figure 2

The aircraft was landing at a farm strip. Approach and touchdown were normal but, as the pilot started to apply the brakes, the aircraft swung to the left and he was unable to prevent it from veering off the runway at slow speed and into a tall crop, where it overturned. Subsequent examination found that wear in a component of the left main landing gear leg was allowing considerable torsional movement of the left wheel, causing an uncommanded application of the cable brake on that side.

The owner-pilot was initially unsure as to the reason for the loss of control, although he states that he sensed that the left brake may have been occasionally dragging after the aircraft was righted and was being wheeled into a hangar. However, once the aircraft was jacked, he noticed that the left wheel could be rotated around the axis of the MLG leg through about $\pm 10\text{-}12^\circ$ and that, at the fully 'toed-out' condition, a pull on the brake cable was also applying the brake. Upon removal of the tube and piston assembly from the housing, it could be seen that there was considerable rotary play between the piston and the tube and that, when the brass seal strips

were unscrewed, the two pins fell out freely from the piston, exhibiting considerable wear as well as ovality of the holes in the piston (see Figure 2). The right MLG also exhibited rotational looseness, but this was limited to about $\pm 3\text{-}5^\circ$.

Photograph of disassembled piston, showing wear to the pins, ovalisation of the holes and indentations on the brass sealing strips showing lateral movement of the pins

The owner advised that he had carried out an overhaul of both brake assemblies fairly recently but had not noticed the degree of play, probably because the aircraft had been jacked on the bottom of each MLG leg. He has notified the Light Aircraft Association of his findings with a recommendation that other Minicab owners should check for this condition.
