AAIB Bulletin No: 1/96

Ref: EW/C95/9/5

Aircraft Type and Registration:	McDonnell Douglas DC-10-30, S2-ADB	
No & Type of Engines:	Three CF6-50 C2 turbofan engines	
Year of Manufacture:	Not known	
Date & Time (UTC):	28 September at 1209 hrs	
Location:	London Heathrow Airport	
Type of Flight:	Public Transport	
Persons on Board:	Crew - 21	Passengers - 210
Injuries:	Crew - None	Passengers - None
Nature of Damage:	Loss of left half of No 1 engine thrust reverser cowl	
Commander's Licence:	Airline Transport Pilot's Licence	
Commander's Age:	47 years	
Commander's Flying Experience:	17,000 hours (of which 4,500 were on type) Last 90 days - 175 hours Last 28 days - 50 hours	
Information Source:	AAIB Field Investigation

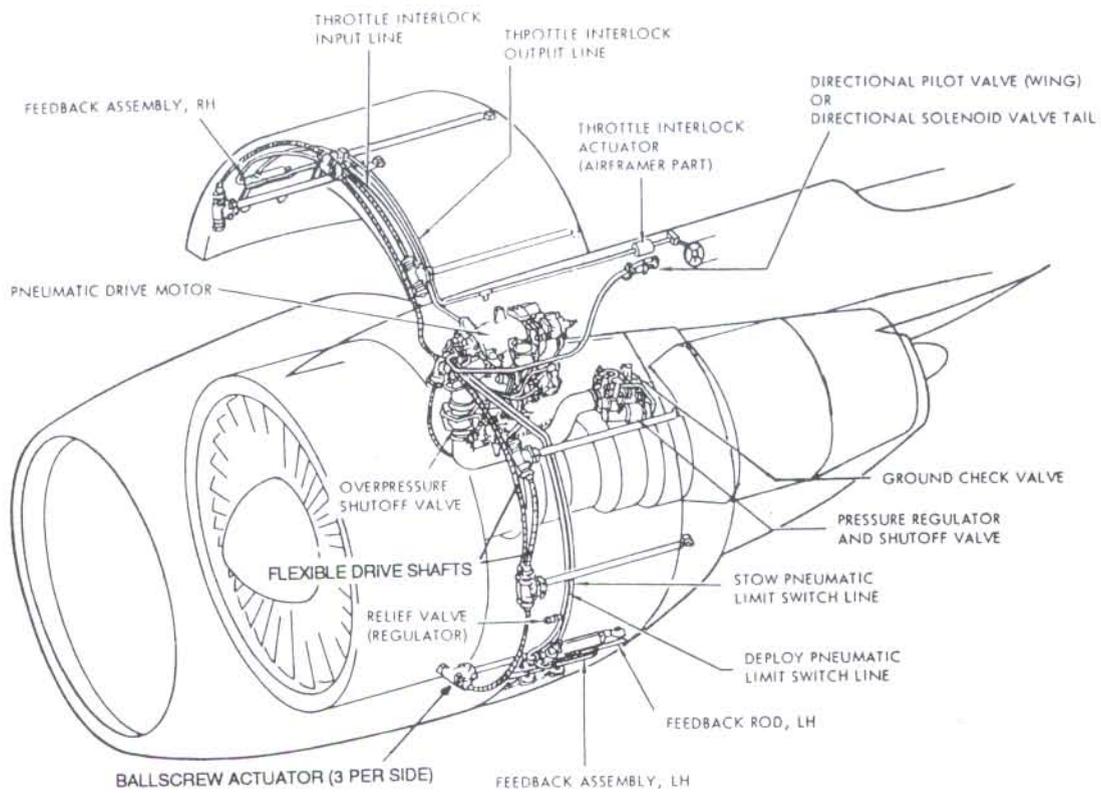
FIG 1 CF6-50/-45 THRUST REVERSER SYSTEM

ballscrew actuators, the operation of which causes the cowl to move along the 'T' tracks. Motive power is provided by a pneumatic drive motor (PDM) mounted on top of the reverser, and which runs off compressor bleed air. A shut-off valve controls the supply of air to the PDM. Flexible drive shafts run from the PDM to the centre actuator on each cowl half; secondary drive shafts run from the centre actuator to the upper and lower actuators. Blocker doors are mounted on the inner surface of each cowl half and these are connected, via struts, to the centre body of the fan duct. Aft movement of the cowls causes the blocker doors to deploy into the airflow from the fan, which is thus deflected out of cascade assemblies, thereby providing reverse thrust. The diagram at FIG 1 shows some of the pertinent features.

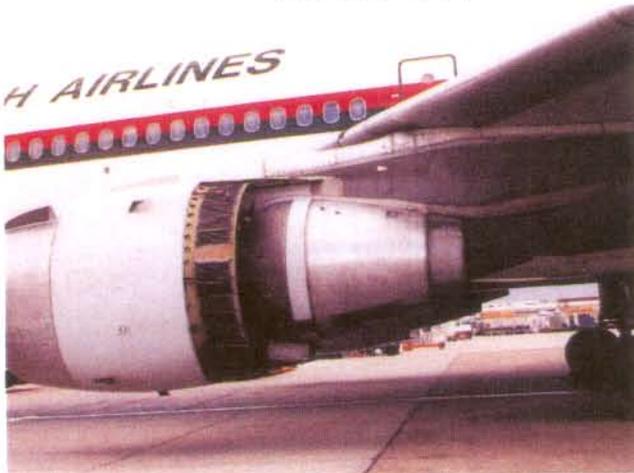
FIG 2
As found-translating cowl missing

It was subsequently found that the entire left half of the No 1 engine thrust reverser translating cowl had departed from the thrust reverser assembly. Parts of the attachment fittings were not recovered, and this hampered the subsequent investigation.

Photographs of the engine minus its translating cowl, and of the detached cowl are presented at FIGs 2 and 3.

All three ballscrew actuators were found in the stowed position, which initially gave the impression that the attachments had failed after the cowl had reached the end of the stow operation. This was reinforced by the fact that the feedback yoke had failed along a weld such that the yoke no longer made proper contact with the forward lug on the feedback rod. This could have resulted in the loss of the

cancellation signal, with a consequent high speed impact into the stow position. However, a metallurgical examination of the yoke showed that the weld was of good quality and had failed as a result of a single overload application. It was then found, by experimenting with the actuators, that although the outer cylinders were no longer constrained from rotating following their detachment from the cowl, they could still be wound towards the stow position if the drive shafts were rotated. This was probably achieved as a result of the outer cylinders intermittently contacting the structure of the reverser as they rotated, thus slowing them down relative to the inner shafts. Marks on the cascades confirmed this, and locally severe damage had been inflicted by the anti-rotation lugs where they had flailed against the cascade vanes after the actuators had reached the stow stops.

Both flexible drive shafts from the PDM were found to have failed close to the body of the motor. On the right-hand side, the failure had the appearance of a torsional overload, which probably occurred when the right cowl actuators hit the stow stops at high speed due to the absence of the 'slow down' and 'stow' feedback signals following the loss of the left side cowl. The left side drive shaft failure was different in that its outer casing had been ruptured. The broken strands of the shaft that were visible through the rupture were discoloured as a result of intense heat, and it was clear there was an absence of graphite grease in comparison to that found on the right side. This led to the conclusion that the failure of this shaft had occurred as a result of seizure due to continuous rotation within its outer casing. The lack of feedback signals noted above would have caused the PDM to continue to run at high speed, and also would have accounted for the 'VALVE OPEN' indication on the flight deck.

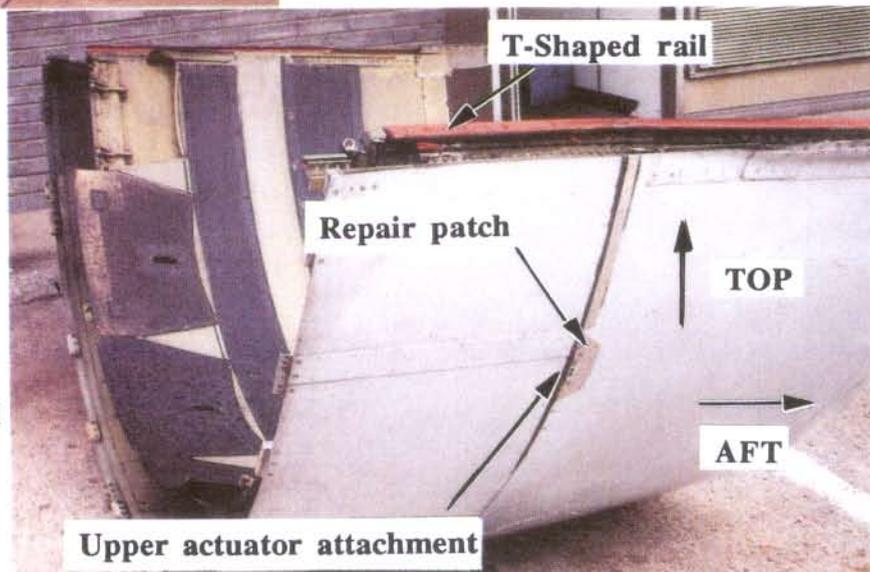
FIG 3 View of cowl

Attention then turned to the 'T'-shaped rails at the top and bottom of the cowl that were located in the T tracks on the reverser. Considerable distortion had occurred in these areas in a manner which suggested that the cowl had become skewed, ie the top and bottom had moved different distances along the tracks. Silicon rubbing strips were bonded to the surface of the 'T'-shaped rails, and it was noted that a section of strip on the lower rail had been peeled off in a rearwards direction. It was apparent that the peeling action had been caused by a corner at the aft end of the 'T' track on the reverser, as the cowl was being pulled towards the stowed position. For this to have occurred, the cowl must have been in a skewed attitude, with the upper rail most probably out of its track. This in turn suggested that the upper actuator attachment was the first to fail, possibly at the end of the preceding deploy cycle, or even the stow operation before that.

The lower actuator was attached via a cast bracket; it was clear this had failed in overload. The centre and upper attachments are identical in design in that the clevis mentioned earlier is attached (via rivets and two screws) between the inside of the cowl outer skin and a clevis flange plate which is in turn riveted to a circumferential stiffening hoop inside the cowl. A representation of the actuator attachments is shown at FIG 4. The centre actuator clevis had pulled out cleanly, leaving the flange plate behind. The upper clevis (which was not recovered) had been pulled out complete with its plate. Access to both attachment areas was restricted due to the narrow gap between the inner and outer cowl

panels, and examination was conducted with the aid of a boroscope. This showed that the centre clevis had departed due to overload, in shear, of the rivets. The upper clevis attachment rivet holes, in contrast, showed evidence of 'working', with some of them being elongated. It was clear that the cowl outer skin in this area had been the subject of a repair, with a small repair patch visible on the exterior. The patch covered the outer surface close to a butt joint; this was removed for examination (see FIG 5). The cowl outer skin in fact consisted of a double thickness, and a section of the outermost skin, measuring approximately 100 mm by 20 mm, which had presumably contained the damage that necessitated the repair, had been cut away and replaced with a similarly shaped piece of skin. This merely served as a packing piece between the innermost skin layer and the patch, and contributed nothing to the load bearing capability of the repair. The presence of sealant showed that the three layers had not been pressed tightly together, which may have resulted in a somewhat flexible riveted joint. This view was reinforced during a laboratory examination of the component parts, when evidence of fretting was found on some of the remaining rivets.

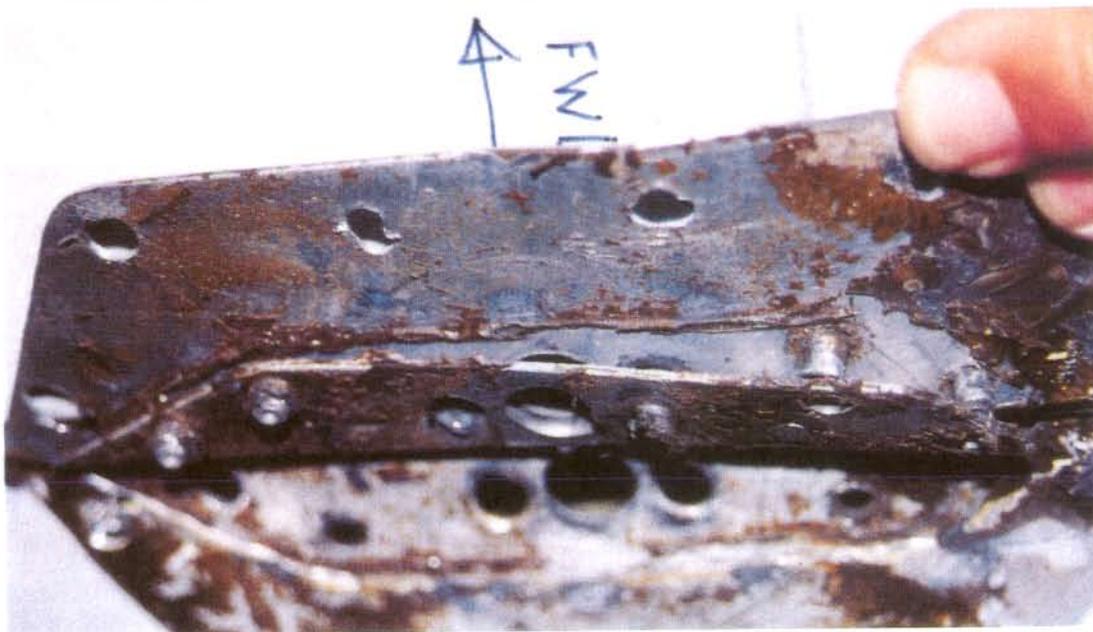
The engine manufacturer had published a repair scheme for the centre and upper clevis attachments (Ref Repair No 10 in General Electric CF6-50 Shop Manual, Section 78-32-01). Much of the associated detail is concerned with replacing the clevis flange, mounted on the stiffening hoop. This area had not been touched during the repair, which involved only the outer skin. Nevertheless, an outer skin patch plate is called up in the repair scheme, and it was noted that it was approximately 30 mm wider than that found on the subject cowl. Furthermore, no mention is made of removing one of the outer skin layers and inserting a packing piece in its place. Although a larger patch plate would distribute the actuator loads over a larger area of the cowl, it was clear that no problem had resulted, in this case, from the use of a smaller patch, as it had remained securely attached. It was thus concluded that the failure had occurred due to weakness brought about by the removal of the section of skin underneath the patch plate.

It was established that the upper actuator attachment had been the subject of an unauthorised repair, which had probably resulted in a weakened joint between the clevis and cowl. It is considered likely that the joint progressively lost strength in service to the point where it failed completely on either the stow or deploy cycles prior to the detachment of the reverser cowl. When reverse thrust was selected on landing at Heathrow, the top of the cowl would have overtravelled, probably coming out of the 'T' track on the reverser. Although the exact sequence of events was difficult to determine, it is possible that the associated distortion on the cowl caused the feedback yoke to jump over the aft lug on

FIG 5 View of repair, with patch plate and "packing piece" being removed from cowl
