ACCIDENT

Aircraft Type and Registration:	Ikarus C42 FB UK, G-IAJS	
No & Type of Engines:	1 Rotax 912 ULS piston engine	
Category:	1.4	
Year of Manufacture:	2005	
Date & Time (UTC):	30 August 2005 at 1910 hrs	
Location:	Kinderton Farm, Middlewich, Cheshire	
Type of Flight:	Private	
Persons on Board:	Crew - 1	Passengers - 1
Injuries:	Crew - 1	Passengers - none
Nature of Damage:	Substantial damage to right wing, cabin floor, propeller and landing gear	
Commander's Licence:	National Private Pilot's Licence	
Commander's Age:	36 years	
Commander's Flying Experience:	237 hours (of which 34 were on type) Last 90 days - 8 hours Last 28 days - 0 hours	
Information Source:	Aircraft Accident Report Form submitted by the pilot

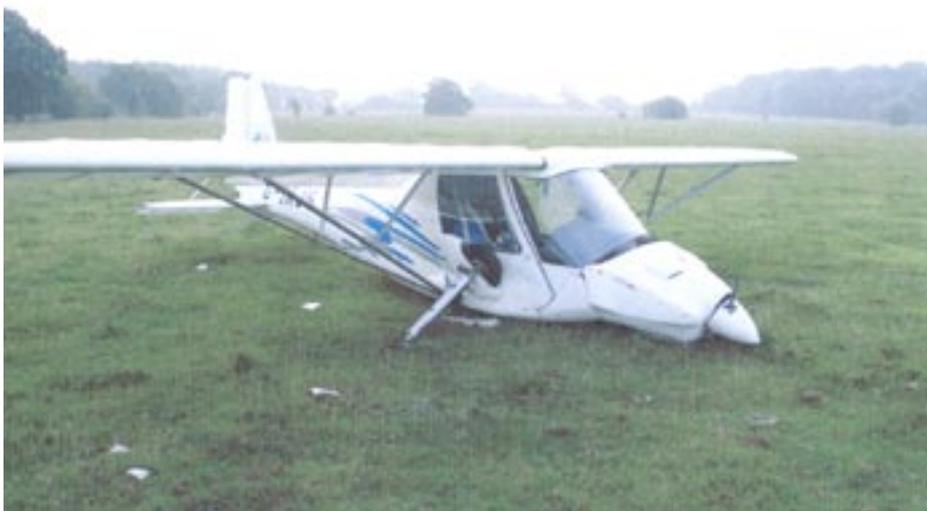
Figure 1

substantial damage, most significant being damage to the propeller, landing gear, cabin frame and the right hand rear wing spar. A general view of the aircraft is shown in Figure 1.
