ACCIDENT

Aircraft Type and Registration:	Breezer B600, G-OLSA	
No & Type of Engines:	1 Rotax 912ULS piston engine	
Year of Manufacture:	2010	
Date & Time (UTC):	25 June 2011 at 1600 hrs	
Location:	Membury Airfield, Berkshire	
Type of Flight:	Private	
Persons on Board:	Crew - 1	Passengers - 1
Injuries:	Crew - None	Passengers - None
Nature of Damage:	Damage to nose landing gear, left main landing gear, one propeller blade, engine mount, firewall and wings	
Commander's Licence:	Private Pilot's Licence	
Commander's Age:	36 years	
Commander's Flying Experience:	2,225 hours (of which 31 were on type) Last 90 days - 58 hours Last 28 days - 11 hours	
Information Source:	AAIB Field Investigation

Synopsis

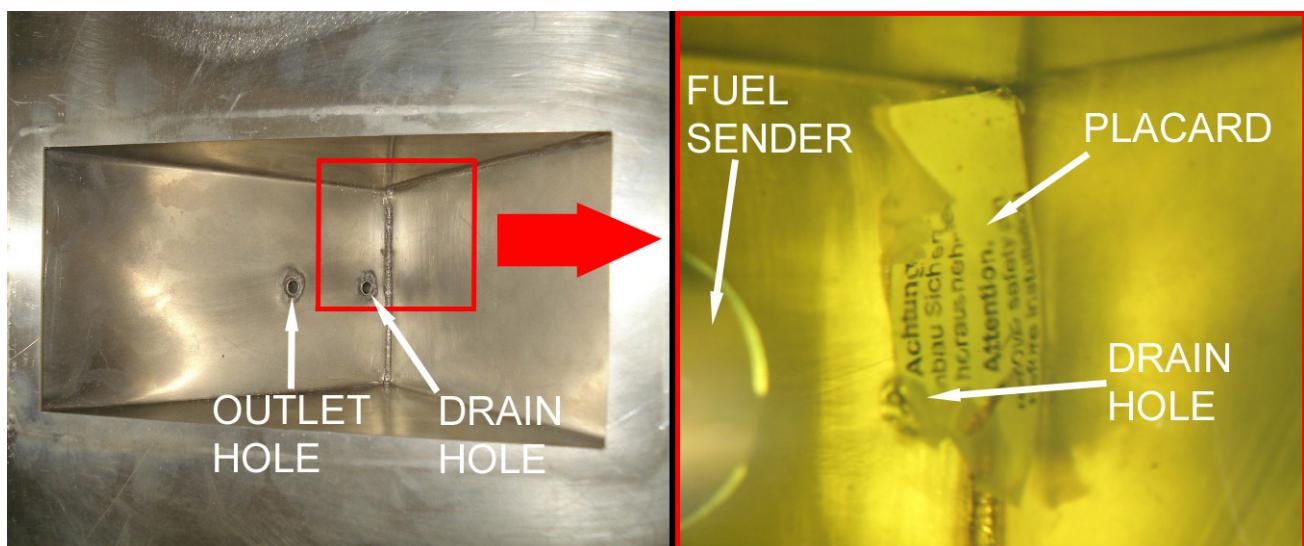
Figure 2

The aircraft was examined by a maintenance engineer who focussed his initial investigation on the fuel system due to the low fuel pressure warning that had been received. There was sufficient fuel remaining in the fuel tank so he removed the in-line fuel filter inside the engine compartment and this was found to be clear. He then disconnected the fuel pipe at the engine-driven pump and turned on the electric fuel boost pump and this resulted in fuel flowing. He then examined the fuel tank more closely and noticed that there were remains of a placard lying at the base of the tank near the outlet hole and partially covering the drain hole (Figure 2).

been removed prior to installation. In the case of G-OLSA the placard had not been removed and the fuel would have acted as a solvent on the placard adhesive until it eventually detached and sank into the base of the tank. Although the placard was not blocking the outlet hole at the time of examination, the action of sucking fuel from the outlet hole could have drawn the placard towards it when it detached from the fuel sender.

Base of fuel tank (left) showing outlet and drain holes; placard partially blocking drain hole in G-OLSA (right) – outlet hole not visible due to location of fuel quantity sender

The engine stoppage was probably caused by a fuel restriction when the placard from the fuel sender blocked the fuel tank outlet. The aircraft manufacturer was not able to establish why the placard had not been removed from the fuel sender prior to installation, but it has introduced further checks to ensure that the placard is removed in future. Although not required by CS-LSA or ASTM F2245, the manufacturer has taken safety action to install a fuel strainer at the fuel tank outlet of all new aircraft and is offering the same modification for retrofit.

The Safety Alert was applicable to the Breezer CR, CL and B600. The manufacturer has also designed a fuel strainer modification that is being incorporated in all newly-built aircraft and has published a Service Bulletin (SB11-002) for a strainer retrofit kit for existing aircraft. The manufacturer has also introduced further checks in the assembly process to ensure that the placard on the fuel sender is removed prior to installation.

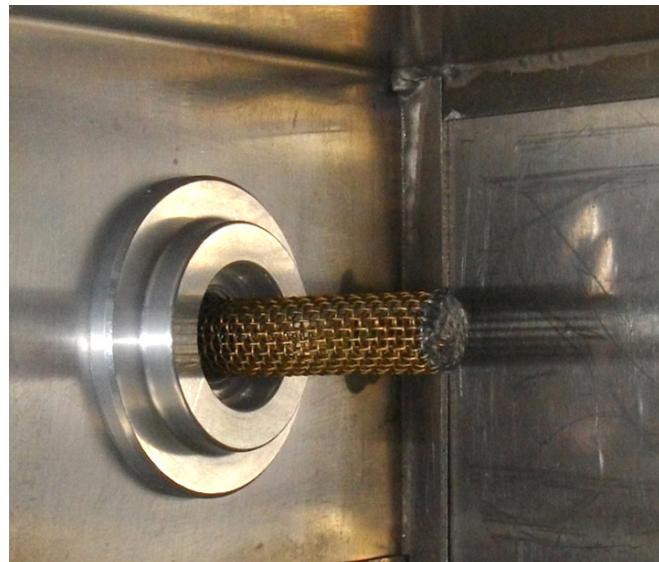
Figure 3

Strainer modification fitted to the fuel tank outlet
(Breezer Service Bulletin SB11-002)
