**ACCIDENT**

<b>Aircraft Type and Registration:</b>	Piper PA-23-160 Apache, G-MOLY	
<b>No &amp; type of Engines:</b>	2 Lycoming O-320-B3B piston engines	
<b>Year of Manufacture:</b>	1959	
<b>Date &amp; Time (UTC):</b>	17 July 2006 at 1645 hrs	
<b>Location:</b>	Little Shelford, Cambridge	
<b>Type of Flight:</b>	Private	
<b>Persons on Board:</b>	Crew - 1	Passengers - None
<b>Injuries:</b>	Crew - None	Passengers - N/A
<b>Nature of Damage:</b>	Damage to left wing tip, pitot mounting, left flap and left landing gear drag link	
<b>Commander's Licence:</b>	Private Pilot's Licence	
<b>Commander's Age:</b>	54 years	
<b>Commander's Flying Experience:</b>	2,242 hours (of which 134 were on type) Last 90 days - 29 hours Last 28 days - 15 hours	
<b>Information Source:</b>	Aircraft Accident Report Form submitted by the pilot and aircraft examination by the repair agency

**Synopsis**

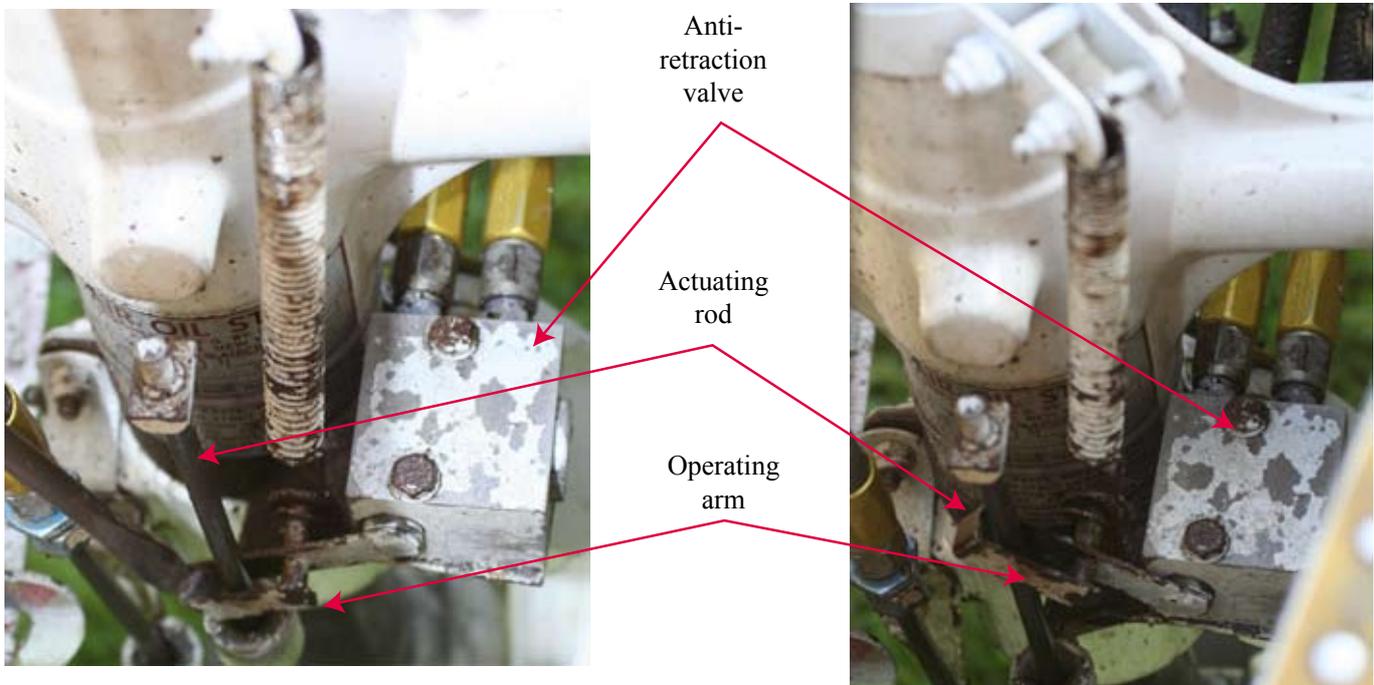
**Figure 1**

Figures 1 and 2 respectively show the anti-retraction valve in the closed position, ie aircraft in flight, and the open position, ie aircraft on the ground. The actuating rod is attached to the left main landing gear; when the oleo is in the compressed position, the rod is pushed

Anti-retraction valve in closed position  
- aircraft in flight

Anti-retraction valve in open position  
- aircraft on ground

up which in turn pushes the valve operating arm up. Examination of the anti-retraction valve showed that the operating arm had been stuck in the closed position. Debris and corrosion in this area had built up causing the operating arm to become stuck. In the opinion of the repair agency it had been in this condition for some time and thus represented a dormant failure. With the anti-retraction valve in the 'FLIGHT' position it was possible for the landing gear to retract when the aircraft was on the ground.

The operating arm was manually freed, the spring pulled the operating arm into the ground position, and the valve then operated correctly.

The Piper Apache service manual requires a check of the anti-retraction system at every 50 hour inspection. The last check on G-MOLY was an annual inspection carried out on the 17 February 2006.
