HS748 FLIGHT CONTROLS

**PREVIOUS HS748 ACCIDENTS AND INCIDENTS
WITH PRIMARY FLIGHT CONTROL RESTRICTION POSSIBLY
DUE TO GUST LOCK SYSTEM**

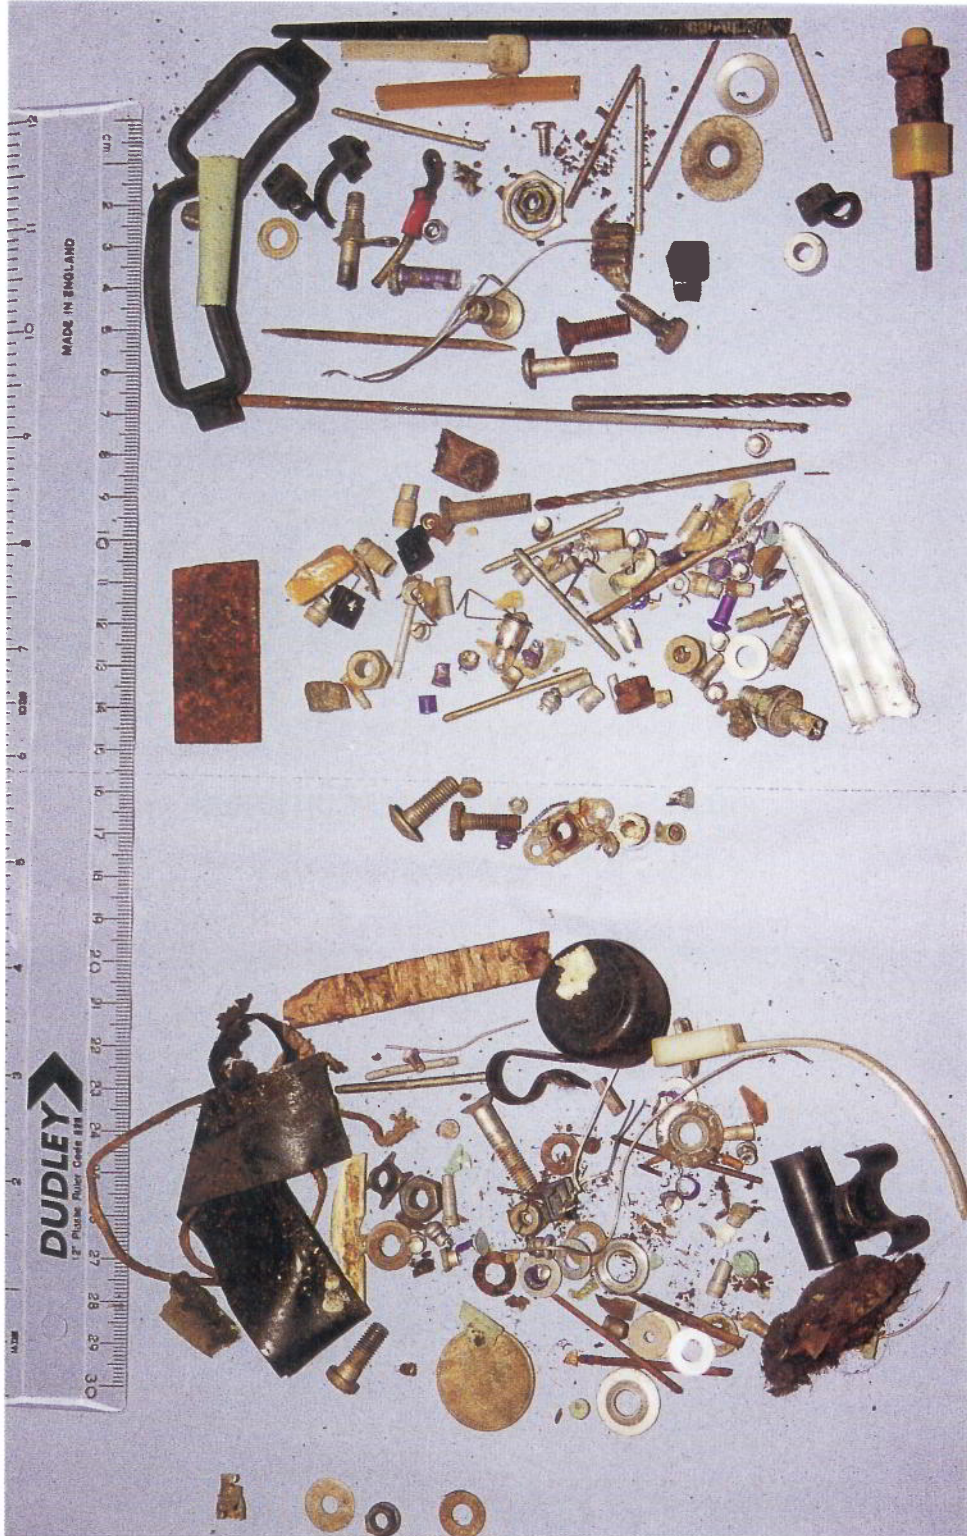
PHOTO 2 - DEBRIS RECOVERED FROM CABIN UNDERFLOOR AREA

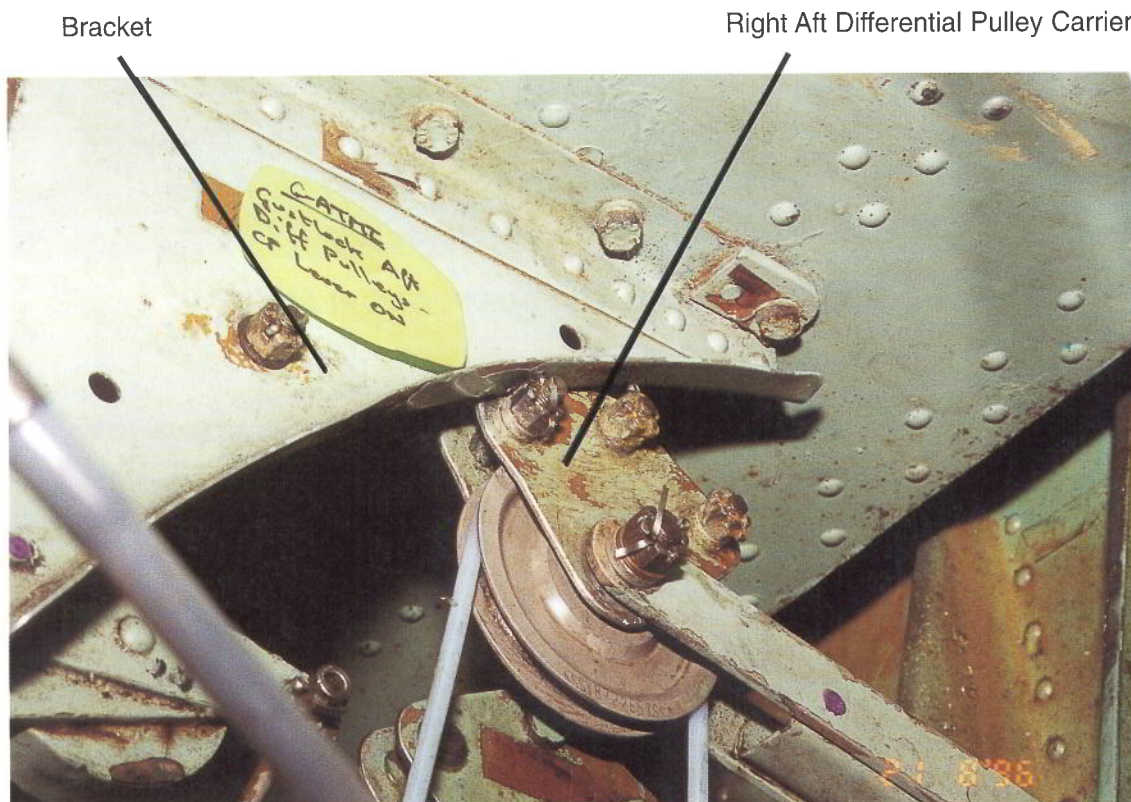
PHOTO 3.2 - AFT DIFFERENTIAL PULLEY FOUL ON BRACKET

Rub Marks from contact with Left Aft Differential Pulley Lever

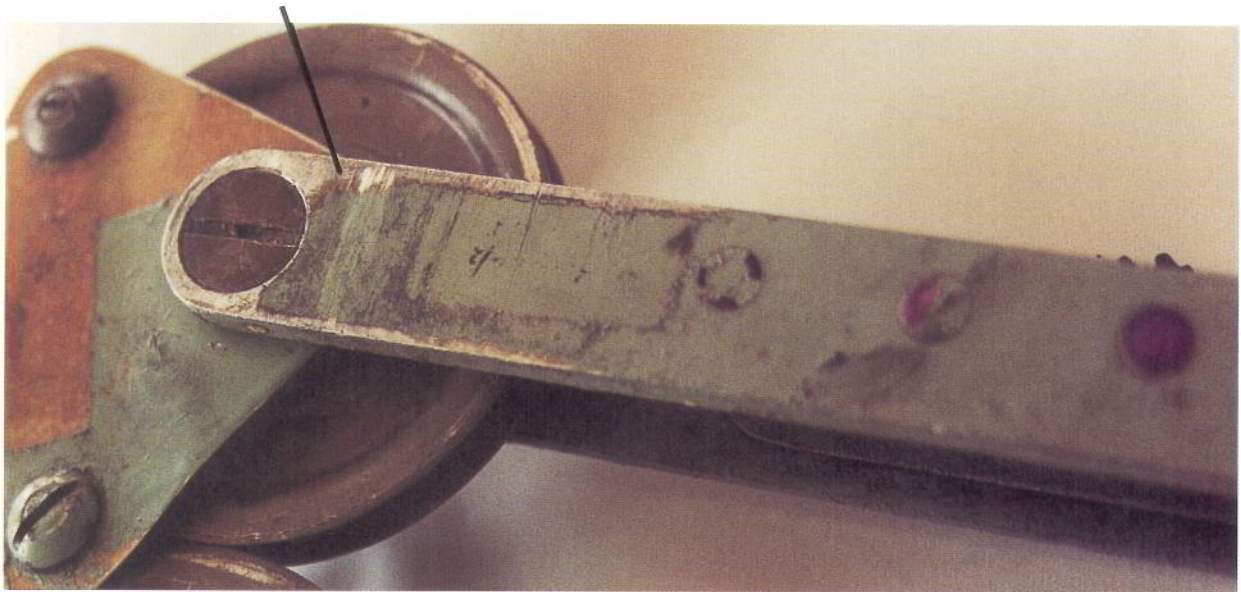
PHOTO 4.1 - RIGHT AFT DIFFERENTIAL PULLEY LEVER

Roller Lever (displaced)

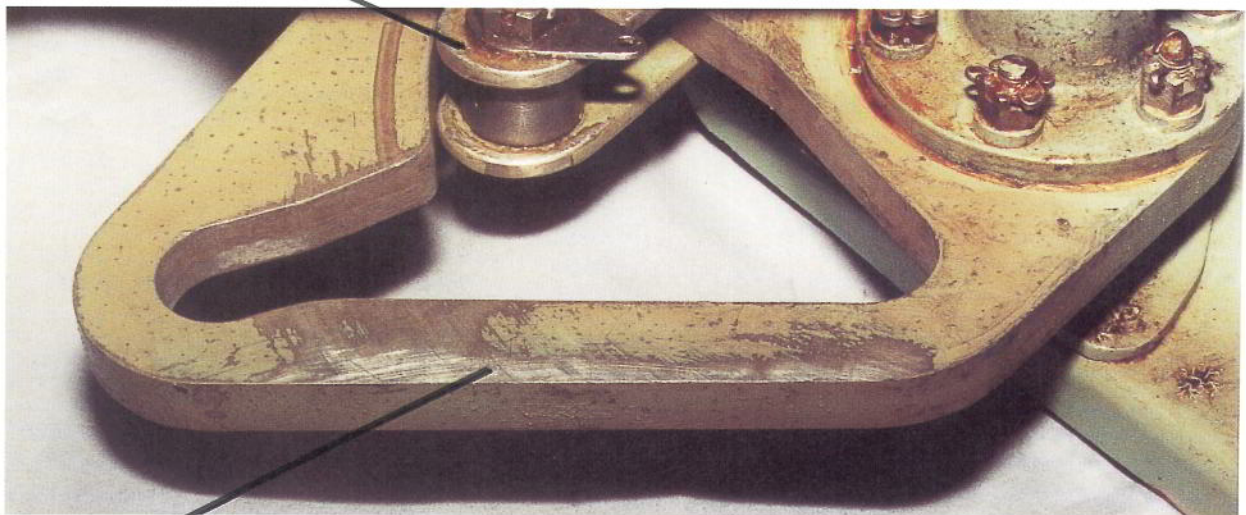
PHOTO 4.2 - ELEVATOR GUST LOCK PLATE

Rub Marks from contact with roller lever

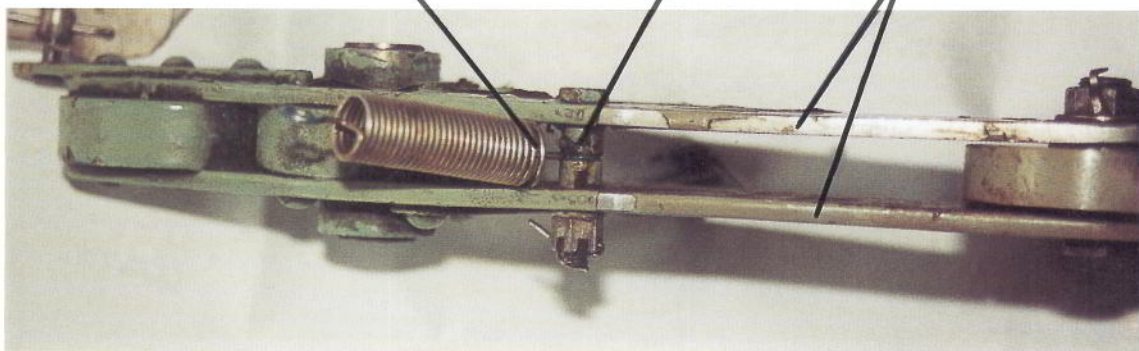
PHOTO 4.3 - ELEVATOR GUST LOCK ROLLER LEVER

Spring Deformation

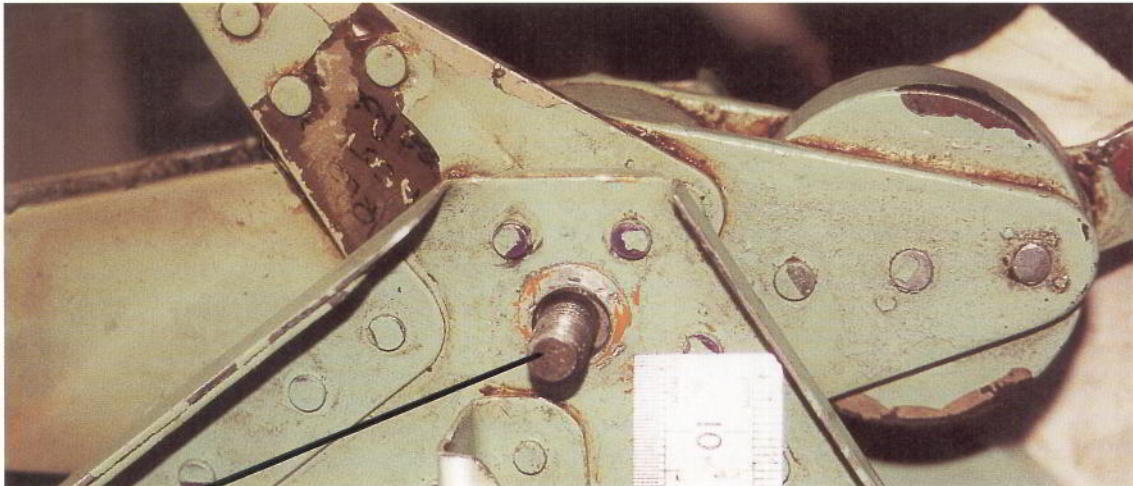
PHOTO 5.2 - ROLLER LEVER PIVOT - LEFT SIDE

Roller Lever
Pivot Bolt
(bush absent)

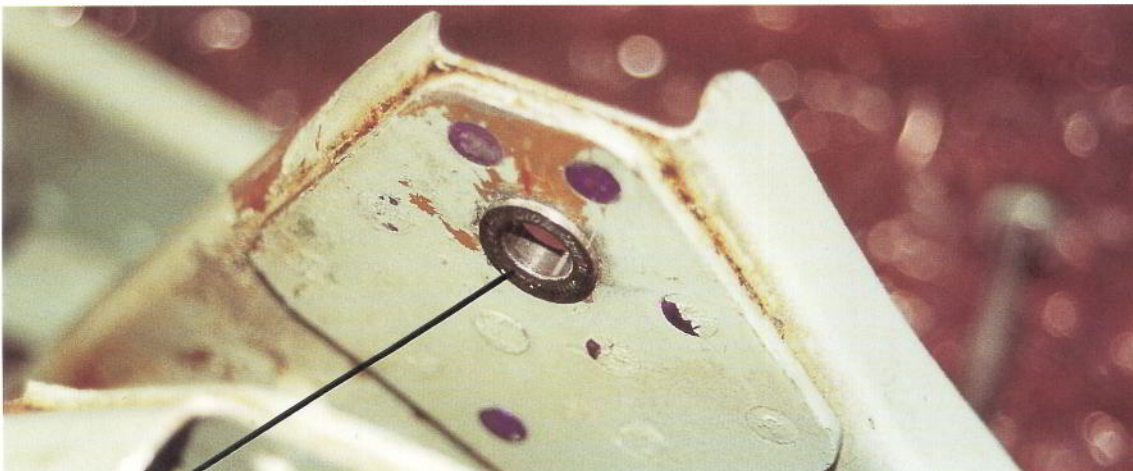
PHOTO 5.3 - ROLLER LEVER PIVOT - RIGHT SIDE

Roller Lever
Pivot Bolt Bush
