Air Accidents Investigation Branch

**Report on the serious incident to
Bombardier CL600-2B16 Challenger 604, VP-BJM
8 nm west of Midhurst VOR, West Sussex
11 November 2005**

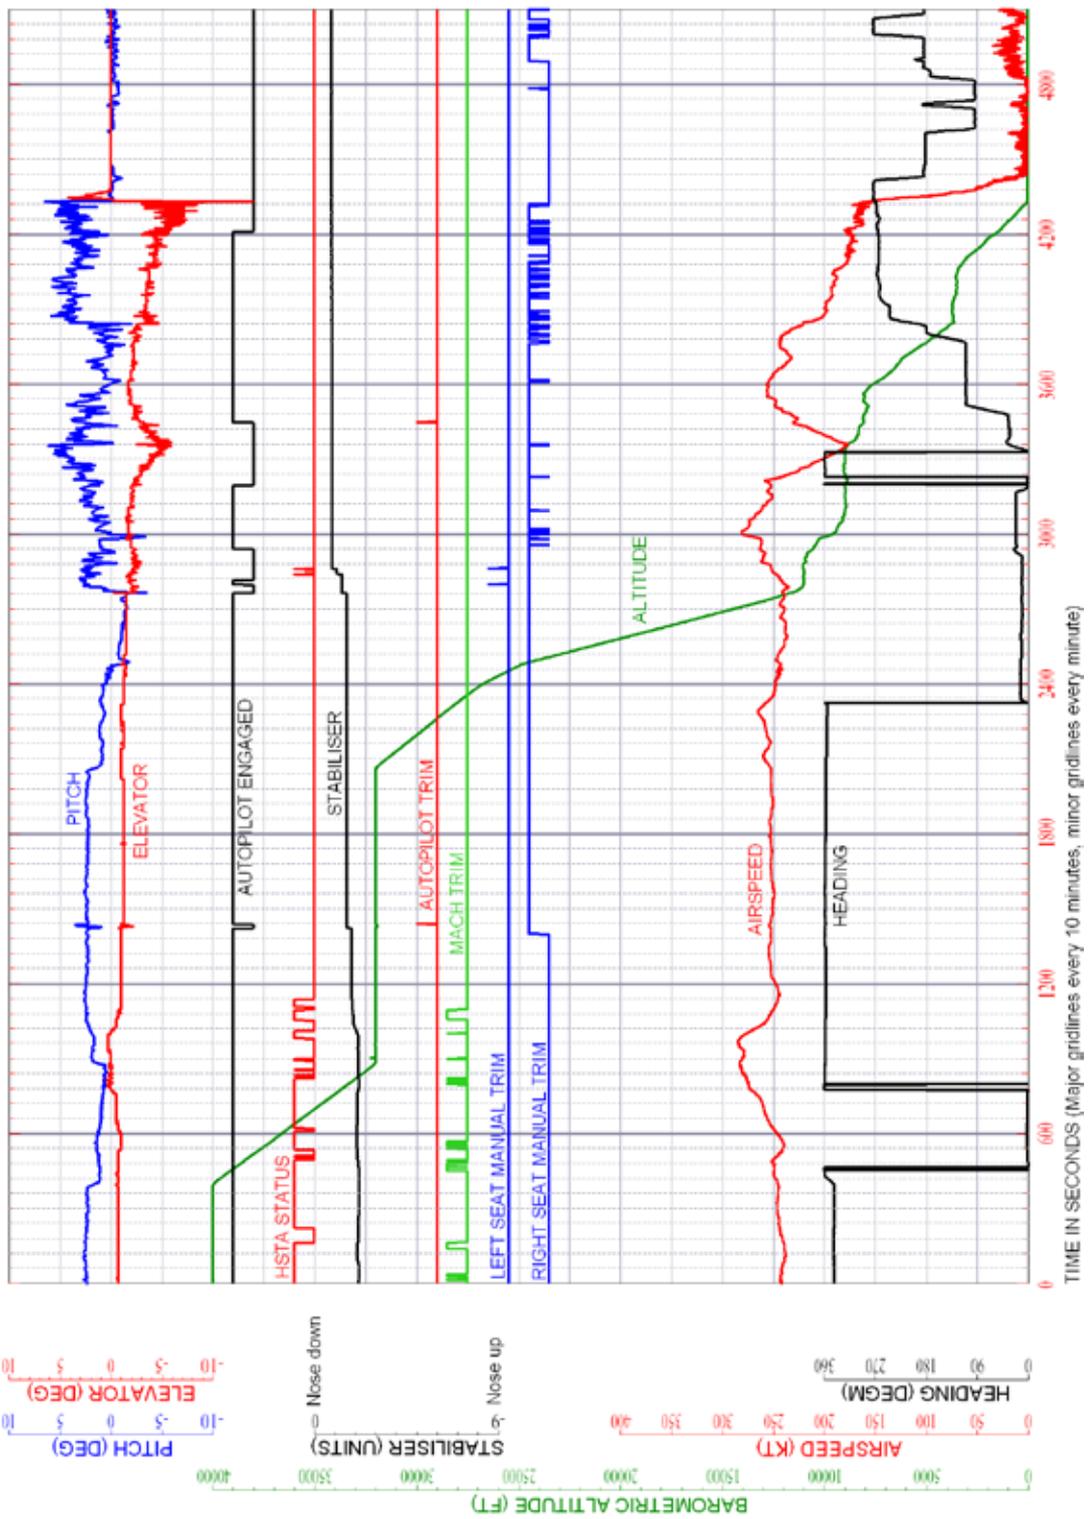
The frequency of these invalid periods increased until, four minutes after reaching and maintaining FL320, HSTA status changed to an invalid state which remained for the great majority of the remainder of the flight⁵. During the final stages of these status transitions, the stabiliser was observed to move further nose down to a new position of -1.8° . No correlation was observed between stabiliser movement and the validity of HSTA status.

Just over four minutes later, whilst still at FL320 and with no further changes in stabiliser position, the recorded data showed a change in the status of the right-hand seat manual trim switch to a continuous manual trim command. Half a minute later the autopilot disconnected⁶ for a period of 15 seconds. Immediately after the disconnection, although no activity was observed on any of the four trim command discrete parameters, the stabiliser moved further to a position of -1.58° and minor perturbations in elevator position and pitch attitude occurred. Upon re-engagement of the autopilot, one autopilot pitch trim command was recorded but there was no associated movement of the stabiliser.

Whilst the autopilot was not engaged, two further instances of nose-down stabiliser movement were recorded, separated by a period of 22 seconds. Final stabiliser position was recorded as -0.84° , which was nearly full nose down. This final position remained unchanged for the remainder of the flight. Coincident with each movement, HSTA status momentarily reflected a valid condition but, as during previous stabiliser movements, no related changes of state were observed on any of the four trim command parameters and the continuous co-pilot manual trim command was still present.

Figure 3
Salient FDR Parameters

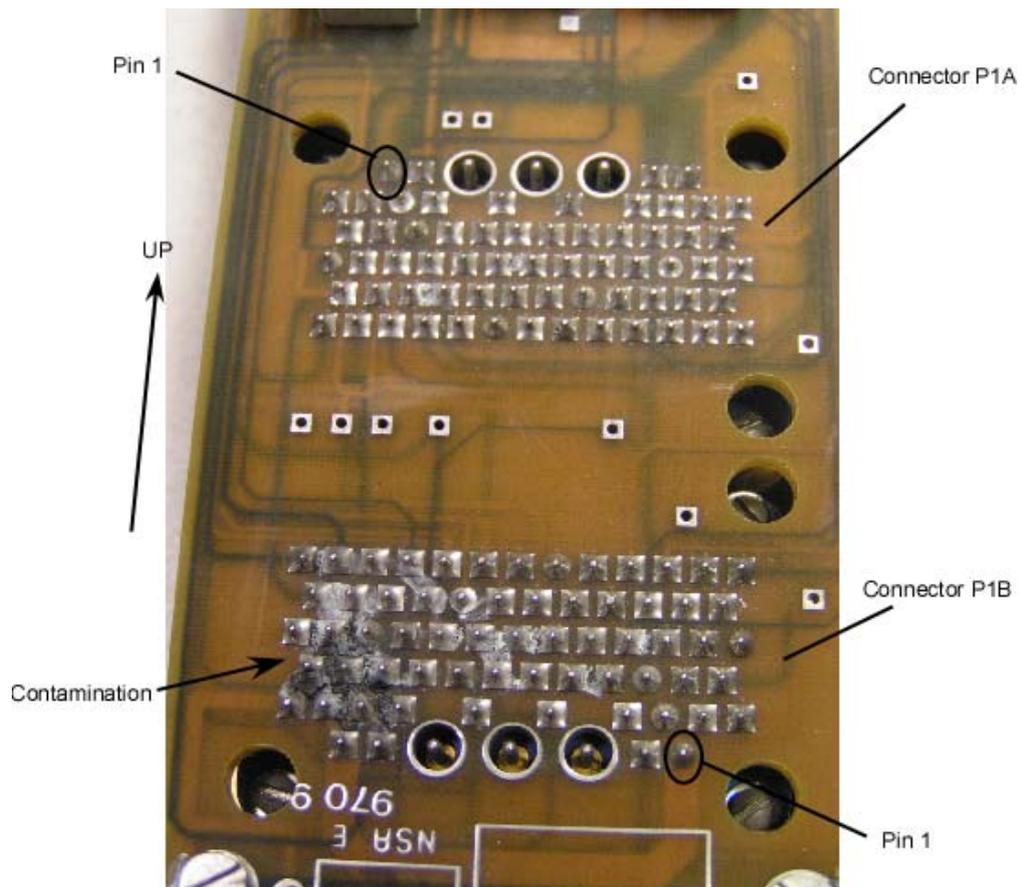
Figure 4

The unit was then opened for a visual examination of the three circuit boards and the mother board. This revealed heavy contamination on the motherboard around the pins of P1A and P1B, Figure 4.

HSTCU Serial Number 568 Motherboard Connector Contamination

The contamination was limited to the surface of the board and later analysis revealed it to contain lead, tin and copper oxides. These were the likely products of electro-migration⁷ in the presence of moisture.

It was only after the HSTCU had been removed from the aircraft and sent to the component manufacturer that the probable cause of the incident was located. The contamination found on the motherboard of the HSTCU can be directly related to the problems experienced by the flight crew of VP-BJM during the incident flight.

The contamination, when sampled, was limited to the surface of the PCB and contained corrosion products of lead, tin and copper. These were likely products as a result of electro-migration which had occurred due to the combination of three factors: circuit board surface contamination, presence of moisture and potential (voltage) difference between pins. At its worst, electro-migration can lead to metallic dendrites and the continuous shorting of pins. However, the HSTCU from VP-BJM passed the bench tests when it was dry and it is unlikely that the corrosion had reached that stage. The faults experienced seemed only occur when the board was contaminated with moisture, borne out later by the laboratory testing.

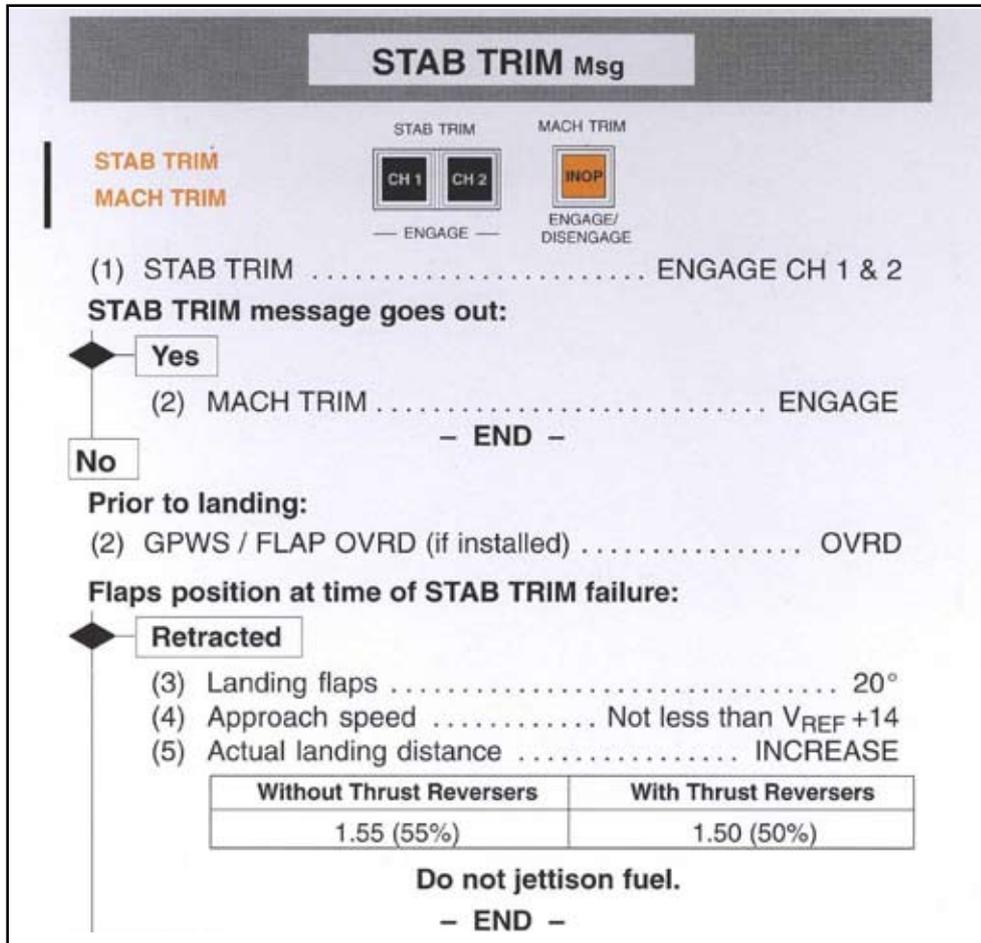
Figure 5

Excerpt from ‘STAB TRIM Msg’ QRH procedure

The manufacturer explained the rationale for advising 20° of flap for landing following a stabiliser trim failure as follows. A failure was deemed most likely to occur during cruise, with flap retracted. Maintaining this configuration for landing would result in the least trim change but a high approach speed. Use of 45° of flap would result in the lowest landing speed but the greatest trim change. The use of an intermediate flap setting was deemed to present a good compromise. It had the additional advantage that, should the stabiliser trim fail shortly after takeoff (which is normally conducted with 20° of flap set) the aircraft would already be in the desired configuration. Accordingly, for the purposes of certification, stabiliser fail cases were demonstrated with 20° of flap set. Satisfactory handling was noted with the aircraft in this configuration.
