**SERIOUS INCIDENT**

<b>Aircraft Type and Registration:</b>	Aeroprakt A22L Foxbat, G-CGWP	
<b>No &amp; Type of Engines:</b>	1 Rotax 912 ULS piston engine	
<b>Year of Manufacture:</b>	2011	
<b>Date &amp; Time (UTC):</b>	10 January 2012 at 1510 hrs	
<b>Location:</b>	Enstone Airfield, Oxfordshire	
<b>Type of Flight:</b>	Private	
<b>Persons on Board:</b>	Crew - 1	Passengers - None
<b>Injuries:</b>	Crew - None	Passengers - N/A
<b>Nature of Damage:</b>	Damage to rudder anti-balance tab, rudder and elevator	
<b>Commander's Licence:</b>	National Private Pilot's Licence	
<b>Commander's Age:</b>	58 years	
<b>Commander's Flying Experience:</b>	329 hours (of which 60 were on type) Last 90 days - 35 hours Last 28 days - 8 hours	
<b>Information Source:</b>	Aircraft Accident Report Form submitted by the pilot and further enquiries by the AAIB

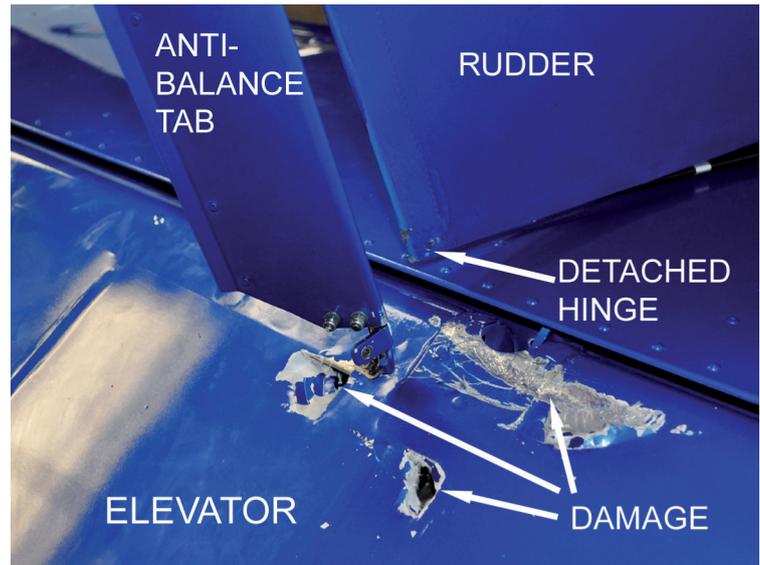
**Figure 3**

G-CGWP was examined by an engineer from the Light Aircraft Association (LAA). The anti-balance tab was found to have separated from the rudder at the lower hinge (Figure 3), allowing the tab to move aft and damage the elevator. The damage to the elevator was consistent with it having been caused by the control horn which had bent downwards (Figure 4). The control horn cable was also found to have failed. The single screw and nut which had attached the lower tab hinge was missing. The top two hinge screws were found to be loose and there was evidence of rubbing on the tab leading edge. The tab was free to move and the spring hinge was working, although there was a clicking noise during rotation, indicating some extra resistance at one point in the tab's range of movement.

The LAA engineer was not able to determine the initiating cause of failure but theorised that if the lower hinge screw had failed or separated first, then that would explain the aft movement of the tab and the rudder flutter due to a reduction of spring force from the spring hinge. The rudder movement would then have stopped once the control horn jammed inside the elevator skin, thus also causing the elevator to jam. The cyclic loads that overloaded the pitch horn probably also caused a fatigue failure of the cable. Alternatively, the lower hinge screw could have failed or separated due to a 'flutter' event caused by some other factor. The evidence of rubbing on the leading edge of the tab could indicate an over-close fitment when the aircraft was manufactured, or it could have been a result of the loose hinges found.

Damaged elevator and separated anti-balance tab hinge on G-CGWP

On 13 March 2012 the LAA published Airworthiness Alert '*Aeroprakt A22L Foxbat, Modification Approval for changes to Rudder Anti-Balance Tab*' (AWA/12/02) which detailed two modification options, and installing either one would remove the flight restriction. The first modification replaces the tab cable with a pushrod and adds doublers to the tab hinge attachment (LAA Modification Approval 13310). The second modification removes the anti-balance tab and replaces it with a rudder centring spring to provide the necessary centring force that was provided by the tab (LAA Modification Approval 13311).

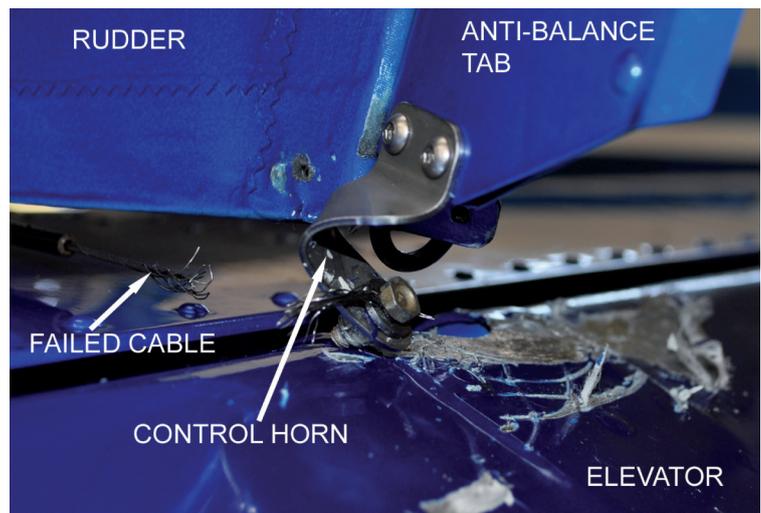
**Figure 4**

Bent control horn and failed cable on G-CGWP
