No: 11/92

Ref: EW/C92/6/1

Aircraft Type and Registration: Douglas Aircraft Company MD-11, N1754

Date & Time (UTC): 4 June 1992 at 1052 hrs

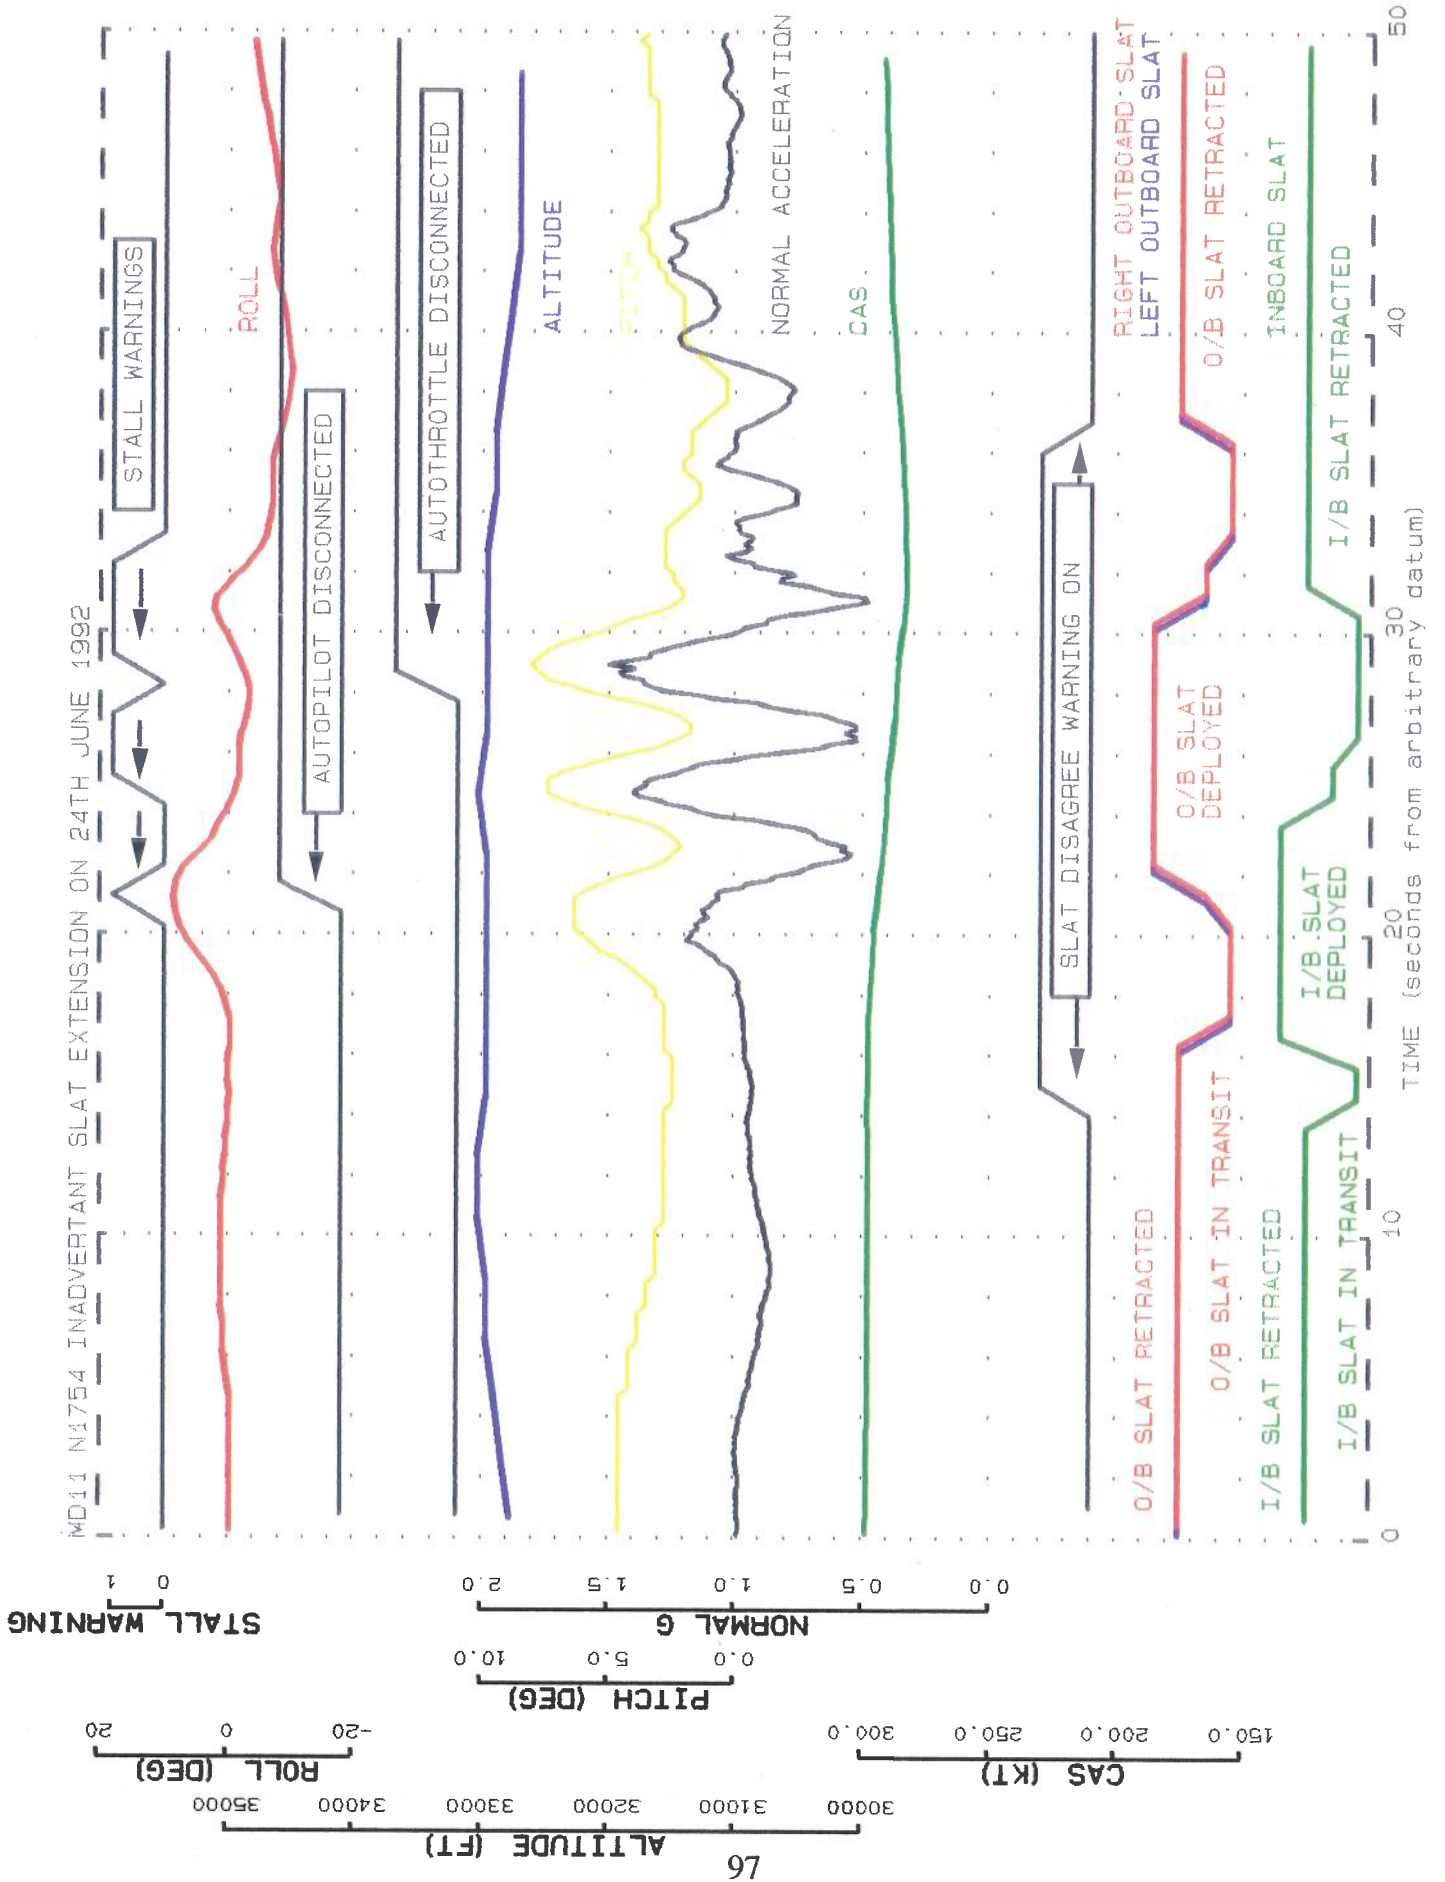
FIGURE 1

The Flight Data Recorder (FDR), a Sundstrand UFDR was removed and sent to the US National Transportation Safety Board in Washington D.C. for readout. The data was also supplied to the AAIB. Figure 1 shows some of the parameters during the incident, the aircraft was at 33,000 feet, with an airspeed of 297 kt CAS and 0.83M.

Slat position is sampled from the left inboard and left and right outboard once per second, the position is recorded as retracted, in transit or deployed. Figure 1 shows the inboard slats started to extend at time $T = 14$ seconds (from an arbitrary datum), this co-incident with the slat disagree warning, and the inboard slats were fully deployed within 3 seconds. The outboard slats then started to extend at $T = 16$ seconds and were fully deployed in 6 seconds. The inboard slats started to retract at $T = 24$ seconds, and were fully retracted within 8 seconds. The outboard slats started to retract at $T = 31$ seconds, and were fully retracted in 7 seconds.

At $T = 18$ seconds the aircraft started to pitch up, initially at $T = 21$ seconds to an attitude of 6.3° nose-up, there was also a slight roll to 8° right wing down, and a peak value for normal acceleration of 1.2g. The autopilot was disconnected at $T = 21$ seconds. The minimum pitch attitude during the recovery was 2.1° nose-up with a minimum normal acceleration of 0.56g. The maximum recorded value of alpha was 6.15° , and the stall warning operated for one second at $T = 21$ seconds. There was also a slight roll to 8° right wing down.

There followed two more pitch up and recoveries the second of which was more severe. During the first pitch up the peak attitude recorded at $T = 25$ seconds was 7.4° nose-up and a normal acceleration of 1.39G, the minimum pitch attitude during the recovery was 1.75° nose-up and a normal acceleration of 0.53G. The maximum alpha recorded was 7.9° , the stall warning operated for 3 seconds. The autothrottle was disconnected at $T = 28$ seconds.

The maximum pitch attitude recorded during the final pitch up at $T = 29$ seconds was 8.1° nose-up and 1.5g normal acceleration, and the minimum pitch attitude during recovery was 1.75 deg nose-up and a normal acceleration of 0.5g. The stall warning again operated for 4 secs at $T = 29$ seconds, the maximum alpha was 8.6° .

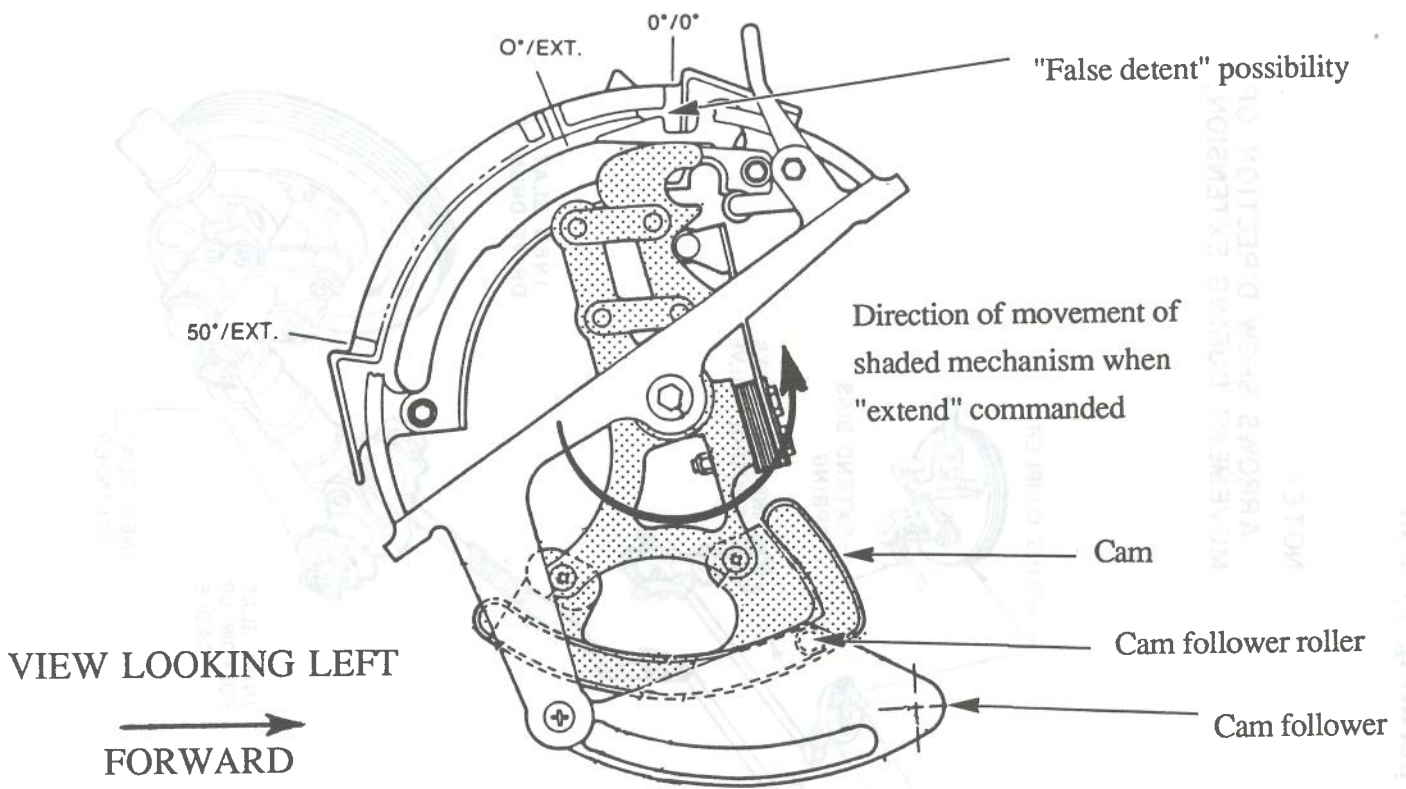
FIG.3 Flap/slat lever mechanism in centre pedestal with cam and follower in slats extended position. Note: actual lever omitted for clarity.

Single lever operation of the flaps and slats is achieved by a cam mechanism in the centre pedestal (see Figure 3). Rearward movement of the lever (not shown) from the 0°/0° retracted detent rotates a cam plate anti-clockwise. A roller forming part of a cam follower is thus moved downwards until, at the 0°/ext detent, the slats are extended and further rearward movement of the lever causes no further vertical motion of the follower. It is this vertical motion which is transmitted to the cable system and thence to the inboard slats control valve and it should be noted that there is no proportional movement of the slats. At a point during travel of the cam the slat control valve is given a signal to commence and fully complete the extension cycle, although the motion can be reversed at any point in the cycle if the lever is moved back to retract. Consideration of the cam and follower geometry shown in Figure 3 shows that the rigging of the follower roller is highly critical since small variations in the rigged position have a very large effect when the roller is moving in the slat operating part of the cam. The significance of this should become evident later.

It is also necessary to describe the operation of the flap/slat lever detents and gates. When the crew select the slats to extend, they must *lift* the lever out of the 0°/0° detent and pull it aft before allowing it to drop into either the 0°/ext (no flap, slats extended) detent or into one of the flaps extended detents. When retracting the slats, the crew must *push down* on the lever so that the detent pin pushes past the spring-loaded zero gate and springs back into the 0°/0° detent. Studies arising from the previous incidents of inadvertent slat deployment (see following paragraph) suggested that, with a combination of friction forces and the presence of the extend bias spring, the detent pin could sit in a "false detent" created by the profile of the gate and detent hardware (see Figure 3). Disturbance of the lever could

allow the pin to open the gate and extend the slats. The extend bias spring, fitted as an FAA and JAA certification requirement, is intended to ensure that the slats will remain extended if the control cable circuit is disrupted but has the effect of applying a tension on the extend cable and hence the lever will move towards the extend position if not securely located in a detent. Position of the flap/slat lever is signalled by a microswitch located on the cable quadrant beneath the pedestal and is used only as an input to the indication logic. Since any disparity between the position of the slats and the position of the handle would bring on an amber caution and the caption SLAT DISAGREE, a time delay is incorporated to prevent this occurring every time the slats are in transit following a deliberate selection although the FDR records all slat disagree messages without delay.

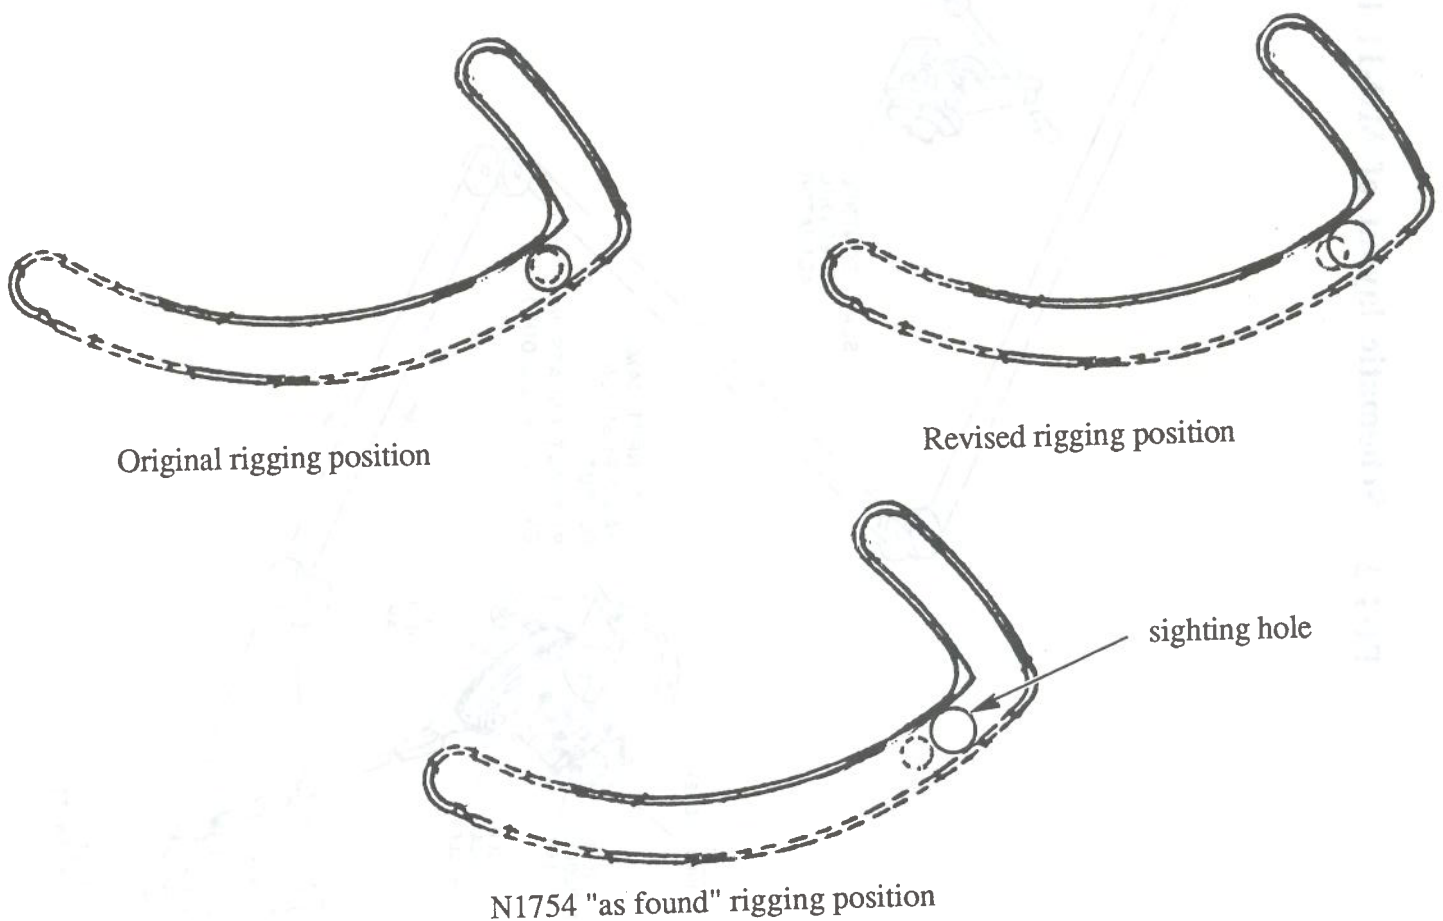
FIG.4 View of cam/cam follower showing variations in rigging.

Following the series of checks and component changes the aircraft embarked on a test flight and was then ferried back to the airline's main base at Dallas/Fort Worth in the United States for further investigation. During the course of this investigation the airline reported to the manufacturer that the rigging of the flap/slat control system had been found to be out of tolerance. Some confusion existed when it was thought that the airline was not aware of revised rigging procedures which had been adopted by the manufacturer but not yet promulgated by revision of the Maintenance Manual. However, evidence was produced which showed that the "as found" rig was incorrect even to the revised standard. Referring to Figure 4 it can be seen that the original design called for the system to be rigged with the cam follower concentric with the rigging sighting hole. The revised rigging position had the centre of the follower level with the aft edge of the sighting hole (this was in response to crew complaints of difficulty in stowing the lever in the 0°/0° detent). N1754 had the forward surface of the follower level with the aft edge of the hole as shown. Two other components of the system, the input pushrod and the input clapper, were also found out of adjustment in the extend sense. Tests by the manufacturer on a deliberately misrigged aircraft showed that, in this configuration, the slat handle became extremely sensitive and minor disturbances, even when stowed in the 0°/0° detent, could result in accidental full deployment of the slats.

However, on 28 June a further case of inadvertent slat deployment occurred on an MD-11 which led to at least three cases of injury to occupants. Inspection of the slat control system revealed similar out-of-rig conditions to those found on N1754 (the aircraft was one fuselage later in the production sequence from N1754). On 29 June the FAA issued Emergency Airworthiness Directive T92-14-51 mandating SB A27-29 with a compliance time of 10 days, and which expressed their concern about the possibility of structural damage occurring to the elevators. Yet another case of inadvertent initiation of slat extension occurred on 16 July but in this case the crew reported that there had been accidental movement of the lever out of the 0°/0° detent followed by an immediate restow. No injuries or damage occurred.

On 23 June Douglas issued a telex Alert Service Bulletin No. A27-29 recommending checks on the slat control rigging within 30 days and on 25 June circulated an AOL describing the procedures to be adopted by flight crews to restow the slats should deployment occur with or without lever movement.

Douglas had already initiated a design review of the MD-11 slat control system in conjunction with the FAA and it is understood that a comprehensive redesign of several components in the system is urgently underway. Additionally, the FAA noted that the flight and ground crew training simulators did not accurately replicate the forces required to move the flap/slat lever and were therefore requiring that training on flap/slat operation be accomplished on an aircraft. Douglas advise that all MD-11 simulators worldwide have now been modified to accurately represent flap/slat handle forces.
