APPENDIX A

G-BEWL Seating Arrangement and Injury Severity Scores (ISS)

Brent Spar helideck showing impact marks and damage

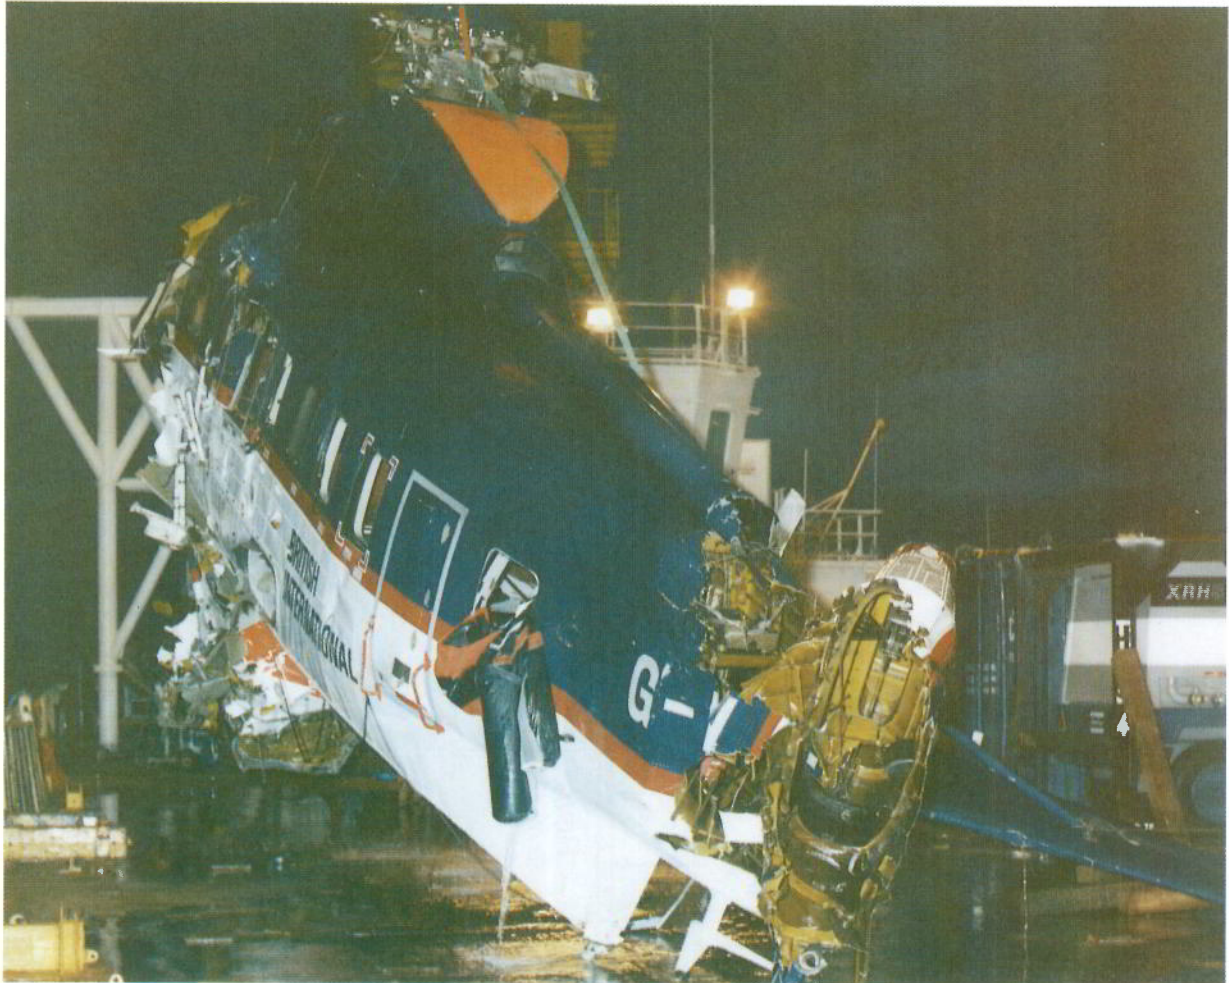
G-BEWL after recovery to the deck of MSV Stadive

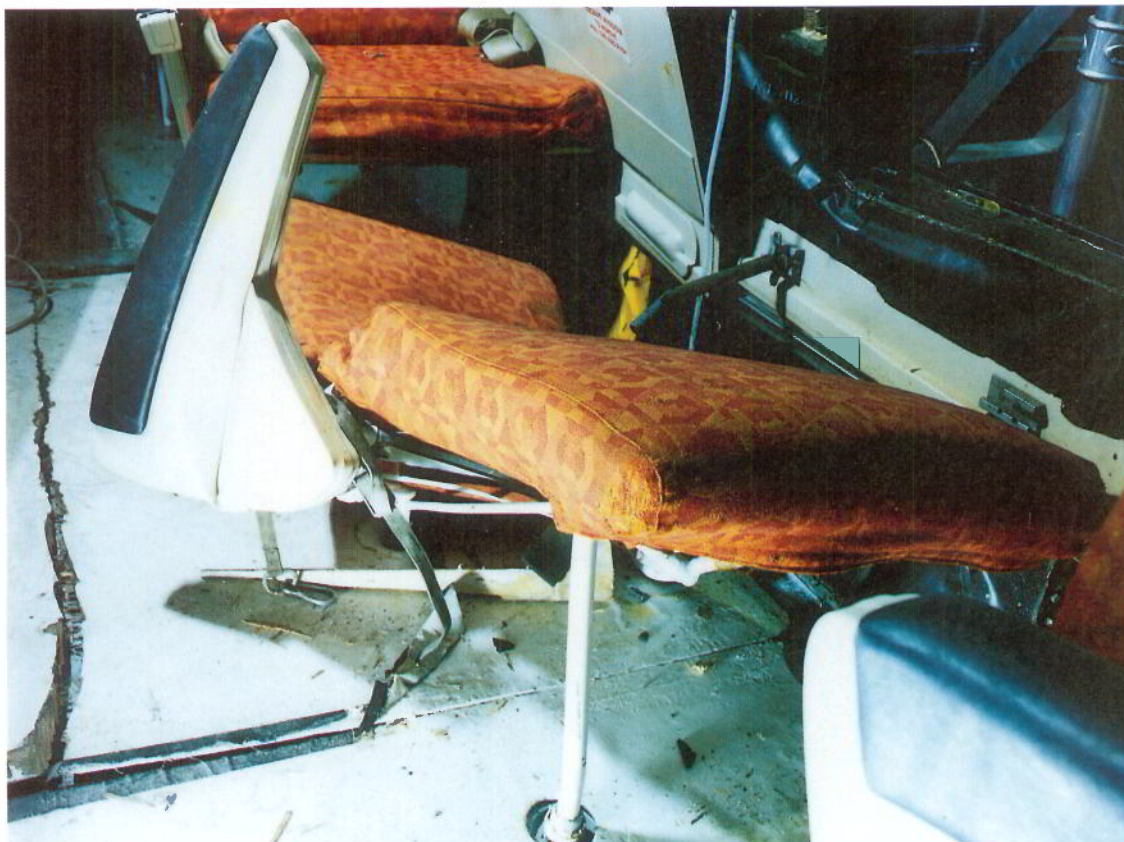
Seat 5L - left side of passenger cabin

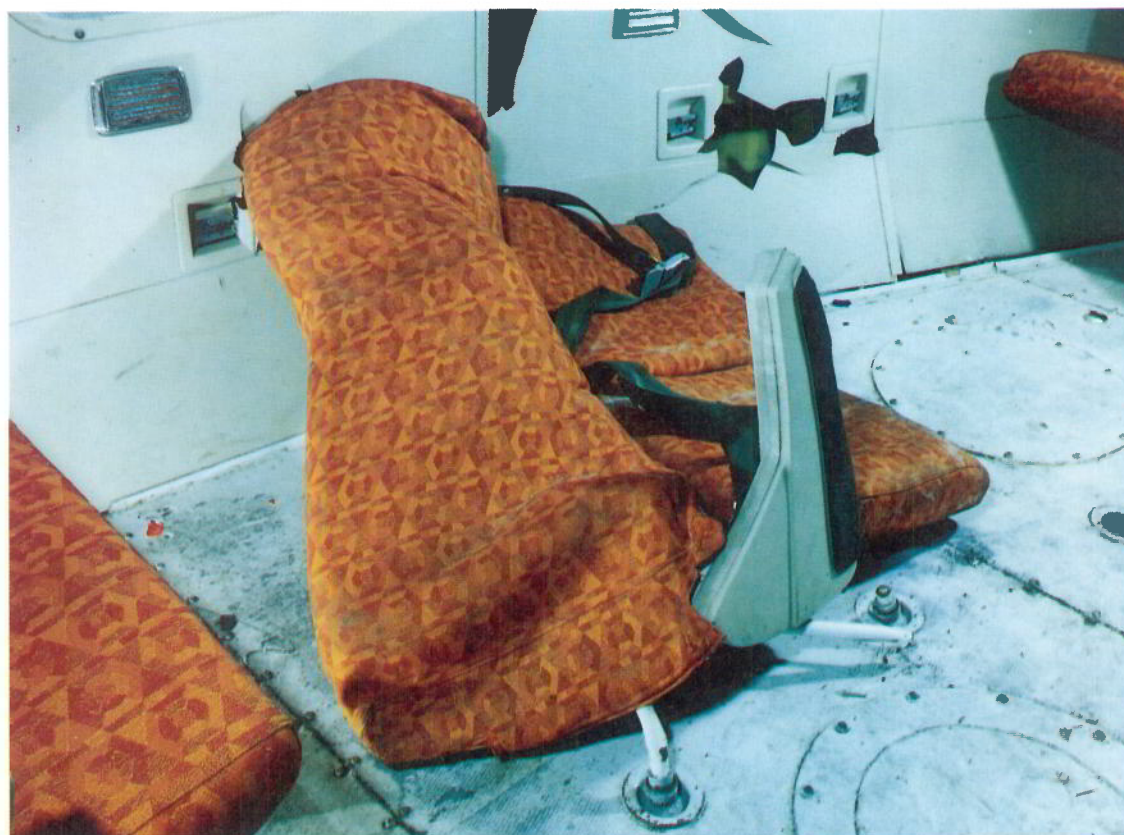
Seat 9R - right side of passenger cabin

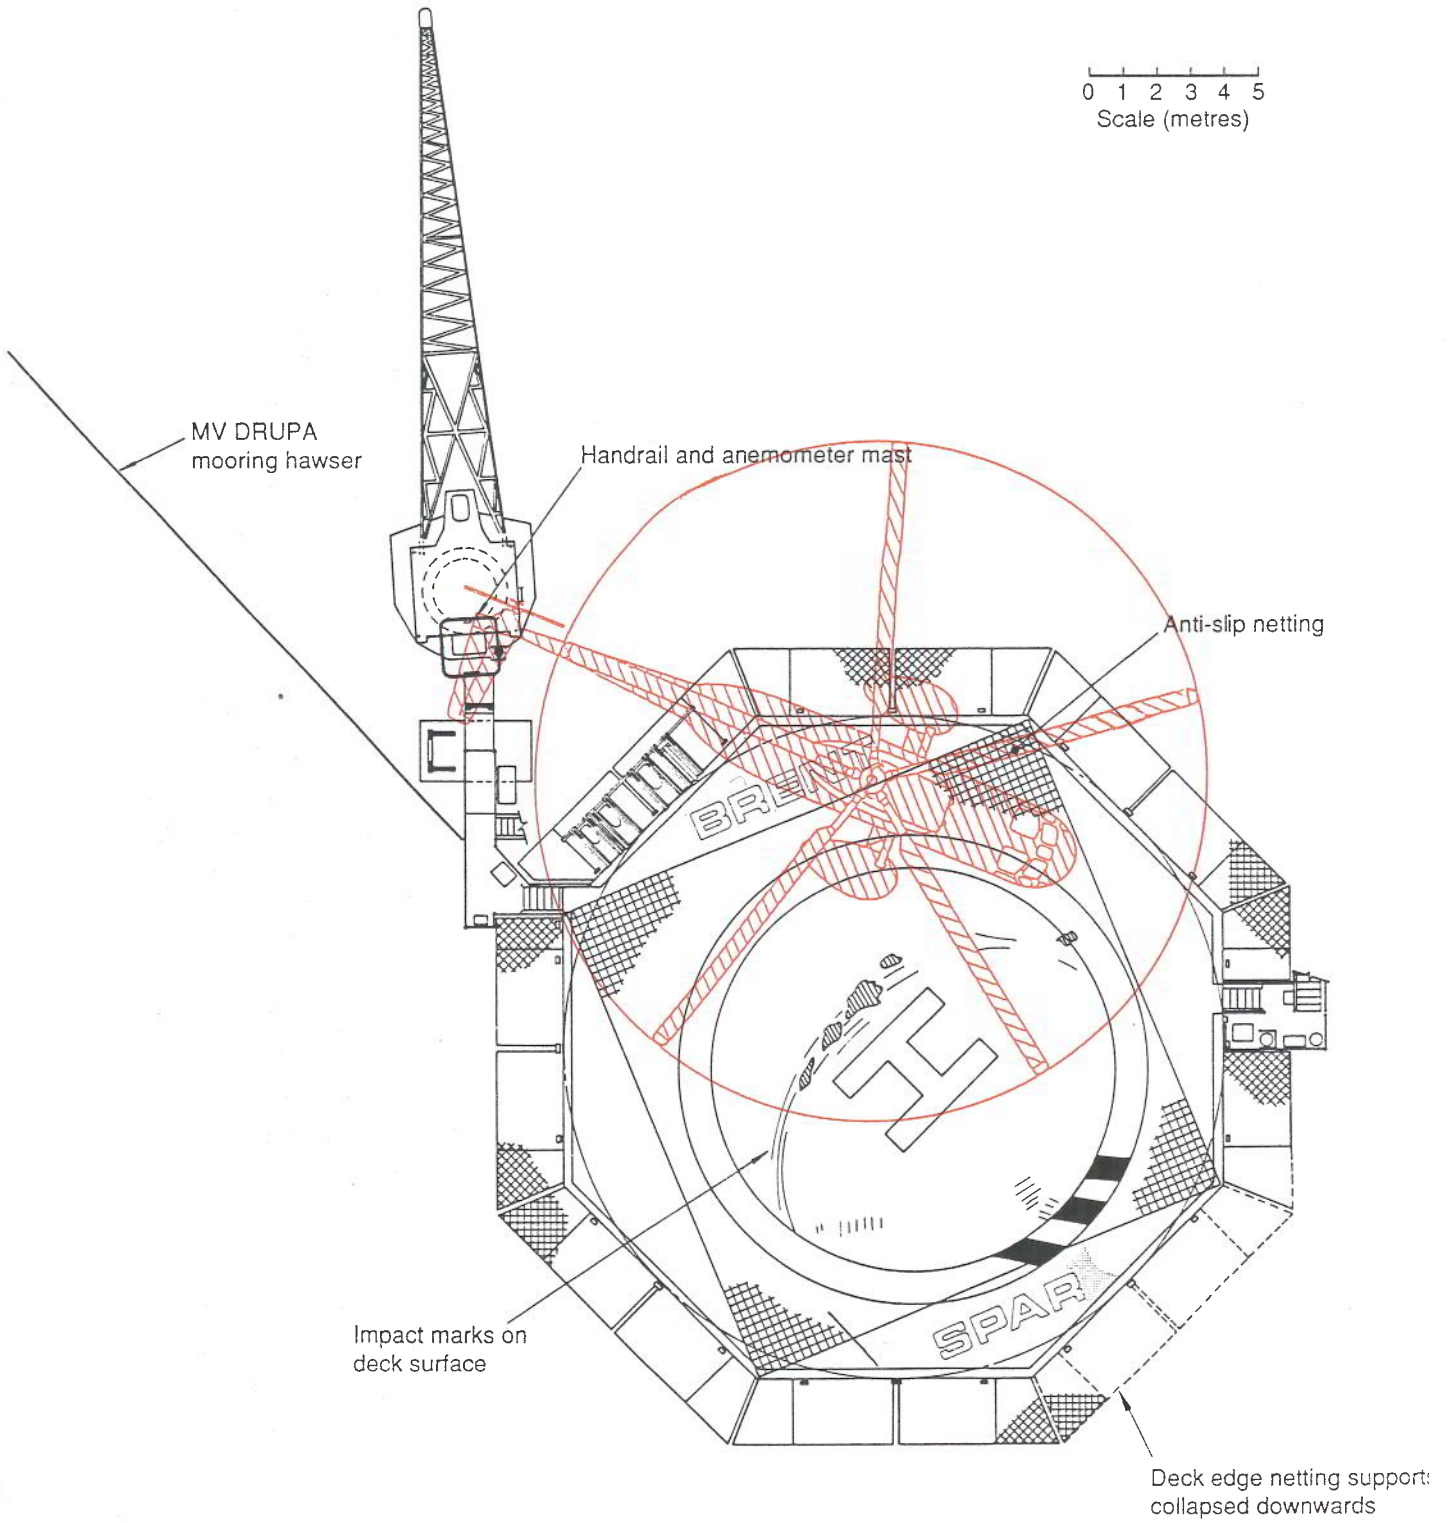
Overlay depicting relative position of G-BEWL at moment of tail rotor impact

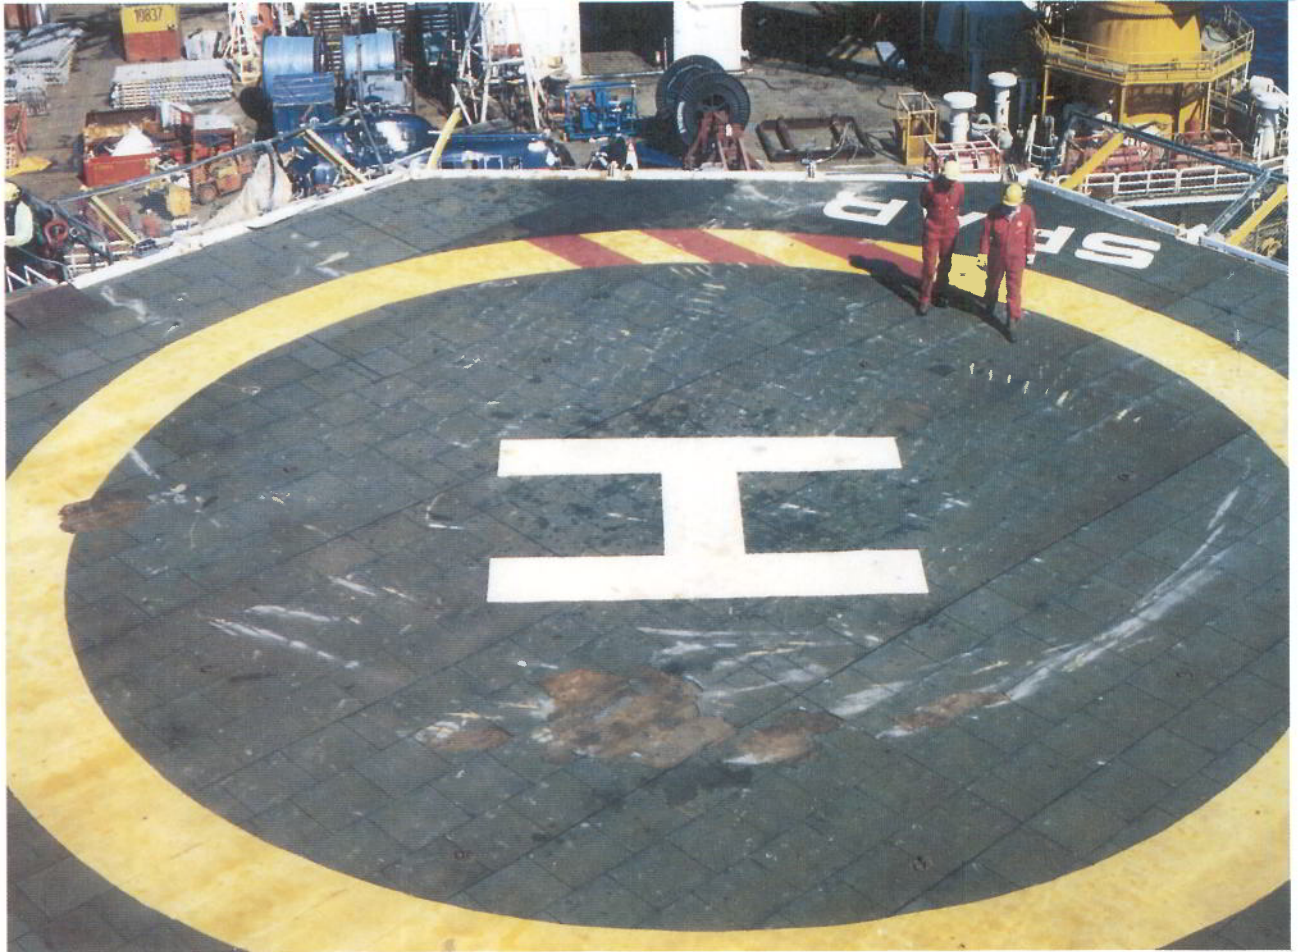
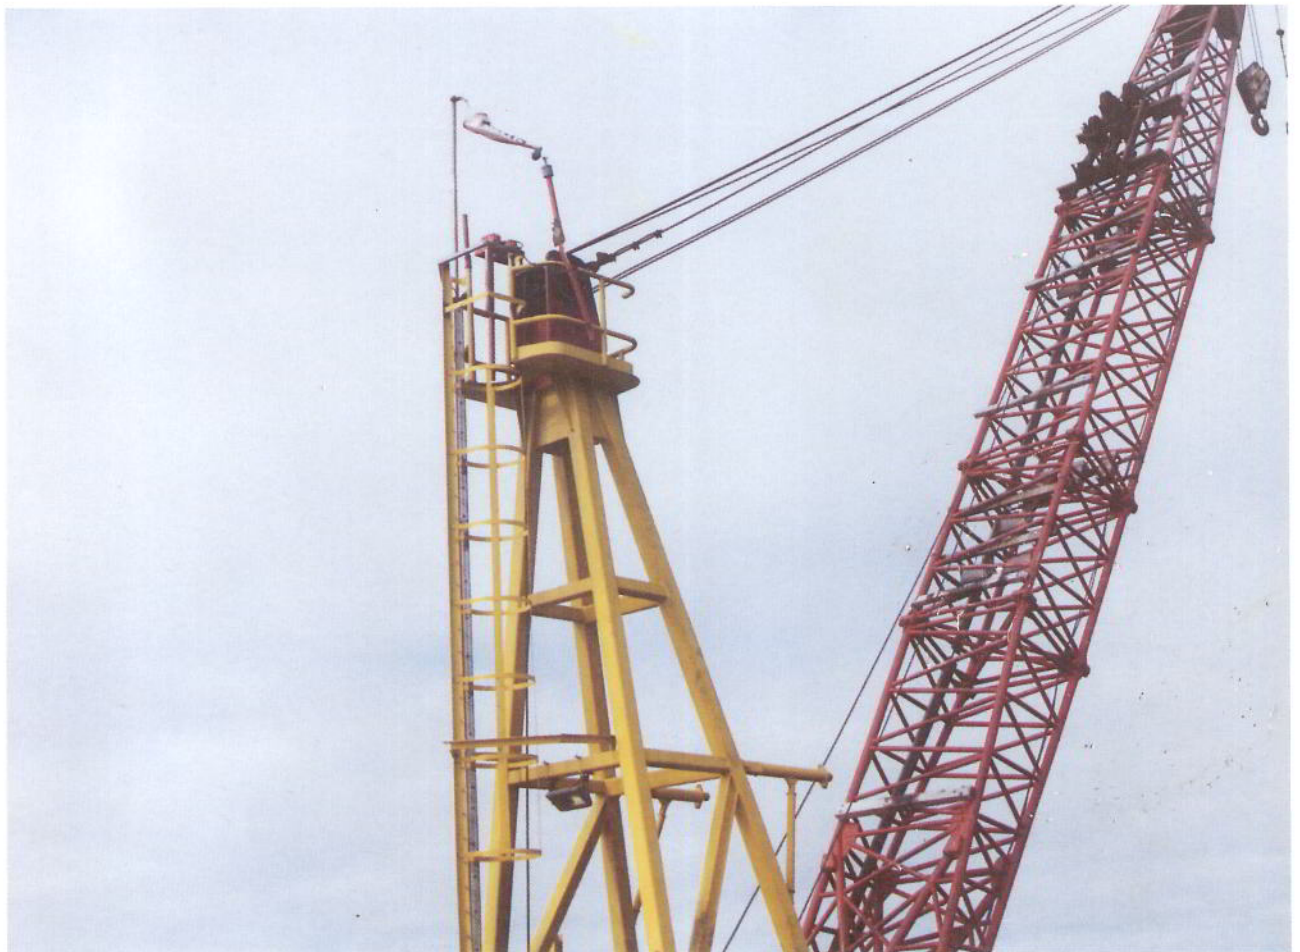
Damage to Brent Spar helideck and crane "A" frame.

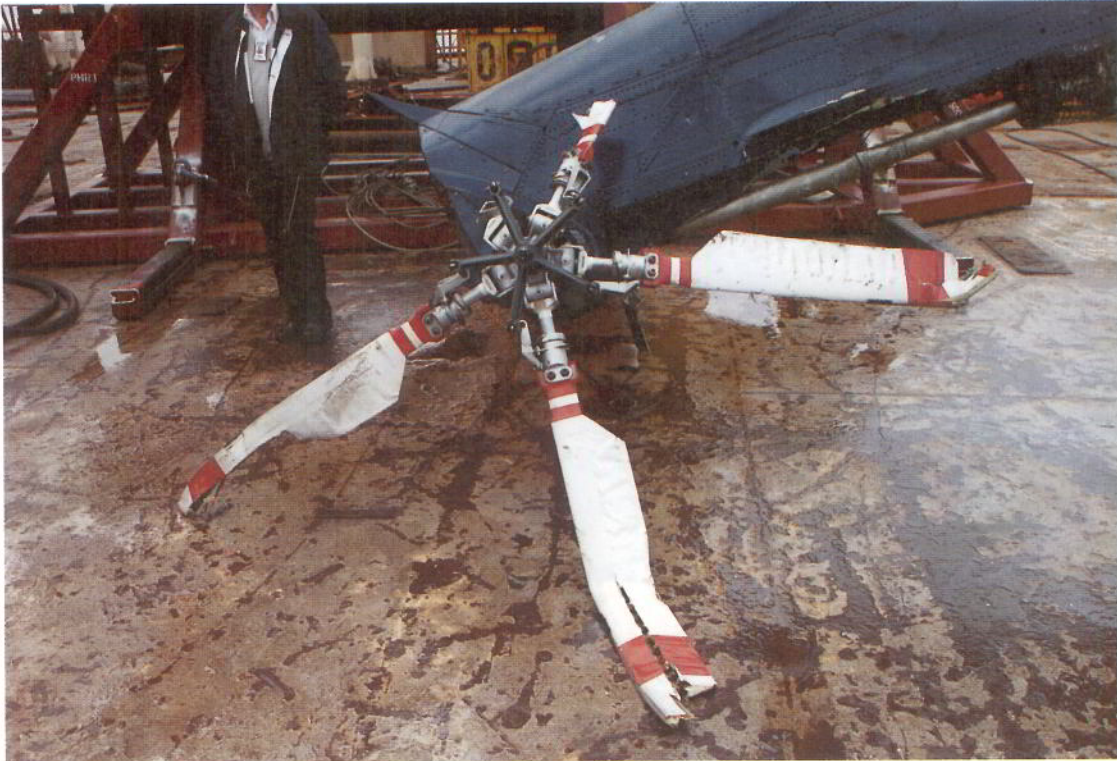
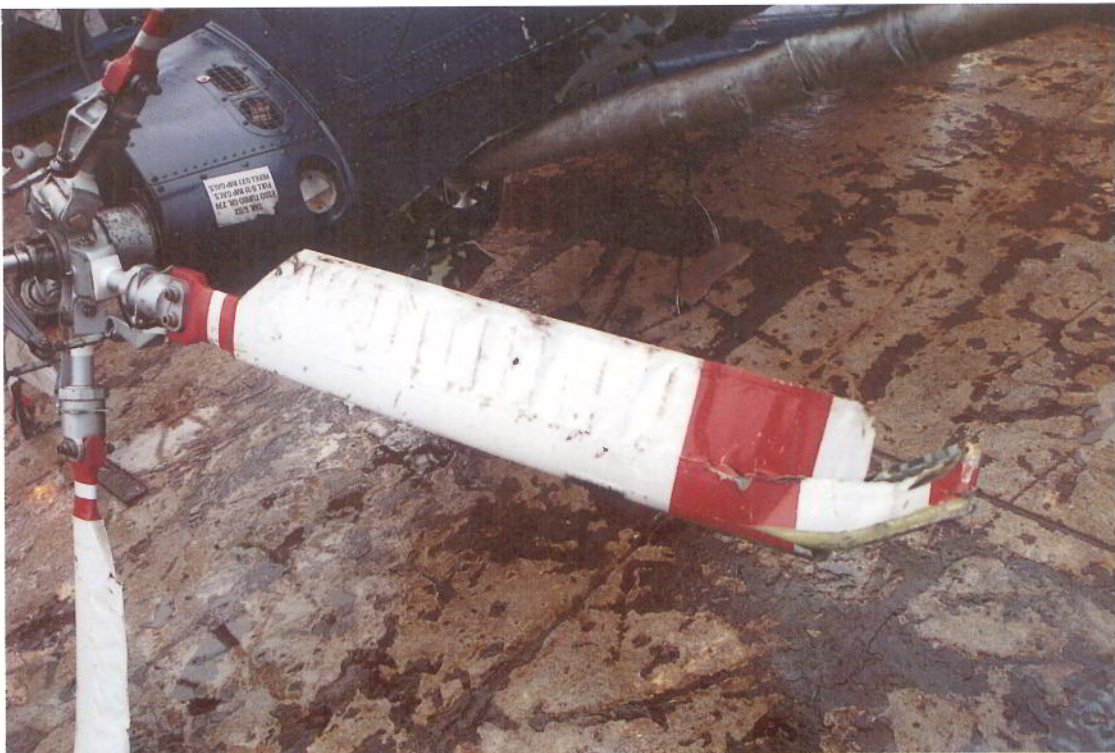
Damage to tail rotor.

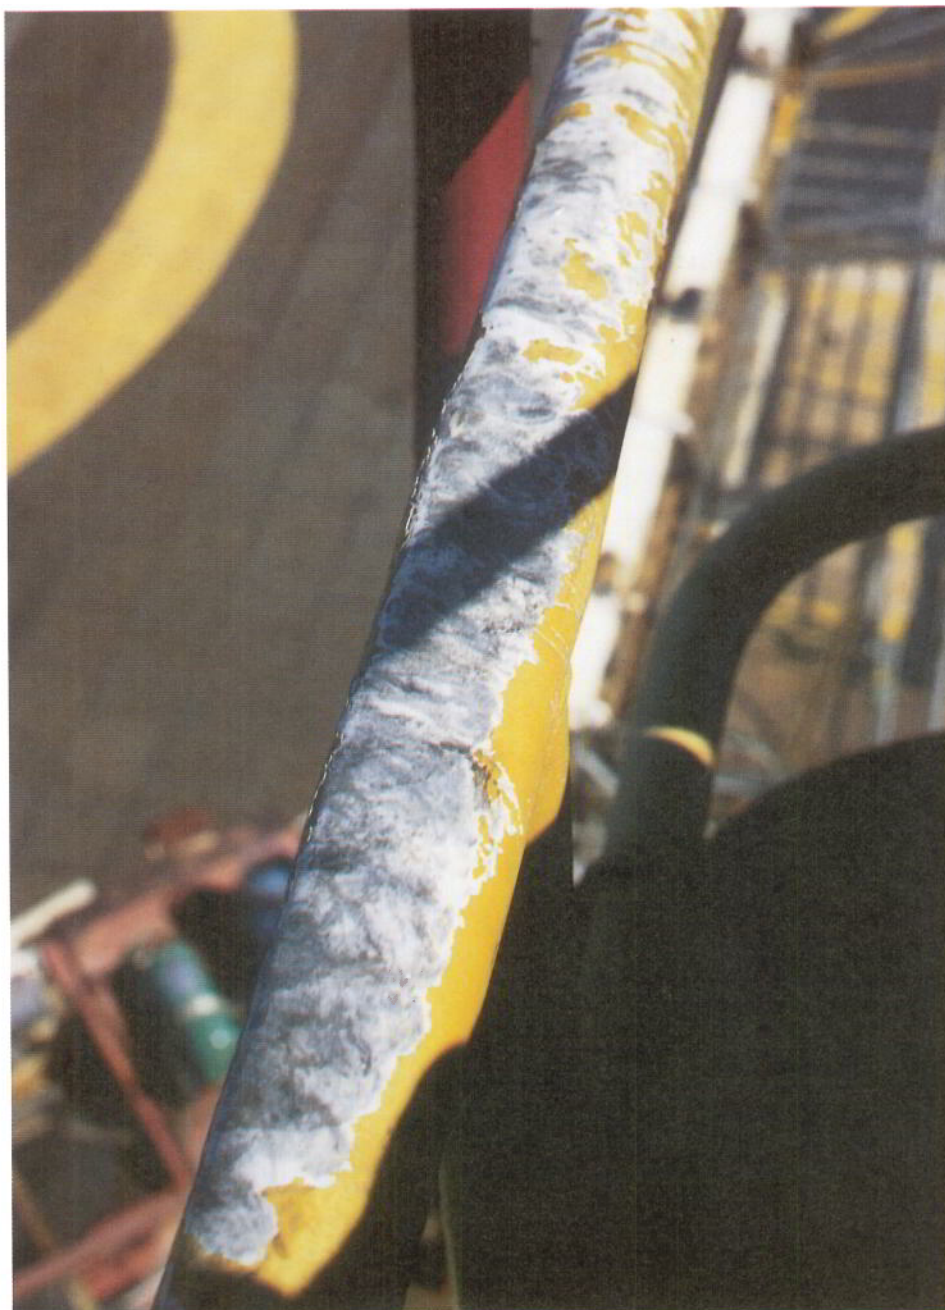
Damage to crane "A" frame handrail.
