ACCIDENT

Aircraft Type and Registration:	Cessna 402B Utililiner, G-NOSE
No & Type of Engines:	2 Continental Motors Corp TSIO-520-EB piston engines
Year of Manufacture:	1975 (Serial no: 402B-0823)
Date & Time (UTC):	14 March 2013 at 1102 hrs
Location:	Shrivenham, Oxfordshire
Type of Flight:	Aerial Work
Persons on Board:	Crew - 1 Passengers - 2
Injuries:	Crew - None Passengers - None
Nature of Damage:	Minor damage to right emergency exit door
Commander's Licence:	Commercial Pilot's Licence
Commander's Age:	27 years
Commander's Flying Experience:	3,000 hours (of which 250 were on type) Last 90 days - 54 hours Last 28 days - 20 hours
Information Source:	Aircraft Accident Report Form submitted by the pilot

Synopsis

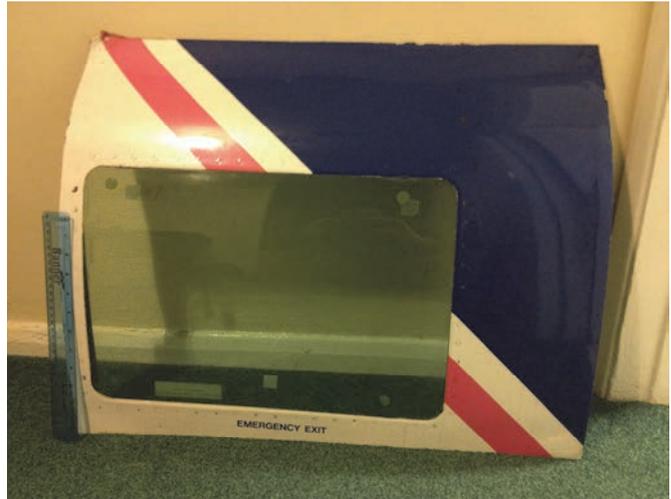
Figure 1

The right emergency exit door fitted to G-NOSE consisted of a windowed panel, approximately 60 cm x 100 cm, Figure 1. The door is fitted with a flange on its upper edge which locates in a groove in the upper door aperture. The lower edge of the door is secured by two locking pins which pass through lugs on the lower edge of the door. The locking pins are attached by a cable to the door release handle, located in a receptacle on the cabin wall, immediately below the door. The locking pins are prevented from disengaging from the door lugs by two shear pins. Pulling the door release handle breaks the shear pins and withdraws the locking pins from the door lugs. It also operates an arm on the lower edge of the door aperture which pushes the door away from the fuselage side. A 'tell-tale' wire is fastened between the lever arm and the aircraft structure which breaks if the lever arm moves from its normal, stowed position.

Examination of the door confirmed that there was no evidence of adverse wear to the door attachment flange or to the two securing lugs. An inspection of the aircraft, carried out by the operator, confirmed that the door release handle had not been operated and was secure in its receptacle. The 'tell-tale' wire attached between the door release arm and the fuselage was found intact and the shear pins retaining the door locking pins were in place.

G-NOSE right emergency exit door

The door had not been the subject of recent maintenance and an inspection of the aircraft structure and door release mechanism did not identify any defects which would have allowed the door to be released without pulling the release handle.

There remains a possibility that the relative movement between the right exit door and the aircraft structure, coupled with dynamic flight loads, may have been sufficient to disengage the locking pins and release the door.
