No: 3/92

Ref: EW/G91/09/12

Aircraft Type and Registration: Piper PA-34-200T Seneca II, G-BPCY

Nature of Damage: Propellers bent, engines shock loaded, nose landing gear, fuselage nose and left wing damaged

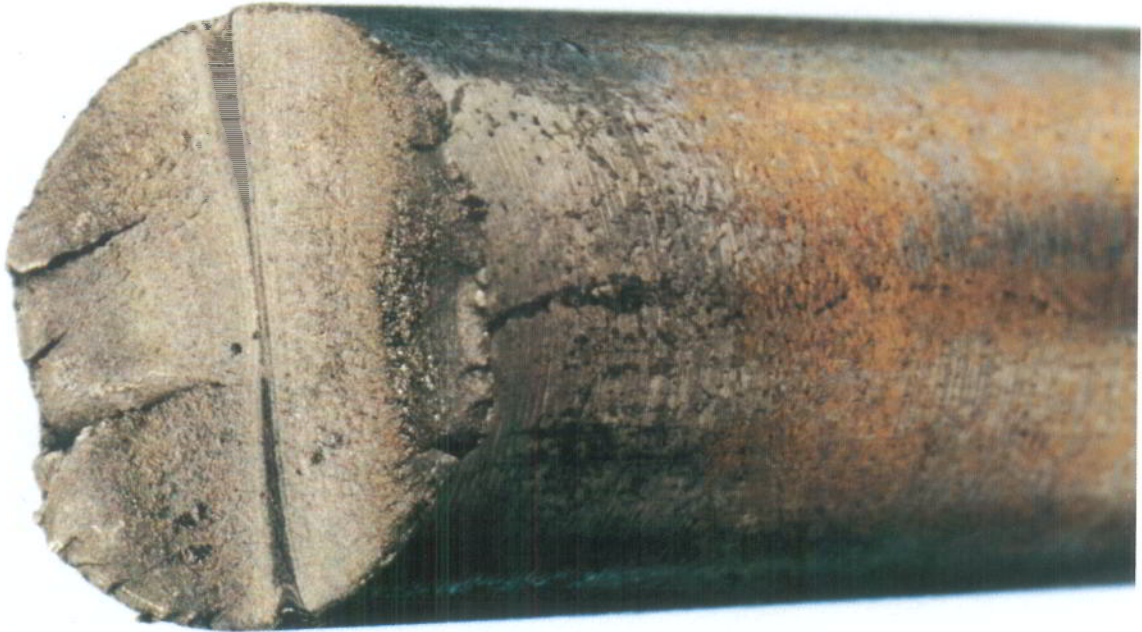
Subsequent examination of the nose landing gear showed that the bolt which had attached the forward end of the downlock link to the top of the nose landing gear leg had failed. The Piper part number for this bolt was 400-274 (AN7-35). The failed bolt and the downlock link were submitted to the Materials & Structures Department of the Defence Research Agency Aerospace Division at RAE, Farnborough for detailed examination. Their examination of the bolt concluded that it had failed in 'double-fatigue' (photograph No. 1), largely as a result of the growth of fatigue cracks from defects in the surface. The fatigue extended across the complete cross-section of the bolt. The defects in the surface were associated with decarburisation which had occurred during manufacture. It was concluded that the failure of the bolt had been strongly influenced by its substandard condition.

With regard to the fracture of the bolt, which had occurred close to the interface between the downlock link and the nose landing gear leg, it is possible that although the bolt was clearly defective and therefore susceptible to fatigue damage, its failure could have been assisted by the increased bending loads which would have been introduced by the offset between the downlock link and the nose landing gear leg resultant from the displacement of the bush. The ovality and deformation evident at the downlock link end of the bolt hole in the nose landing gear leg certainly suggested that incorrect loading of the bolt had occurred.

Photograph No. 1. Double fatigue failure of the bolt.

The CAA introduce a 'one-time' inspection be carried out on all Piper PA 34 aircraft to ensure that the specified washer is fitted to the downlock link/nose landing gear bolt; that such bolts have the correct head markings and the surface condition of their shanks is satisfactory.

The CAA require that a suitable life be determined for downlock link/nose landing gear bolts on Piper aircraft.

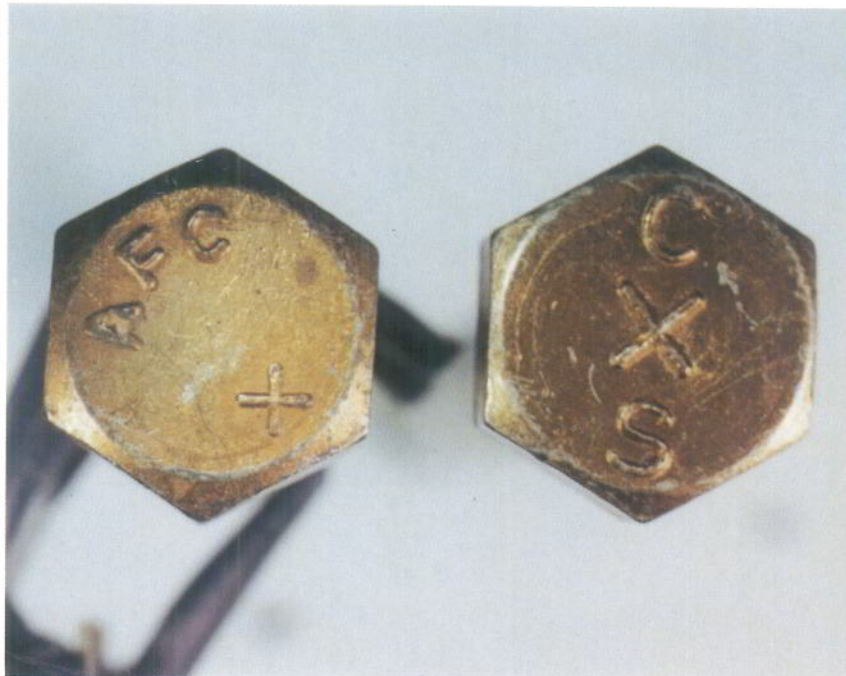
Similar bolts were removed from two other Piper PA 34 nose landing gears, one having achieved approximately 2500 hours and the other 120 hours. Both had similar manufacturer's markings on the bolt heads which were totally different from the markings on the head of the bolt that failed (photograph No. 2). Neither of these two bolts had any fatigue cracks, although the 2500 hour bolt had very heavy wear-induced 'grooving' in the area where the failure had occurred in the subject bolt. Hardness testing of the two intact bolts showed them to be considerably stronger than the failed bolt. It was not possible to establish the source of supply of the bolt that had failed. There was no record of this bolt having been replaced in the period since the aircraft was placed on the United Kingdom register in November 1988. The aircraft had accumulated a total of 3300 hours since manufacture.

Photograph No. 2. Head of failed bolt (left) & "good" bolt (right).

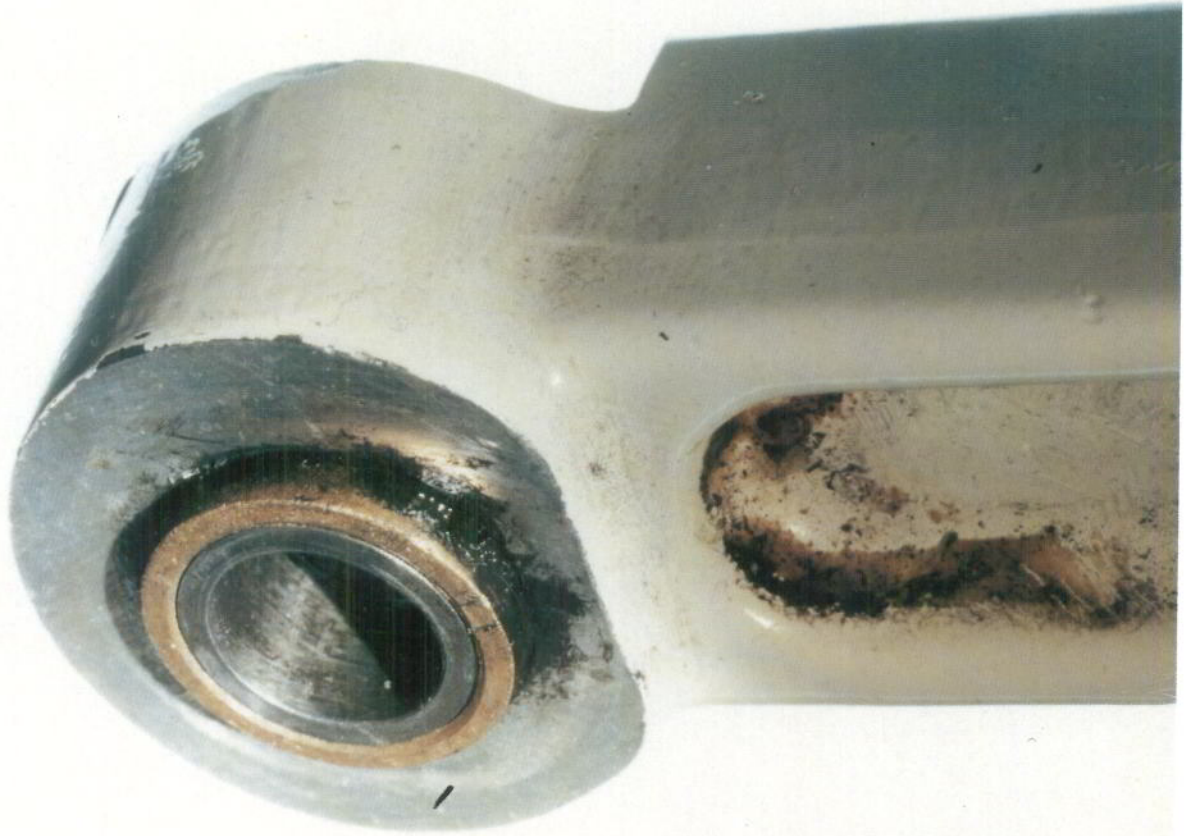
The downlock link had a bronze bush fitted at the end which connected to the top of the nose landing gear leg. This bush, which was a 'press-fit' in the link, was found to be protruding from the inner face (photograph No. 3), *ie* the surface adjacent to the top of the nose landing gear leg, by approximately 2 mm. A build-up of a black, grease-like deposit on the protruding surface and the recessed face on the outer side indicated that the bush had probably been displaced for some time, *ie* the displacement had not occurred at the time that the bolt had failed. Further examination of the protruding end of the bush revealed a crack in its rim, and in the region of the crack there was a small lip on its outer diameter (photograph No. 4), suggesting that it had been locally deformed by pressure on its end face, although there was no evidence of associated damage on that face. Marks were apparent which extended part-way around the outer surface at various positions along the length of the bush. These marks appeared to be consistent with either a 'rebushing' operation, with some misalignment of the bush within the link when pressure had been applied to fit the bush, or with the bush having worked its way out of the downlock link whilst a bending load had been applied to the bolt. At the other end of the bush there was a clear impression of the bolt head on the end face and six matching 'indents' in the bore of the downlock link (photograph No. 5). These marks indicated that the bolt had been fitted without a washer under its hexagonal head and that it had been 'pulled' into the recess. On the inner face of the downlock link, around the bore, there was a faint annular marking with a diameter of approximately 25 mm, which was larger than the external diameter of the bush, suggesting that a washer/spacer had been present between the downlock link and the nose landing gear

The reason for the displacement of the bush was unclear. The appearance of the damage to the protruding end, *ie* cracking, local deformation and marks on the outer surface, was consistent with difficulties having been experienced during the fitting operation of the bush or by the bush working its way out of the downlock link during service. The faint annular marking on the inner face of the downlock link suggested that a washer may have been present at some time, although the size of the mark was not consistent with that of the washer that should have been used in this assembly, and there was no similar evidence on the adjacent face of the nose landing gear leg. The manner in which the bolt head had pulled into the bore of the downlock link, as a consequence of the absence of a washer in that position, appeared to confirm that the bush had been protruding at the time of the last assembly. The only other conceivable possibility was that one or two washers had been fitted at some time between the downlock link and the nose landing gear leg and that their internal diameter was large enough to allow them to fit over the bush, such that the bush could then be drawn through during tightening of the nut. However, in order for this to have occurred the bush and the washers would have had to be accurately aligned when assembled in the horizontal position and this would have been extremely difficult. The evidence of the build-up of a grease-like deposit on the protruding surface indicated that these washers had not been fitted during the last occasion upon which the bolt had been fitted.

Photograph No. 3. Protruding bush in the downlock link.

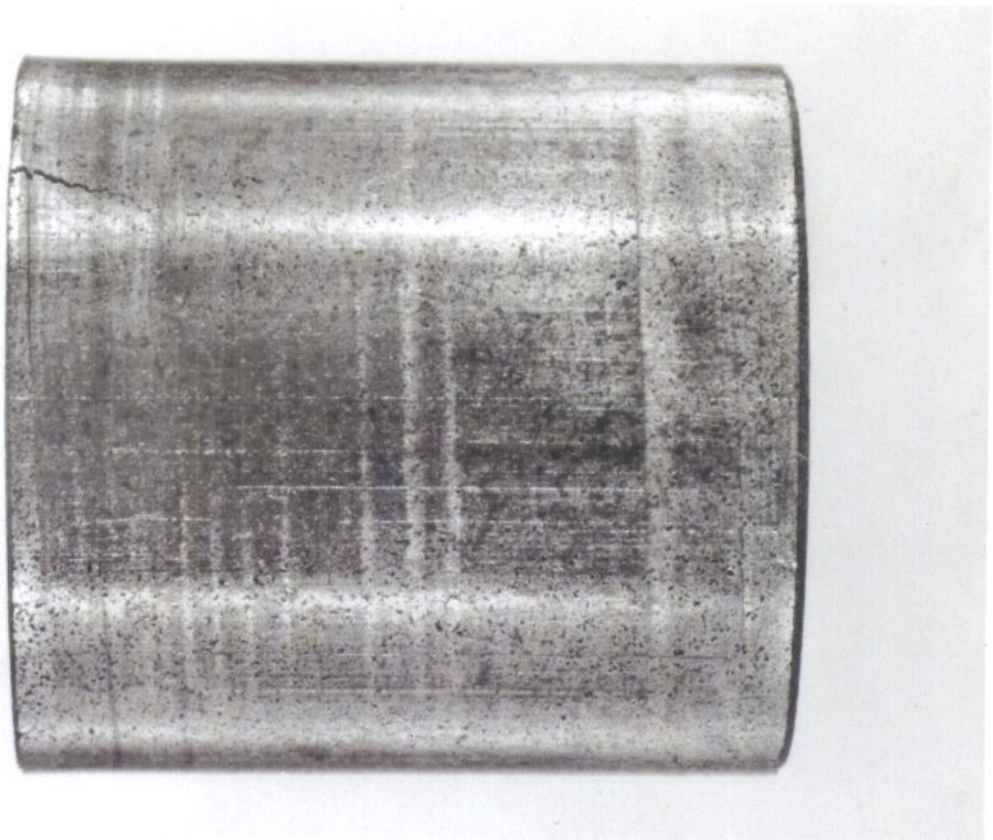
Photograph No. 4. Side view of the bush showing the crack and deformation lip.

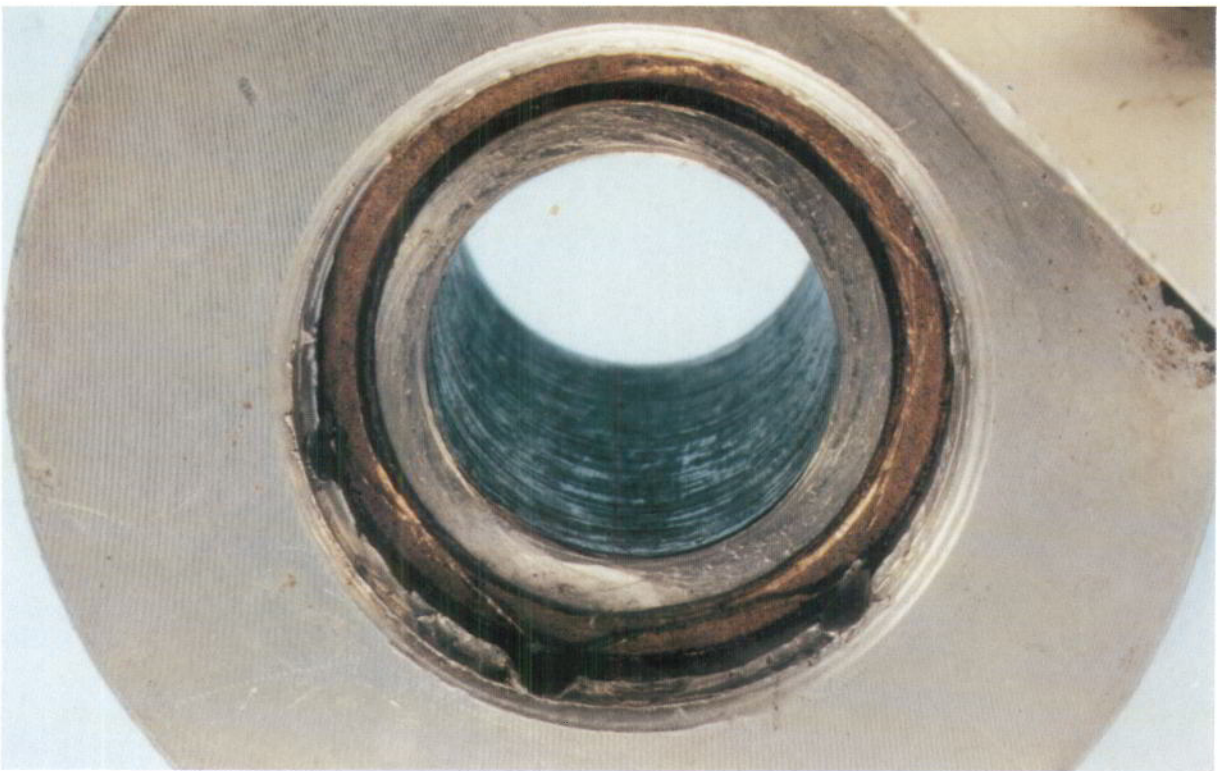
Photograph No. 5. Bolt head markings in the downlock link and bush.

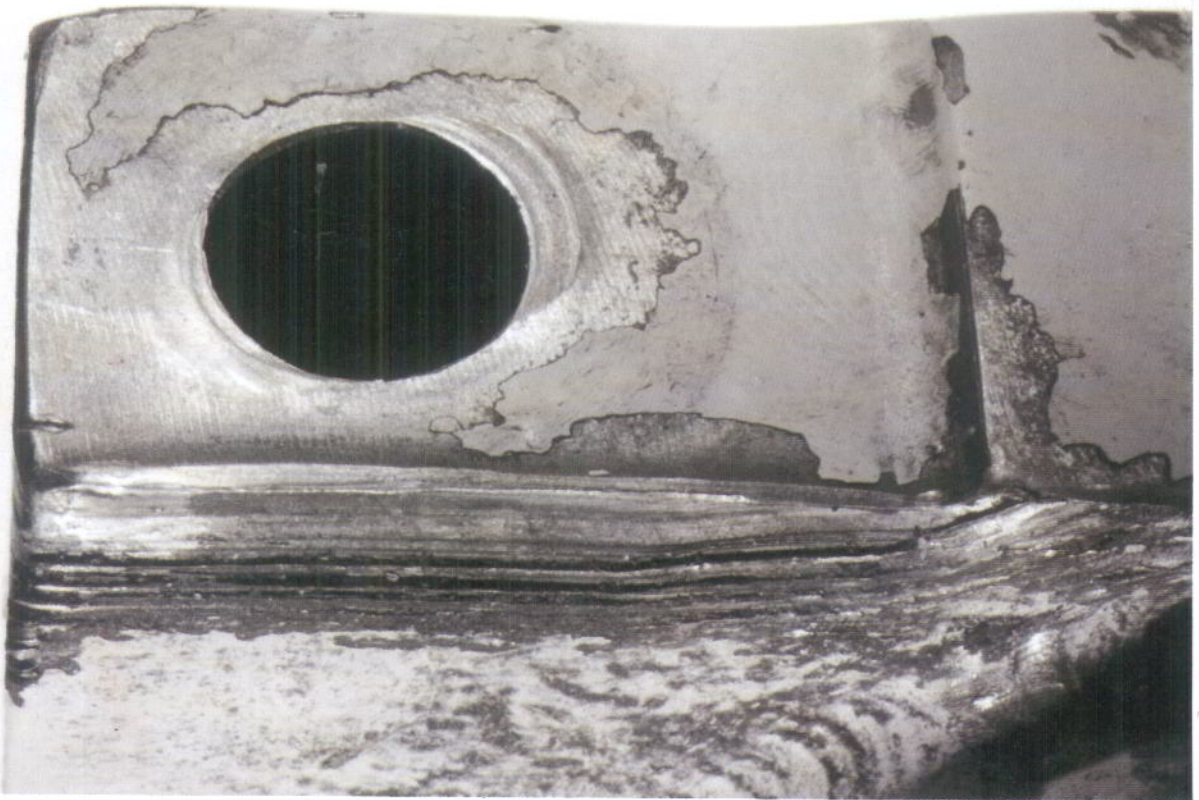
Examination of the area of the bolt hole at the top of the nose landing gear leg, where the downlock link was attached, showed deformation of the steel and ovality of the hole (photograph No. 6) which had occurred over a period of time prior to the bolt failing. There was, however, no marking on the adjacent surface that could be associated with a washer or with contact with the protruding bush.

Photograph No. 6. Ovality of the bolt hole in the top of the nose landing gear leg.
