ACCIDENT

Aircraft Type and Registration:	Piper PA-34-200T Seneca II, G-ROUS	
No & Type of Engines:	2 Continental Motors Corp TSIO-360-EB piston engines	
Year of Manufacture:	1978	
Date & Time (UTC):	12 November 2008 at 1525 hrs	
Location:	Oxford Kidlington Airport	
Type of Flight:	Training	
Persons on Board:	Crew - 3	Passengers - None
Injuries:	Crew - None	Passengers - N/A
Nature of Damage:	Damage to left landing gear retraction mechanism, left wing tip, left aileron hinge bracket, left aileron and flap	
Commander's Licence:	Commercial Pilot's Licence	
Commander's Age:	47 years	
Commander's Flying Experience:	2,684 hours (of which 965 were on type) Last 90 days - 87 hours Last 28 days - 39 hours	
Information Source:	Aircraft Accident Report Form submitted by the pilot and further investigation by AAIB

Synopsis

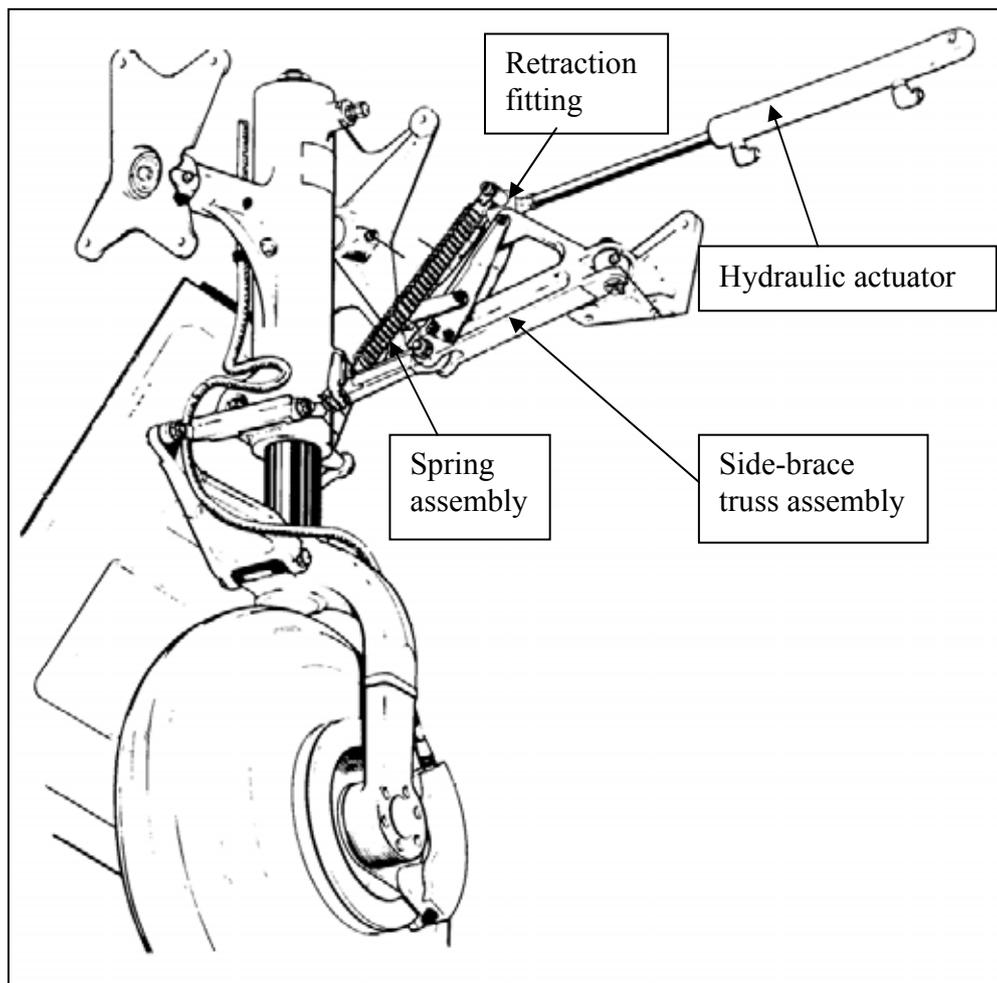
Figure 1

The hydraulic actuator ram for the main gear leg is attached to a retraction fitting. The fitting is located at the top of the truss assembly and is a key component in the extension and retraction system. The spring assembly and downlock hook mechanism are also attached to this fitting. As the hydraulic actuator ram extends, the fitting rotates forward, pushing the truss assembly against the spring pressure until the gear leg is down and the over-centre position of the truss assembly is reached. The downlock hook is also pushed forward by this action until it latches onto the lower truss link. Retraction of the gear works in the opposite sense, with the downlock hook being pulled off the lower truss link, as the retraction fitting and upper truss link rotate back with the retracting hydraulic actuator ram.

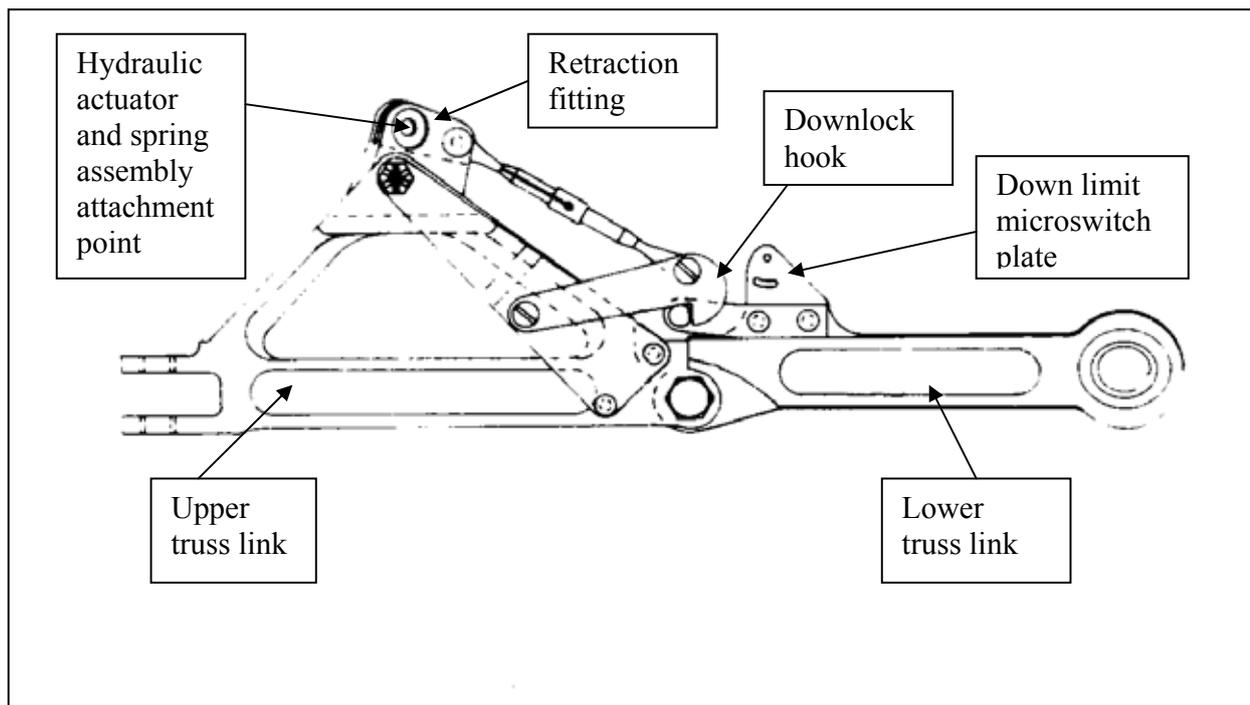
Figure 2
Side-brace truss assembly

The gear would therefore have been 'down' as observed by the tower controller and holding pilot. However, the lack of hydraulic actuator connection or downlock hook securing the side-brace truss meant that it was not over-centre and not locked, leading to the cockpit indication observed by the instructor. When the aircraft landed, the unsupported gear leg then collapsed under the weight of the aircraft, trapping the downlock hook assembly as found during the aircraft recovery.

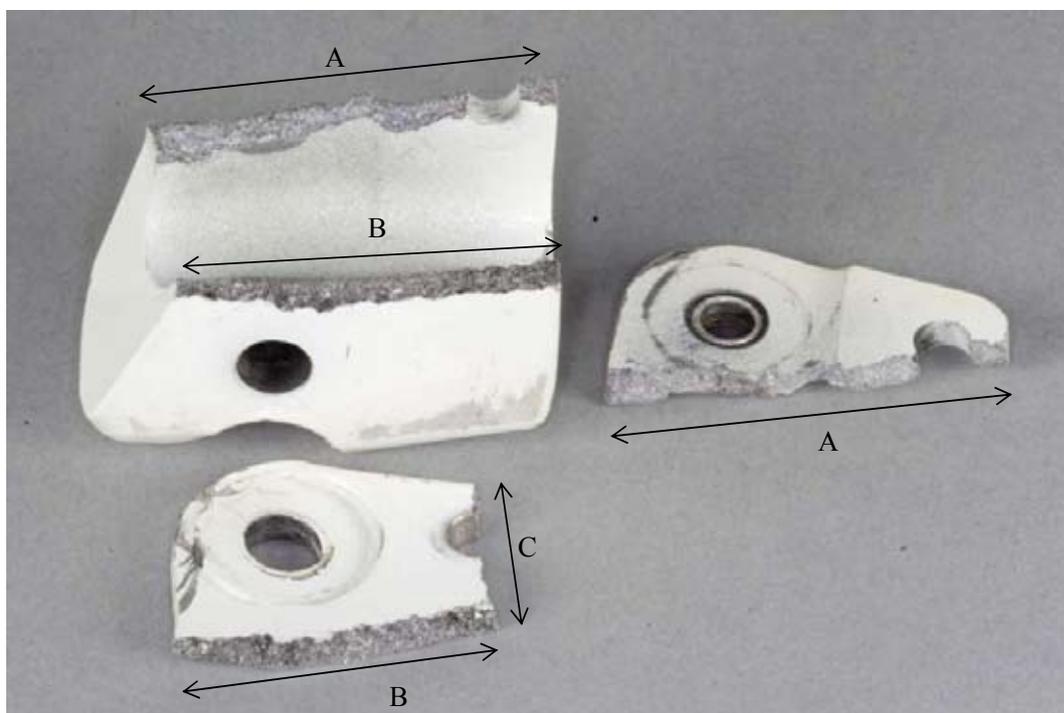
Figure 3
Failed retraction fitting

Inspection of the left landing gear identified that the retraction fitting had failed along three fracture lines (Figure 3). This had resulted in the top sections of the lugs, where the hydraulic actuator eye end and

the spring are attached, separating from the lower half of the fitting, which remained bolted to the truss assembly. A section of the retraction fitting, forward of the attachment point for the downlock hook assembly, was missing completely. The downlock hook assembly had detached from the retraction fitting and was lodged between the down limit microswitch plate and the lower truss link assembly.

Detailed inspection of the retraction fitting identified various impact and wear marks, specifically around each of the bolt holes and on the body of the fitting. A wear mark on the rear under-surface of the fitting also

correlated with a witness mark on the truss assembly. The retraction fitting had been installed on the aircraft, as new, three years (1,508 flight hours) previously. The fitting is an aluminium silicon casting and the fracture surfaces had a characteristic granular appearance. The fracture surfaces for failures B and C were significantly darker in colour than for failure A and showed evidence of polishing of the raised sections of the surface.

The discolouration and polishing exhibited on the fracture surfaces of failures B and C suggest that these failures occurred prior to failure A. All the fracture

surfaces were consistent with ductile overload. Cast aluminium has low fracture toughness and is susceptible to shock overload type failures.

Failures B and C probably occurred during a retraction cycle in a previous flight, when the load generated by the downlock hook release was applied to the fitting through the downlock hook assembly for reasons that are not evident. Continued operation of the gear meant that the fitting and downlock assembly would not be working symmetrically, causing the bolt holes in the fitting to wear. This may eventually have resulted in the downlock hook dropping to a lower position than normal during the first extension cycle of the accident flight and, rather than hooking around the 'stop' on the lower truss link, it butted against it. As the hydraulic ram tried to extend the gear fully, the load would be transferred up the downlock assembly and into the remaining intact side of the retraction fitting, causing it to fail in overload and the downlock assembly to drop down.

The operator has commenced a fleet-wide inspection programme of the retraction fitting and truss assembly at the next 100 hour maintenance check, with a repeat inspection each annual maintenance check. At the time of writing, six aircraft have been inspected with no adverse findings. The operator also comments that this is the first failure of a retraction fitting in their extensive experience of operating this aircraft type.
