ACCIDENT

Aircraft Type and Registration:	Zenair CH 601UL Zodiac, G-CCVT	
No & Type of Engines:	1 Rotax 912-S piston engine	
Year of Manufacture:	2004	
Date & Time (UTC):	2 September 2011 at 1730 hrs	
Location:	Private airstrip, Glenmavis, Lanarkshire	
Type of Flight:	Private	
Persons on Board:	Crew - 1	Passengers - None
Injuries:	Crew - None	Passengers - N/A
Nature of Damage:	Extensively damaged	
Commander's Licence:	Private Pilot's Licence	
Commander's Age:	61 years	
Commander's Flying Experience:	922 hours (of which 496 were on type) Last 90 days - 16 hours Last 28 days - 3 hours	
Information Source:	Aircraft Accident Report Form submitted by the pilot

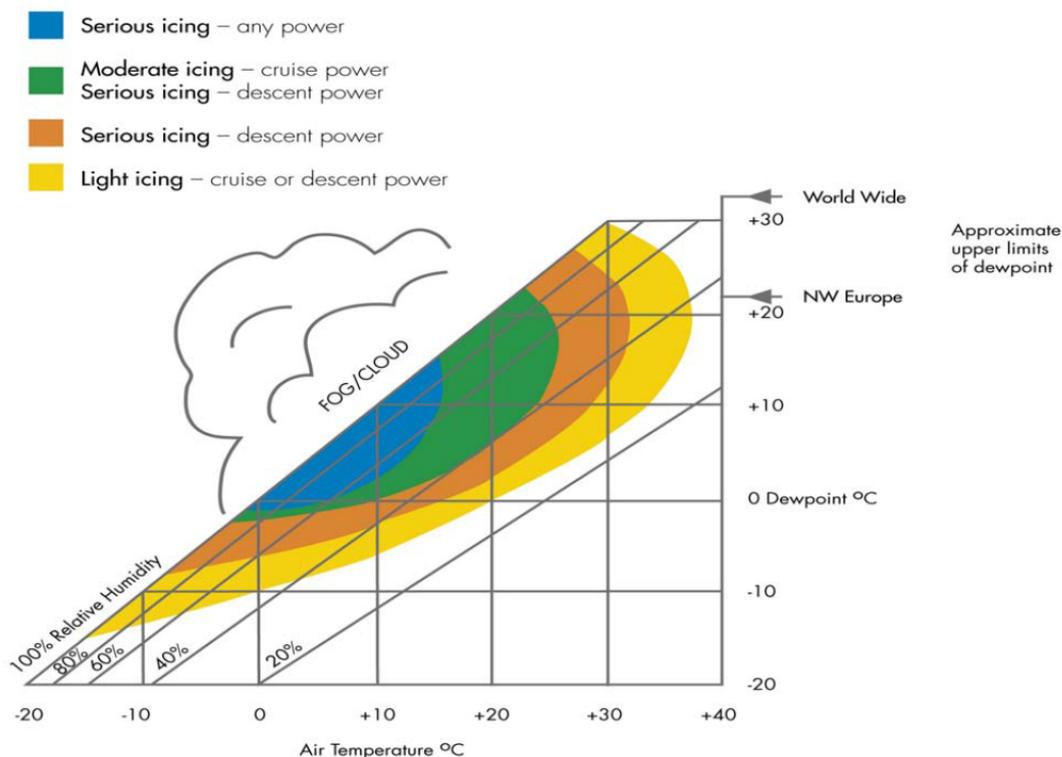
Figure 1
Carburettor icing chart

CAA Safety Sense Leaflet 14 describes the causes of carburettor icing and notes that ‘Carb icing is more likely when MOGAS is used’. The graph from the Safety Sense Leaflet showing the likelihood of carburettor icing is reproduced at Figure 1. From the graph it can be seen that the conditions at the time of the accident would have given a serious risk of carburettor icing at any power setting. However, the pilot’s report that there was a sudden reduction in engine rpm shortly after the aircraft

became airborne is not characteristic of carburettor icing, which in this type of engine installation normally manifests itself as a gradual reduction in power.
