AAIB Bulletin No: 8/95

Ref: EW/C95/1/3

INCIDENT

Aircraft Type and Registration: BAe ATP, G-MANA

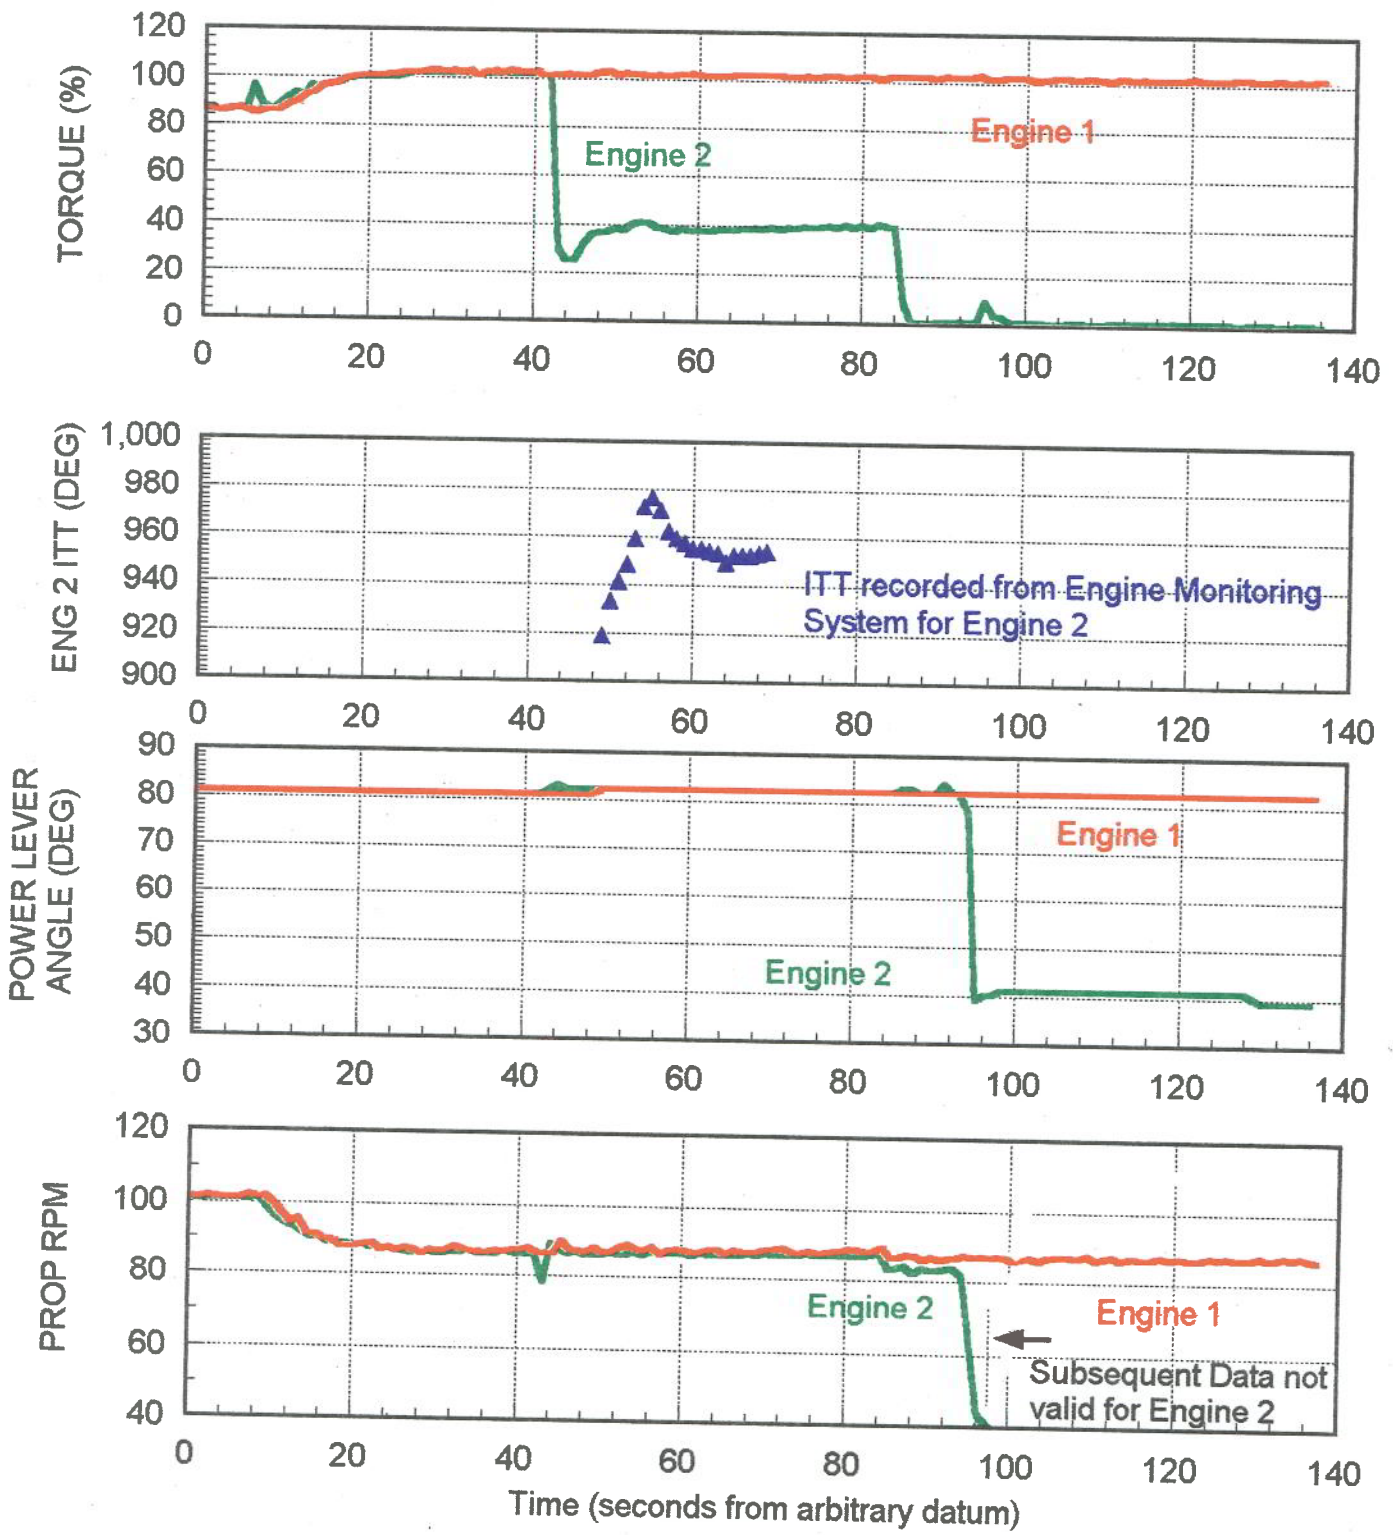
Figure 1 G-MANA FDR data

Figure 1 shows some of the recorded engine data during the incident; the aircraft also carried an engine health monitoring system which recorded exceedance information as well as trend data. Engine No 2 showed a sudden drop in Torque from 100% to around 30% as the aircraft was climbing through 2,750 feet on 1013 mb at 172 kt. This was followed by a rise in Inter-stage Turbine Temperature (ITT) recorded by the health monitoring system, which contained 20 seconds of data on both engines triggered by the ITT exceedance. The maximum ITT was 975°C. There was a second drop in Torque 40 seconds later to around zero, and then 10 seconds later the No 2 engine fire warning illuminated. There was then a reduction in power lever angle and the propeller RPM reduced. The fire warning lasted for 8 seconds on the FDR and the engine was shut down.

There were some problems in the recorded information after the incident when spurious readings were recorded for No 2 engine following the engine shutdown. The Propeller RPM appeared to increase to an overspeed condition (max 110%), and the Low Pressure Turbine (NL2) RPM also appeared to increase despite the engine being shut down. Both indications then decreased, but then showed spikes to higher values (85% Prop RPM and 25% NL) intermittently. Both parameters then stabilised at the same high values that were previously indicated during the spikes. These values made it appear that the engine was running, however other engine parameters show the engine shutdown.

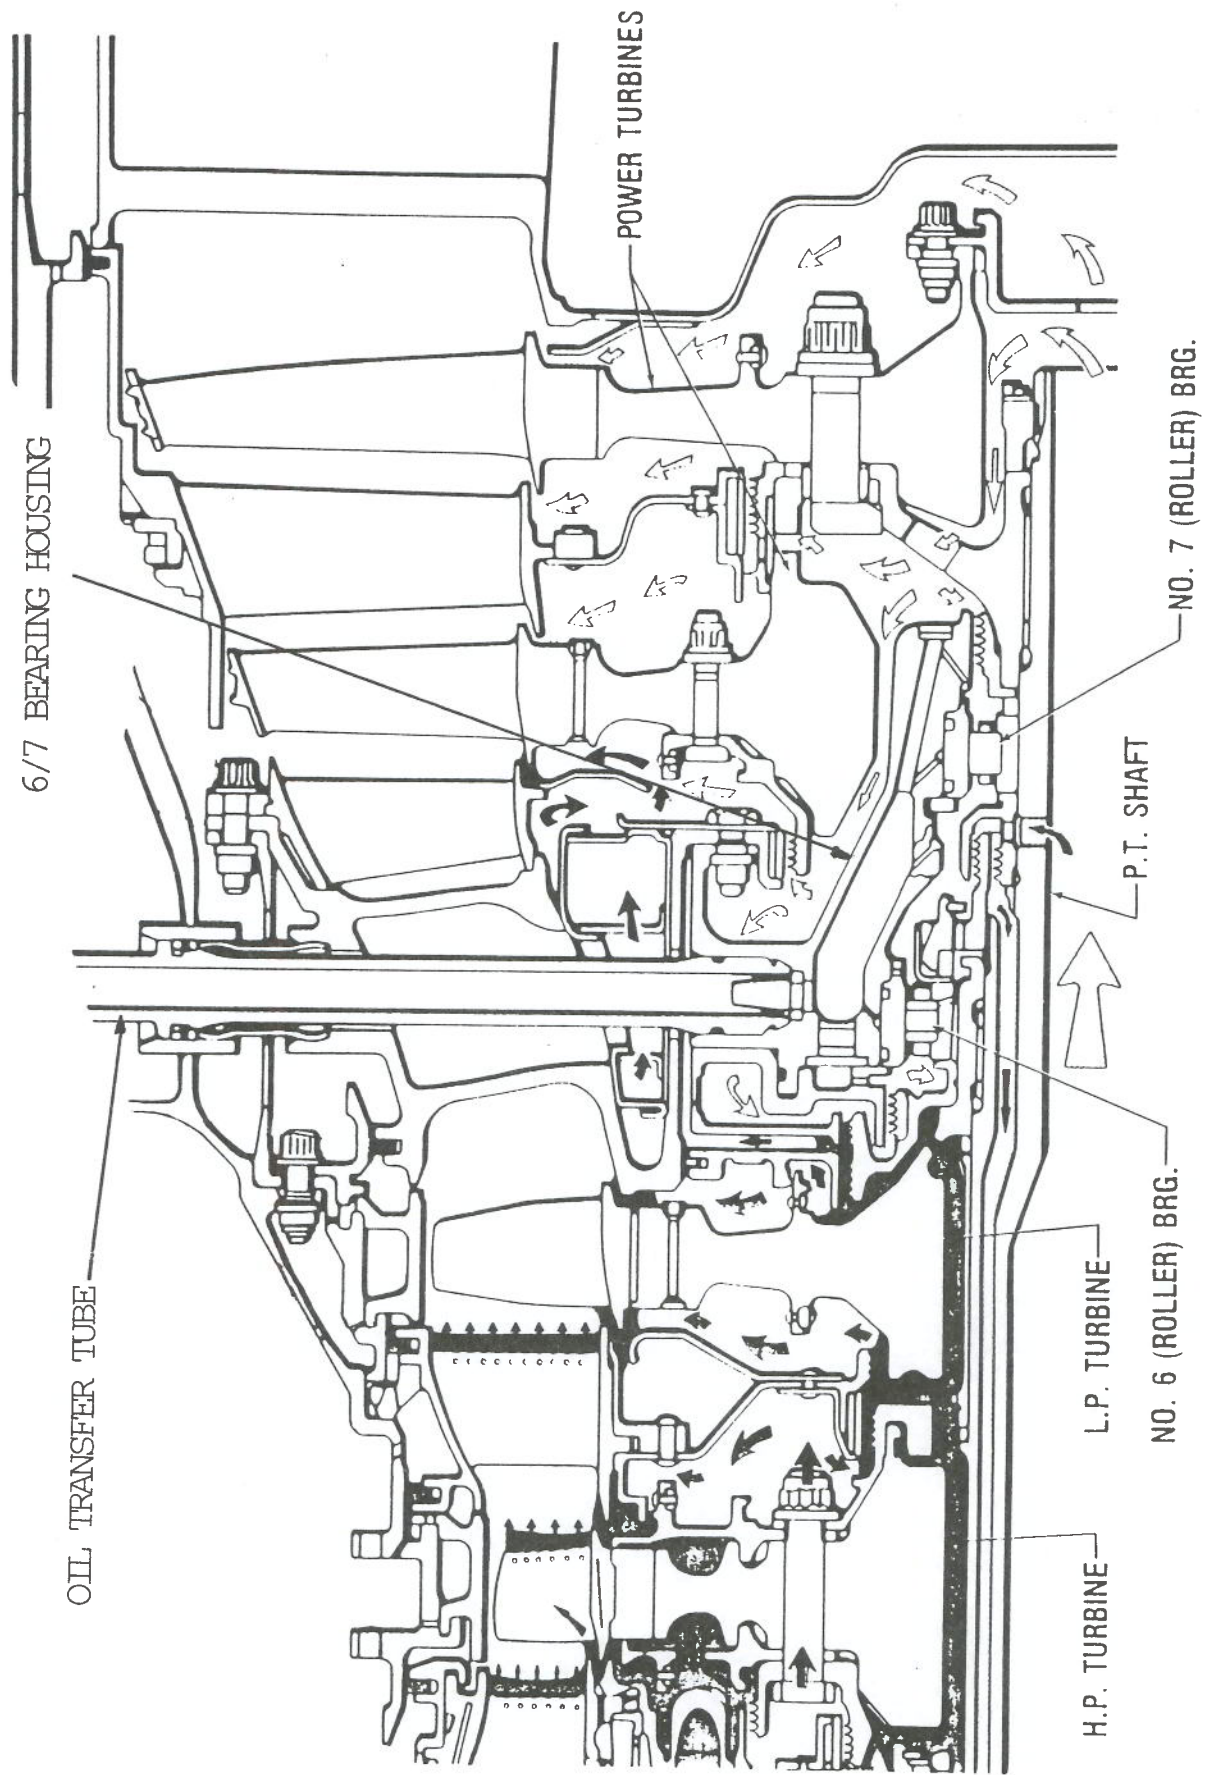
G-MANA: PW126 Engine Turbine Cutaway Diagram

The long exhaust duct was badly distorted through excessive heat and some metallic debris was lying in the duct. Using a torch, it was possible to see that the Second Stage Power Turbine (PT2) had suffered massive damage with sections missing from almost all of the blades. Once the engine forward cowling was opened it was possible to see that there was no evidence of fire inside the nacelle and the quantity of oil leaked around the engine bay area was described by maintenance personnel as "normal". The casing around the power turbine had numerous bulges where high-energy impacts had occurred inside but none had penetrated the casing. It was later discovered that the three oil transfer tubes associated with the No 6 and 7 bearings were loose, being effectively only located by their pipework (see diagram).

The engine was stripped at the Manufacturer's local overhaul facility under AAIB supervision. In addition to the damage to the PT2 stage previously noted, it was found that the PT1 stage had lost all of its blades. Most had fractured immediately above the platform but a total of twelve had been liberated from their fir tree roots in three locations spaced at 120° around the disc circumference. The low pressure turbine (LPT) had impact damage but was mostly intact. The High Pressure Turbine (HPT) was scarcely damaged, as was the rest of the engine forward of this location. Some abnormal seal rubbing and bearing deterioration was found in the compressor stages but, as discussed later in this bulletin, this was considered consequential to the primary problems which had occurred in the power turbine area. It was also found that the No's 6 and 7 bearing housing had come adrift from its location in the Inter-Turbine Case (ITC) and rotated a small amount due to failure of the twelve bolts securing it. This dislocation of the housing had led to failure of the oil transfer tubes mentioned above. The No's 6 and 7 bearings themselves were intact but devoid of any lubricant and were very badly worn and overheated - the No 7 bearing being worse than the No 6.

The affected parts were examined at the engine Manufacturer's main facility in Canada. The No's 6 and 7 bearing housing bolts were found to have fractured by a fatigue mechanism, as had the oil transfer tubes. Other indications were found which supported a mechanism of severe vibration over an extended period of time having occurred in the power turbine rotor.
