ACCIDENT

Aircraft Type and Registration:	Hawker Hunter T7, G-BVGH	
No & Type of Engines:	1 Rolls Royce Avon MK 122 turbojet engine	
Year of Manufacture:	1958	
Date & Time (UTC):	22 May 2007 at 1300 hrs	
Location:	Exeter Airport	
Type of Flight:	Private	
Persons on Board:	Crew - 2	Passengers - None
Injuries:	Crew - None	Passengers - N/A
Nature of Damage:	Right main landing gear leg failed, damage to right wing and rear fuselage	
Commander's Licence:	Private Pilot's Licence	
Commander's Age:	51 years	
Commander's Flying Experience:	2,350 hours (of which 35 were on type) Last 90 days - 19 hours Last 28 days - 5 hours	
Information Source:	Aircraft Accident Report Form submitted by the pilot and AAIB examination of the aircraft

Synopsis

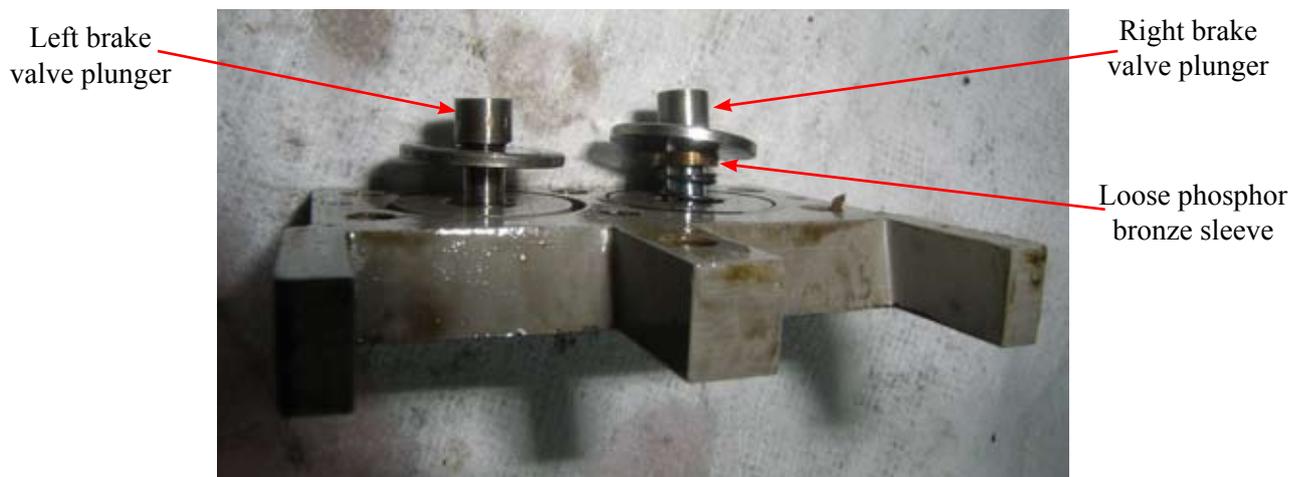
Figure 1

Each plunger passes through a spring-loaded phosphor bronze sleeve within the unit, (Figure 1). The sleeve

Brake valve plungers showing loose support sleeve on the right valve

for the left brake valve was secure within its housing, while the right valve sleeve sprang from the unit during disassembly. The right brake valve plunger exhibited witness marks on its shaft, and these appeared to have been caused by contact with the sleeve during operation; the left valve plunger was undamaged. Measurement of the right valve sleeve showed that a clearance of 0.06 mm existed between the outer diameter of the sleeve and the hole in the housing in which it had been mounted. This clearance would have allowed a small degree of 'rocking' movement of the sleeve which, over time, produced the witness marks on the plunger shaft and, on this occasion led to it becoming jammed.

It is considered that as the aircraft completed its right turn onto Runway 26, the right brake valve plunger within the selector unit became jammed, resulting in

a degree of pressure being continually applied to the right wheel brake. Given that the pilot did not have any directional control issues until the nosewheel left the ground, the level of braking to the right main wheel must have been low. As the aircraft accelerated down the runway, the heat build-up within the right brake unit would have been rapid and it is likely that it was sufficient to cause the brake unit to 'seize', just as the nosewheel lifted from the ground.

The brake selector unit is not subject to a fixed life and it was not determined when this unit had been fitted to the aircraft. As a result of this event, the maintenance organisation has introduced routine spectrographic oil analysis of the hydraulic fluid within the brake system to allow early identification of component deterioration.
