**SERIOUS INCIDENT**

<b>Aircraft Type and Registration:</b>	Dornier 328-100, D-CIRT	
<b>No &amp; Type of Engines:</b>	2 Pratt & Whitney Canada PW119B turboprop engines	
<b>Year of Manufacture:</b>	1997	
<b>Date &amp; Time (UTC):</b>	23 September 2009 at 1410 hrs	
<b>Location:</b>	Dundee, Fife	
<b>Type of Flight:</b>	Commercial Air Transport (Non-Revenue)	
<b>Persons on Board:</b>	Crew - 2	Passengers - None
<b>Injuries:</b>	Crew - None	Passengers - N/A
<b>Nature of Damage:</b>	Damage to air-switching valve in both engines	
<b>Commander's Licence:</b>	Airline Transport Pilot's Licence	
<b>Commander's Age:</b>	45 years	
<b>Commander's Flying Experience:</b>	8,100 hours (of which 400 were on type) Last 90 days - 120 hours Last 28 days - 42 hours	
<b>Information Source:</b>	AAIB Field Investigation

**Synopsis**

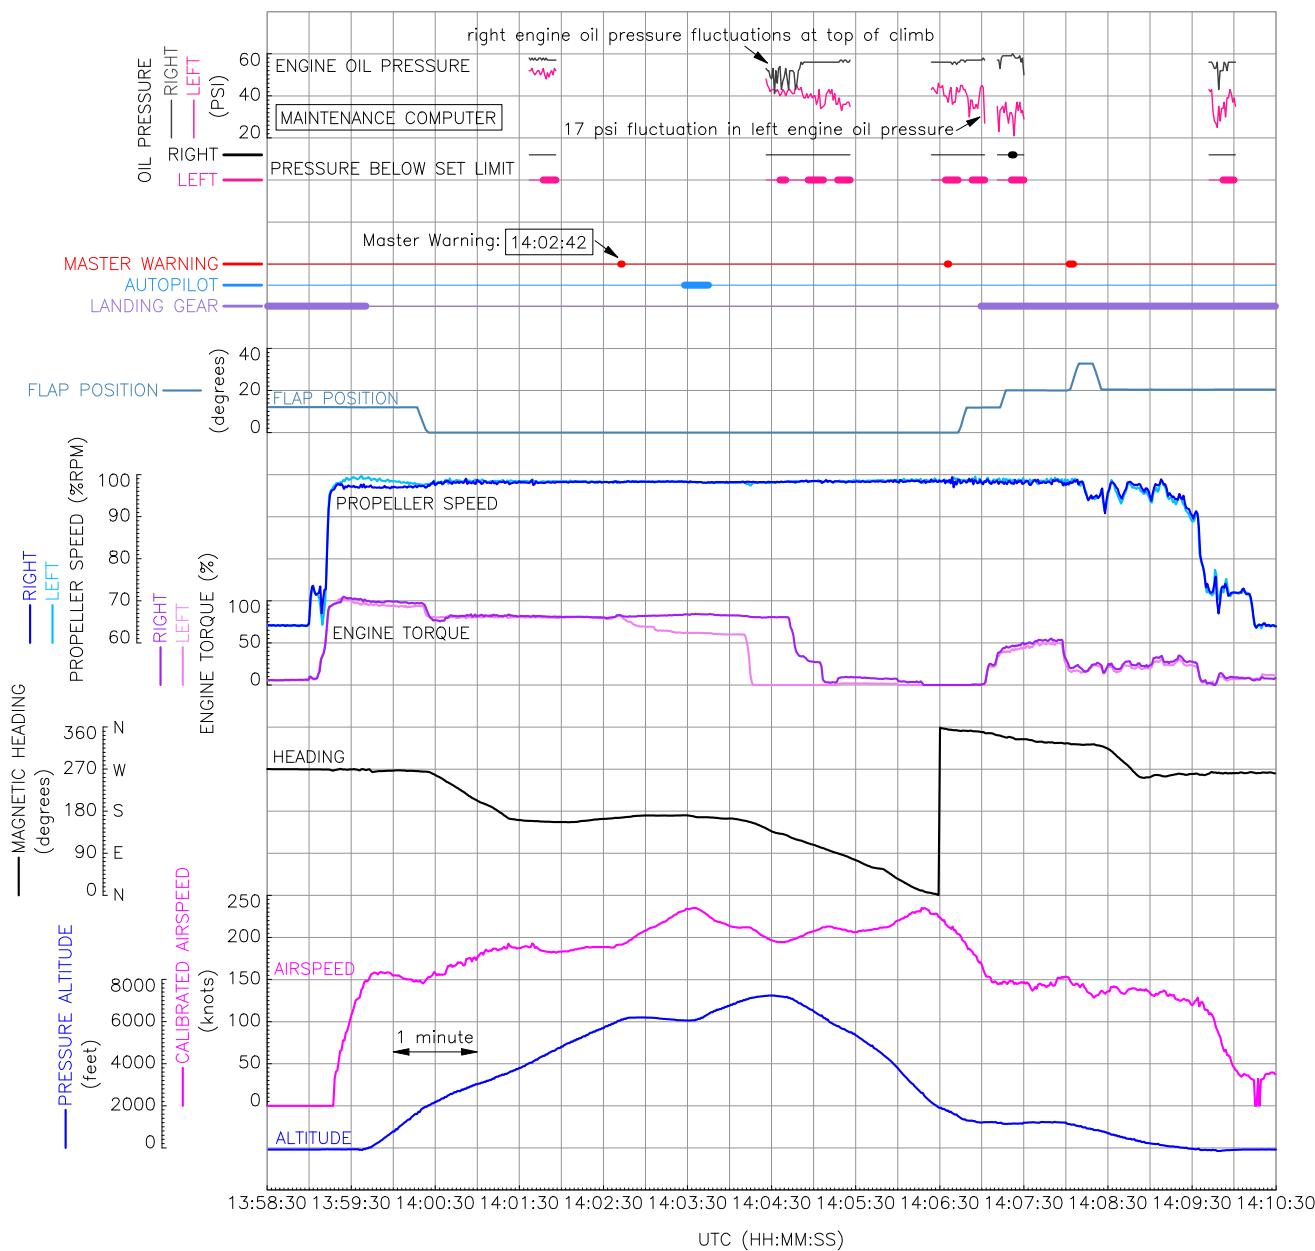
**Figure 1**

Salient FDR parameters and maintenance computer recordings for the serious incident to D-CIRT

The figure shows that the maintenance computer detected an oil pressure ‘below-limit’ state for the left engine during the climb, lasting 10 seconds as the aircraft passed through 4,500 ft pressure altitude. A nominal difference of about 6 psi in oil pressure

was recorded between the left and right engines (left engine lower, at around 52 psi) for similar levels in engine torque and propeller speed. As the aircraft levelled off at approximately FL60, there was a master warning associated with the left engine oil pressure<sup>1</sup>

(time 14:02:42). This was followed by a reduction in engine torque on the left engine (as the crew started to shut it down), reducing from 84% to 62% before the shutdown was cancelled. The autopilot was then engaged for about 20 seconds, during which the aircraft started to climb again.

The ‘top of climb’ was at just above FL70 before the torque on the left engine was reduced to near zero, followed by a stepped reduction in torque on the right engine for the descent. From top of climb, throughout the descent and landing, the maintenance computer detected a further 13 left engine oil pressure ‘below-limit’ conditions and one on the right engine. The associated extracts of engine oil pressures recorded by the computer show that the oil pressure difference between the engines grew as the left engine pressure fell to about 30 psi (ie a 50% reduction), although it fluctuated as much as 17 psi. Fluctuations were also recorded in the right engine oil pressure at top of climb, but stopped once the torque was reduced for the descent.
