ACCIDENT

Aircraft Type and Registration:	Agusta A109E, G-GCMM	
No & Type of Engines:	2 Pratt & Whitney Canada PW206C turboshaft engines	
Year of Manufacture:	2002	
Date & Time (UTC):	19 July 2011 at 1105 hrs	
Location:	Fiveways Trading Estate, Corsham, Wiltshire	
Type of Flight:	Private	
Persons on Board:	Crew - 1	Passengers - 1
Injuries:	Crew - None	Passengers - None
Nature of Damage:	Tail rotor blade and gearbox damaged	
Commander's Licence:	Airline Transport Pilot's Licence	
Commander's Age:	64 years	
Commander's Flying Experience:	12,925 hours (of which 580 were on type) Last 90 days - 145 hours Last 28 days - 62 hours	
Information Source:	Aircraft Accident Report Form submitted by the pilot and further enquiries by the AAIB

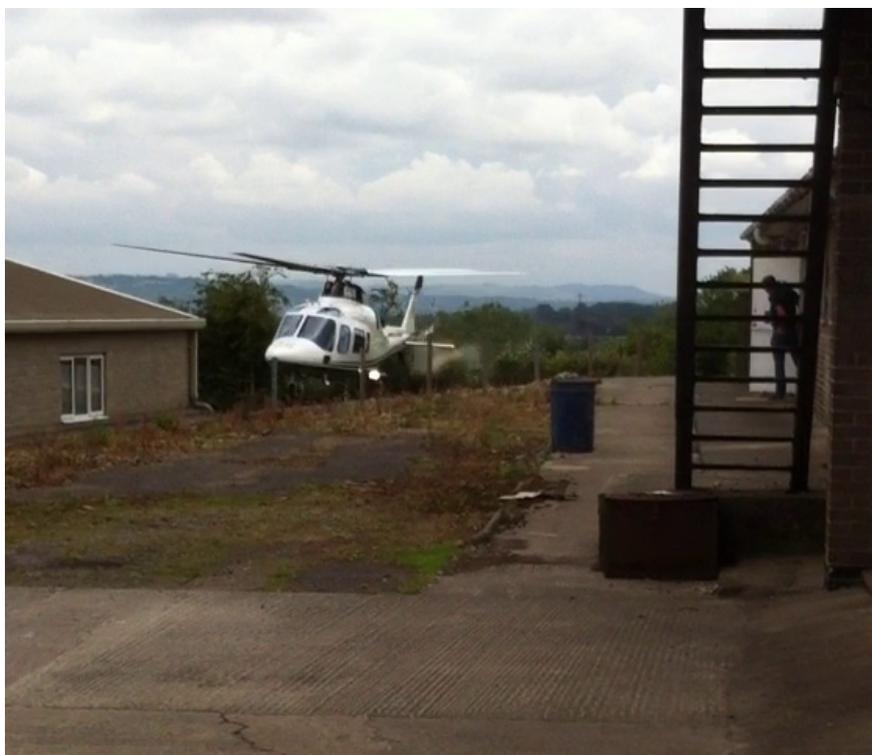
After establishing the helicopter in a hover 5 ft over the landing area the pilot started to lower it. As he did so he felt a “slight shudder” at the rear of the aircraft with no perceptible rotor rpm change, followed by some tail rotor vibration through the rudder pedals. Although the landing was then completed without apparent incident the helicopter’s tail rotor and skid had struck a hedge, consisting of branches 3-4 cm in diameter, and a concrete post.

A video of the accident was filmed by an occupant of one of the adjacent buildings who was standing about 35 m from the helicopter and shows details of the event consistent with the pilot’s recollection. Another person can be seen observing approximately 15-20 m from the helicopter. Figure 1 shows a still from the video at the moment the tail rotor struck the concrete post.

G-GCMM at the moment its tail rotor struck the concrete post

Subsequently, the helicopter’s tail rotor blades, gearbox and pitch change mechanism were replaced.
