INCIDENT

Aircraft Type and Registration:	Boeing 737-377, G-CELF
No & Type of Engines:	2 CFM56-3B1 turbofan engines
Year of Manufacture:	1988 (Serial no: 24302)
Date & Time (UTC):	2 August 2013 at 0617 hrs
Location:	On departure from Leeds Bradford Airport
Type of Flight:	Commercial Air Transport (Passenger)
Persons on Board:	Crew - 5 Passengers - 119
Injuries:	Crew - None Passengers - None
Nature of Damage:	Broken generator harness and over-heated battery charger
Commander's Licence:	Airline Transport Pilot's Licence
Commander's Age:	56
Commander's Flying Experience:	8,130 hours (of which 3,300 were on type) Last 90 days - 66 hours Last 28 days - 34 hours
Information Source:	AAIB Field Investigation

Synopsis

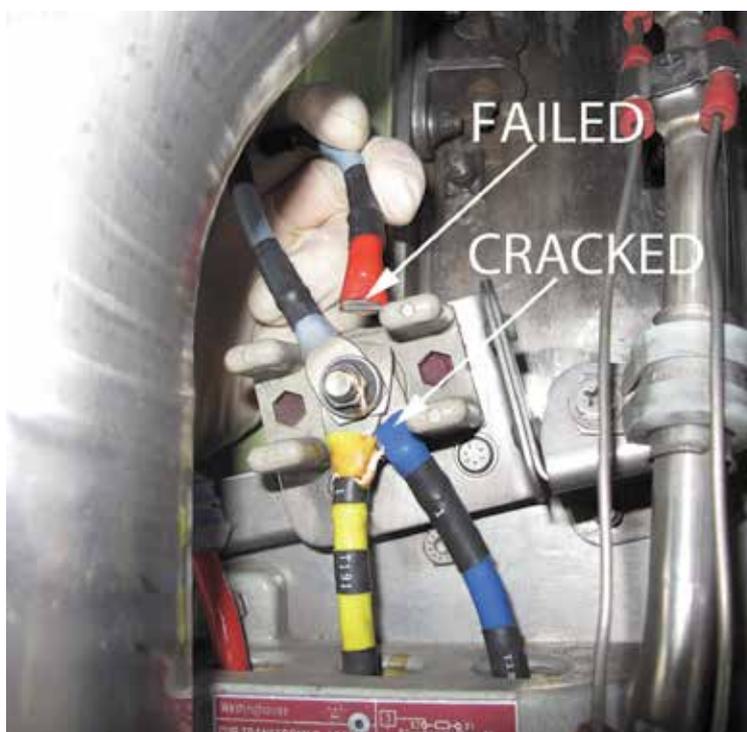
Figure 2

Examination of the aircraft's electrical system revealed that the red phase 'A' ground cable from the No 1 generator had separated from the T191 stud on the side of the No 1 engine (Figure 2). This cable had separated due to a failure of its terminal lug (Figure 3). Further

examination of the generator harness revealed a cracked terminal lug on the blue phase 'C' ground cable at the T191 stud (also shown in Figure 2) and a further cracked terminal lug at the firewall end of the grey ground cable (opposite end of grey cable shown in Figure 2). The crack on the blue phase 'C' lug was only visible after the heatshrink insulation was removed.

Location of separated red phase 'A' generator cable, and cracked blue phase 'C' lug at T191 stud on G-CELLF's No 1 engine

The red phase 'A' cable had a tight bend radius but it was within limits for a cable in a restricted area.

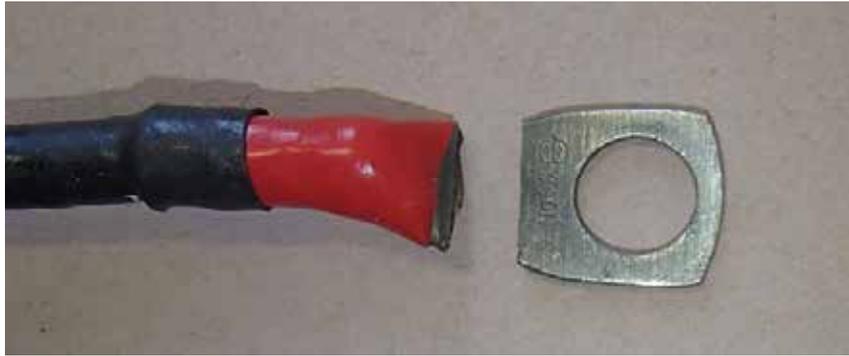
Figure 3

The loss of power was caused by a fatigue failure of the terminal lug on the end of the No 1 generator phase 'A' ground cable. An inspection revealed a number of other lugs which had cracked in the same location, two of which were close to failing in the same manner. The lugs had probably cracked as a result of a combination of engine vibration, a rough surface finish and bending of the lug during installation.

Failed terminal lug on the end of the phase 'A' generator ground cable

The red phase 'A' ground cable terminal lug failed due to corrosion fatigue under the influence of loads consistent with high frequency vibrations. The blue phase 'C' terminal lug and the grey ground terminal lug had started to crack in the same manner and would probably have failed eventually as well. This engine had been subject to higher than normal vibration in the month preceding the failures, which was probably a contributory factor. However, this level of vibration was not unusual and given the large size of the worldwide 737 Classic fleet and the low reported incidents of cracked lugs, it is unlikely that high vibration alone caused the lugs to crack. The terminal lug on G-GDFB had cracked through almost half its thickness without any reported high vibrations in the engine's previous 3 years of service. However, it was possible that this engine had suffered from high vibration prior to 2010 when the operator had taken ownership of it.

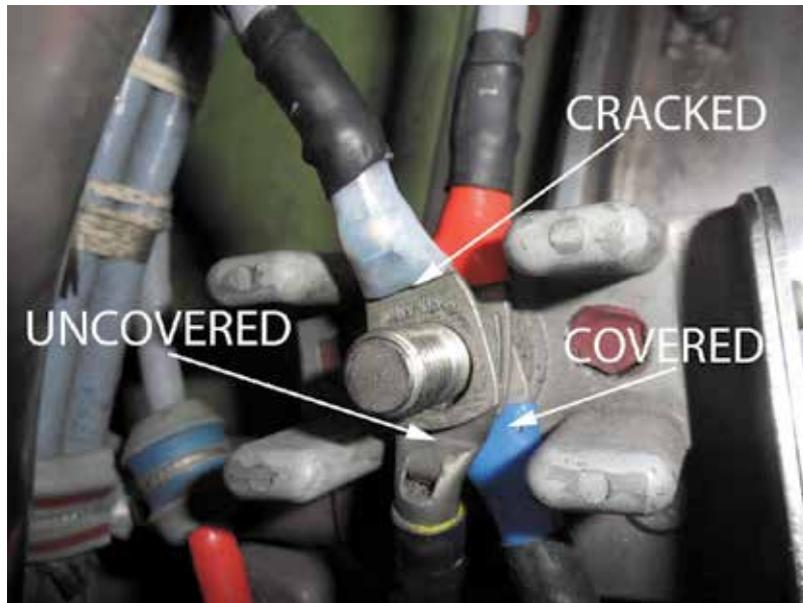
Figure 7

Cracked terminal lug from ground cable at T191 stud on G-GDFB's No 2 engine

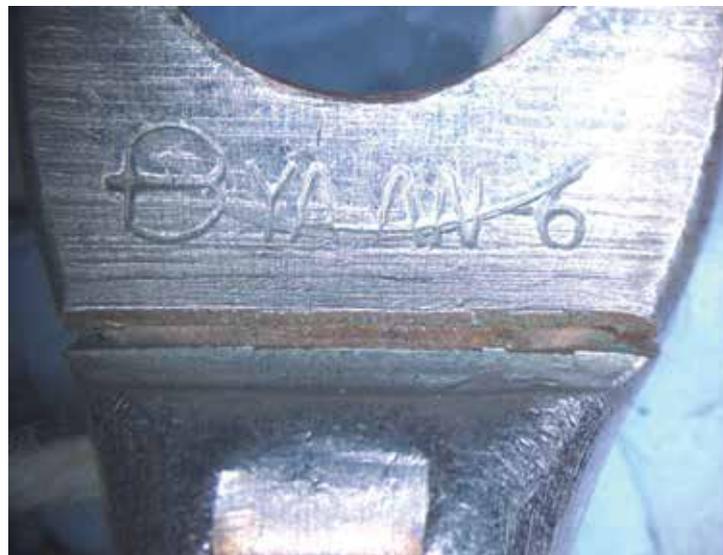
Figure 8

and the vulnerable bend area of the blue phase 'C' lug was not visible. The cracked lug was removed and bent open which revealed that it had cracked through half its thickness (Figure 8).

Close-up of cracked terminal lug from ground cable on G-GDFB's No 2 engine

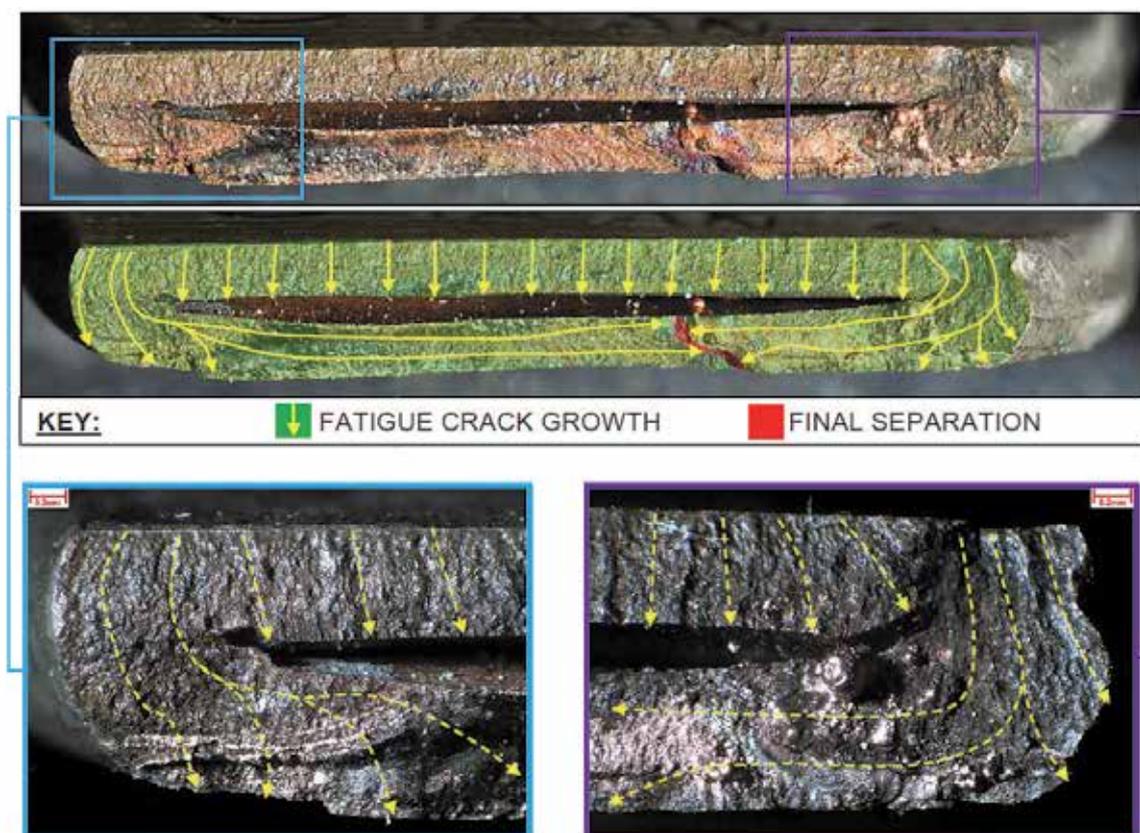
Figure 9

Detailed metallurgical analysis was carried out on the lugs from G-CELF, G-GDFB and G-CELL. The fracture surfaces of the failed lug on the end of the phase 'A' generator ground cable (G-CELF) are shown in Figure 9. This revealed that fatigue cracks had initiated at multiple sites on the lug's upper surface and then coalesced after a short distance to form a single crack front which propagated downwards to the centre of the lug, and then curved round the edges. The crack tips then propagated towards each other, along the lower wall, until they reached a point where the remaining section failed in overload. The large surface area of fatigue crack growth, compared with that of the final separation, indicated that the cyclic loading was of low magnitude, repeated for a large number of cycles.

Fracture surfaces of failed terminal lug on the end of the phase 'A' generator ground cable (G-CELF)

Examination of the lug's upper surface revealed a series of parallel grooves that had been formed by the flattening tool used to make the lug. The fatigue cracks had initiated within one of these grooves.

Examination of the fracture surfaces under SEM¹² revealed regions of both transgranular and intergranular crack propagation, which was consistent with corrosion fatigue. Transgranular crack growth would have dominated during periods when the cyclic stress was relatively high and/or the severity of the corrosive environment was low. Intergranular crack growth would have dominated when the converse was true. Fatigue striations were evident in both the transgranular and intergranular regions and their fine spacing was consistent with a load spectrum of high frequency vibrations.

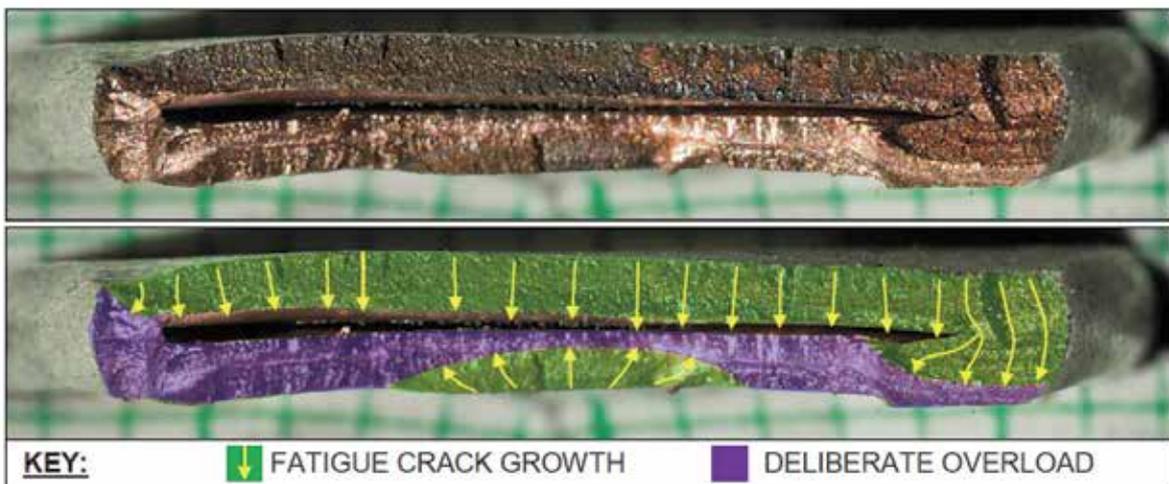
Figure 10

In order to examine the fracture surfaces on the two cracked lugs from G-CELF and the cracked lug from G-GDFB, the lugs were forced open until they failed. The fracture surfaces of all three lugs displayed the same downward fatigue crack growth from multiple initiation sites from within one of the parallel grooves formed by the flattening tool. The fatigue crack on the blue phase 'C' lug from G-CELF had propagated through half its thickness but had not yet propagated around the corners. A secondary fatigue crack had initiated on the lower surface and propagated upwards (Figure 10). The presence of this crack indicated that there had been a degree of reversal in the cyclic bending loads exerted on the lug. The fatigue crack on the ground lug from G-CELF was at an early stage of development and had propagated through less than a quarter of the lug's thickness. The fatigue crack growth on the lug from G-GDFB was similar to that of the phase 'C' lug from G-CELF, and had propagated through over half of the lug's thickness.

Fracture surface of cracked terminal lug on the end of the phase 'C' generator ground cable (G-CELF)

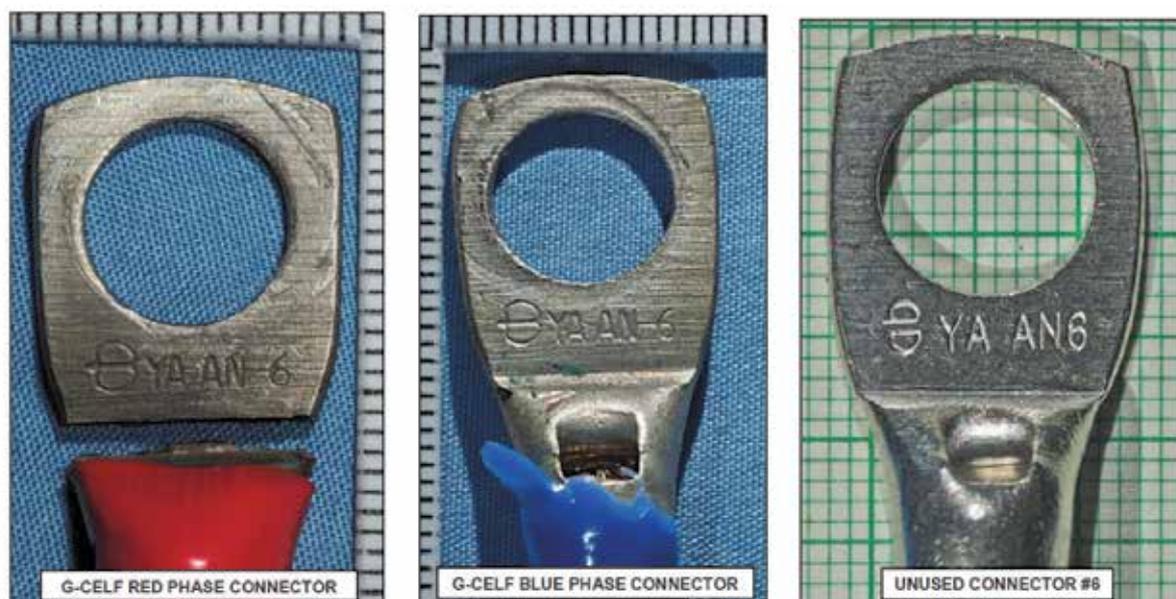
Figure 11

Detailed examination of the pattern of the parallel grooves from which the cracks had initiated revealed that they were the same, indicating that these four lugs had probably been flattened by the same tool. The grooves did not disturb the lettering stamped on the lugs, which indicated that the grooves were made either before or at the same time as the lettering. A sample of new terminal lugs had much shallower grooving (Figure 11). The lug manufacturer stated that lug inspection checks are performed on a sample basis with the naked eye, and that these checks had not noted any grooves of the extent shown in the left and middle images of Figure 11.

Comparison of the parallel grooves on the G-CELF lugs and a new unused lug (right)

Another factor which probably contributed to the cracks was the rough surface finish on the upper surface of the lugs. All the cracks on the G-CELF and G-GDFB lugs had initiated within one of the parallel grooves at the bend. These grooves were visibly deeper than those compared to a small batch of new lugs. It was probable that these lugs had been flattened using the same tool which was more rough than usual. It could not be established how common rough grooving was on these lugs and there was no surface finish specification in BACT12M, and therefore the grooving was considered a contributory factor rather than a sole causal factor.

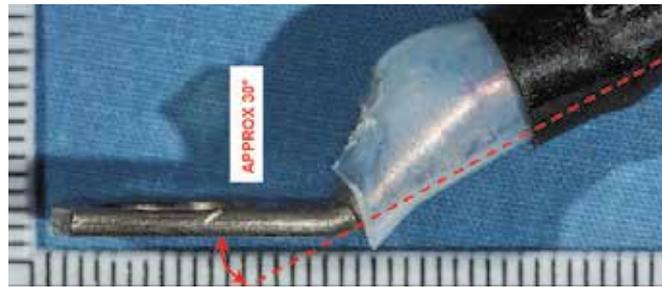
Figure 12

The failed red phase 'A' lug from G-CELF appeared to have minimal bending, although it could have been previously bent and re-flattened. The blue phase 'C' lug from G-CELF was bent downwards by 12°, and the ground lug from G-CELF was bent upwards by about 30° (Figure 12). The cracked lug from G-GDFB was bent downwards by 10°¹⁴, and both connectors from G-CELI were bent upwards by 15°.

30° upwards bend of cracked G-CELF ground lug
