De Havilland Canada DHC-8-311, G-BRYJ

AAIB Bulletin No: 12/2003	Ref: EW/C2003/03/01	Category: 1.1
INCIDENT		
Aircraft Type and Registration:	De Havilland Canada DHC-8-311, G-BRYJ	
No & Type of Engines:	2 Pratt & Whitney Canada PW123 turboprop engines	
Year of Manufacture:	1991	
Date & Time (UTC):	2 March 2003 at 1035 hrs	
Location:	25 miles north of Edinburgh, Scotland	
Type of Flight:	Public Transport (Passenger)	
Persons on Board:	Crew - 4	Passengers - 29
Injuries:	Crew - None	Passengers - None
Nature of Damage:	None	
Commander's Licence:	Airline Transport Pilot's Licence	
Commander's Age:	40 years	
Commander's Flying Experience:	3,300 hours (of which 2,200 were on type)	
	Last 90 days - 86 hours	
	Last 28 days - 25 hours	
Information Source:	AAIB Field Investigation

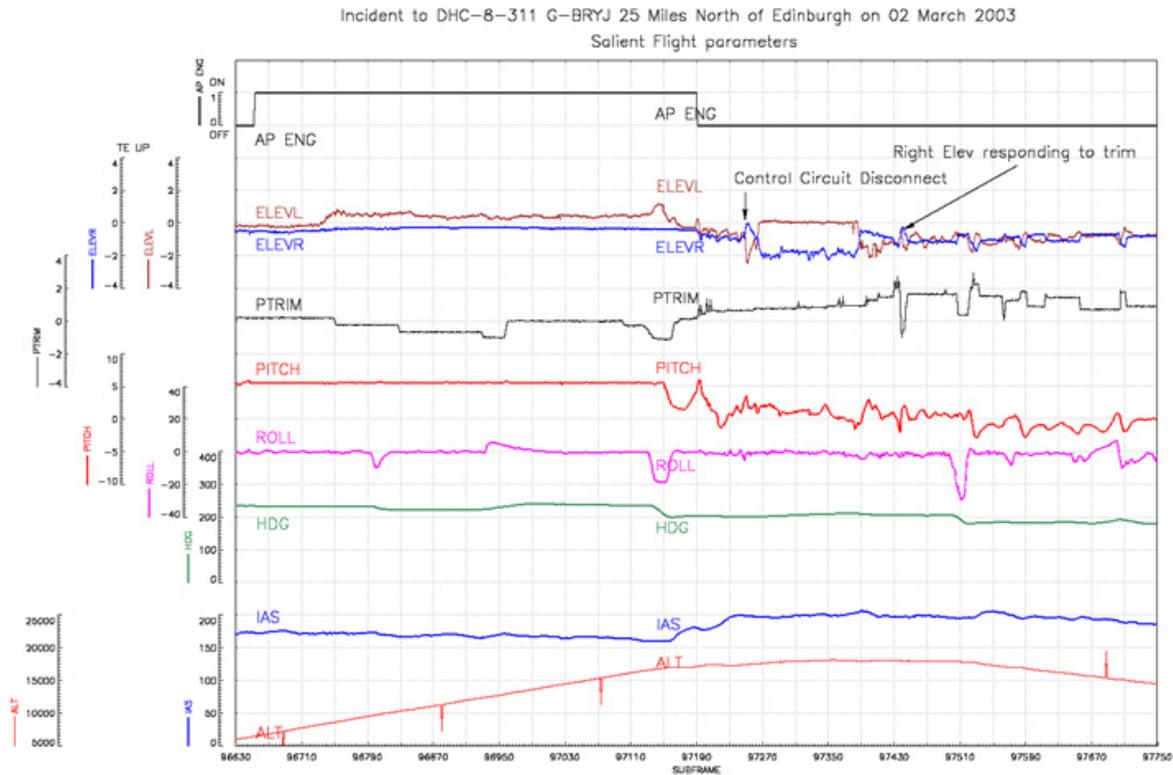
The relevant flight data parameters are shown in Figure 1. The autopilot was engaged about 5 minutes after takeoff with the aircraft in the climb at approximately FL64 at 173 kt. At this stage the left and right elevators appeared to be responding normally to the autopilot pitch trim inputs. Approximately 28 sec later however, whilst the aircraft was climbing through FL80, a pitch trim input was made by the autopilot. Whilst the left elevator appeared to respond to the trim input, the right elevator remained at a constant value of about -0.3° . The right elevator remained at this value until the autopilot was disengaged, about 8 minutes later at 181 kt and FL170. There were small movements of the left and right control surfaces at this time before the left and right sides of the pitch control circuit were split using the pitch disconnect handle. The splitting of the control circuit took place at around 180 kt and FL175 whilst climbing, about 57 secs after the autopilot was disengaged.

The left seat pilot subsequently controlled the aircraft using the left side only of the pitch control circuit, as, from Figure 1, the response of the aircraft in pitch matched closely the left elevator angle. It can also be seen that the right elevator was 'trailing', and not following the left elevator angle.

The right elevator appeared to resume responding to pitch trim inputs some 4 minutes after the pitch disconnect handle was operated with the aircraft at 197 kt and level at FL180; approximately 12 minutes after the original right elevator anomaly occurred.

Analysis of the FDR evidence would suggest that the control difficulties experienced by the crew were due to a restriction of the right elevator spring tab. This prevented both the autopilot and the crew from achieving the desired pitch control using the normal elevator system with the left and right systems interconnected. When the pilots disconnected the left and right systems the commander regained pitch control but the FO still reported control difficulties. No problems were found with the elevator control system post-flight. The subsequent incident which occurred on this aircraft was considered to be unconnected with this event.

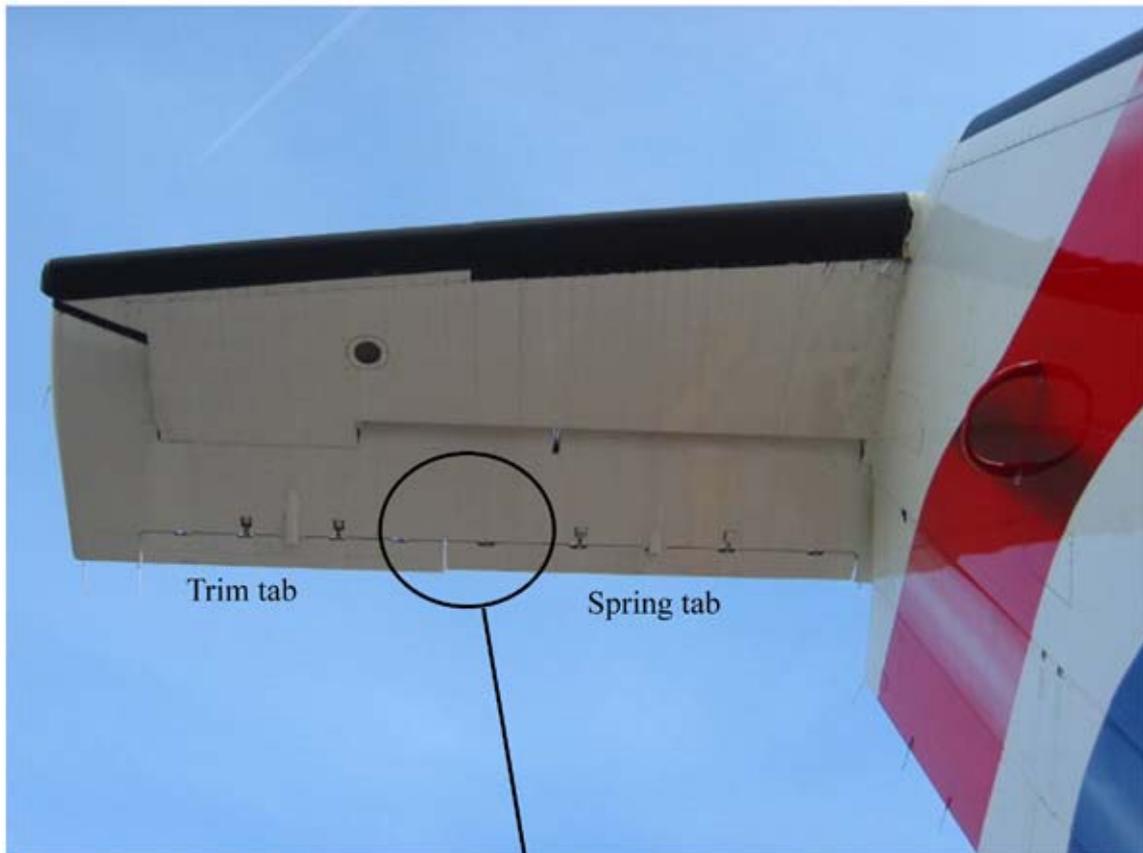
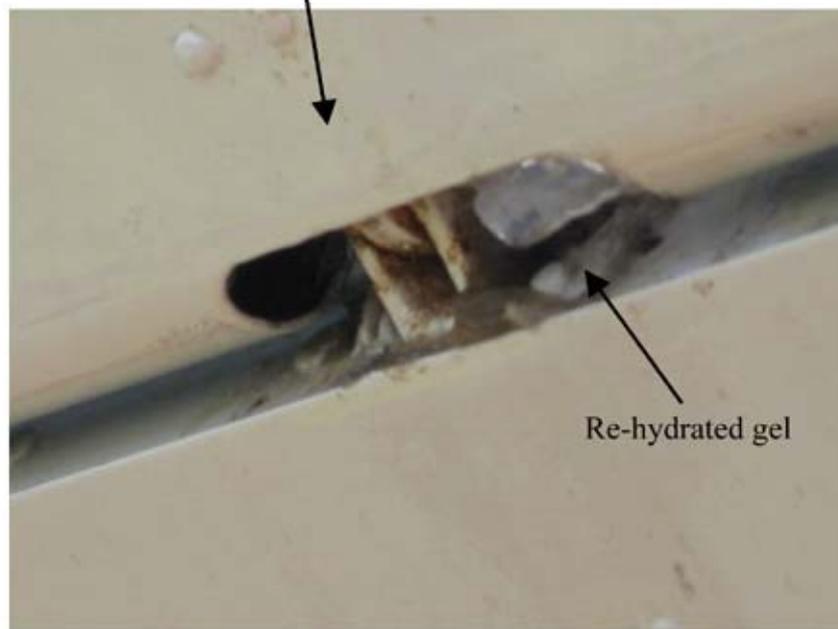
There was evidence of a gel with the consistency of 'wallpaper paste' around the spring tab and trim tab bearings. Figure 2 shows the tab arrangement together with a typical gel deposit found in the area of the hinge bearings.

Figure 2
(Typical re-hydrated gel found around area of tab hinges)

It is probable that the movement of the right spring tab was affected by ice. There had been significant rainfall prior to the incident flight which could have allowed trapped moisture to cause the formation of ice around the spring tab area. Post-flight examination also revealed the presence of re-hydrated residues from previous anti-icing applications around the hinge bearings. Laboratory analysis showed a very low glycol content, and a freezing point of around -1.1°C. Therefore the possibility existed that this re-hydrated gel had frozen around the bearings and thus caused a restriction. This phenomena has also been seen to effect other aircraft types fitted with manual controls.

It is recommended that the Civil Aviation Authority satisfy itself that operators have in place the necessary measures to ensure that they have adopted the advice given in AIC 81/2001.

The Civil Aviation Authority should consult with anti-icing fluid manufacturers with a view to encouraging them to develop fluids, with suitable 'holdover' times, that incorporate gelling agents that are not re-hydratable.
