ACCIDENT

Aircraft Type and Registration:	MD Helicopters MD900 Explorer, G-CEMS	
No & Type of Engines:	2 Pratt & Whitney Canada PW207E turboshaft engines	
Year of Manufacture:	2001	
Date & Time (UTC):	29 July 2011 at 0801 hrs	
Location:	Leeds Bradford Airport	
Type of Flight:	Aerial Work	
Persons on Board:	Crew - 4	Passengers - None
Injuries:	Crew - None	Passengers - N/A
Nature of Damage:	Landing gear forward cross tube fractured, area of fuselage delamination	
Commander's Licence:	Commercial Pilot's Licence	
Commander's Age:	37 years	
Commander's Flying Experience:	2,235 hours (of which 1,007 were on type) Last 90 days - 43 hours Last 28 days - 14 hours	
Information Source:	AAIB Field Investigation

Synopsis

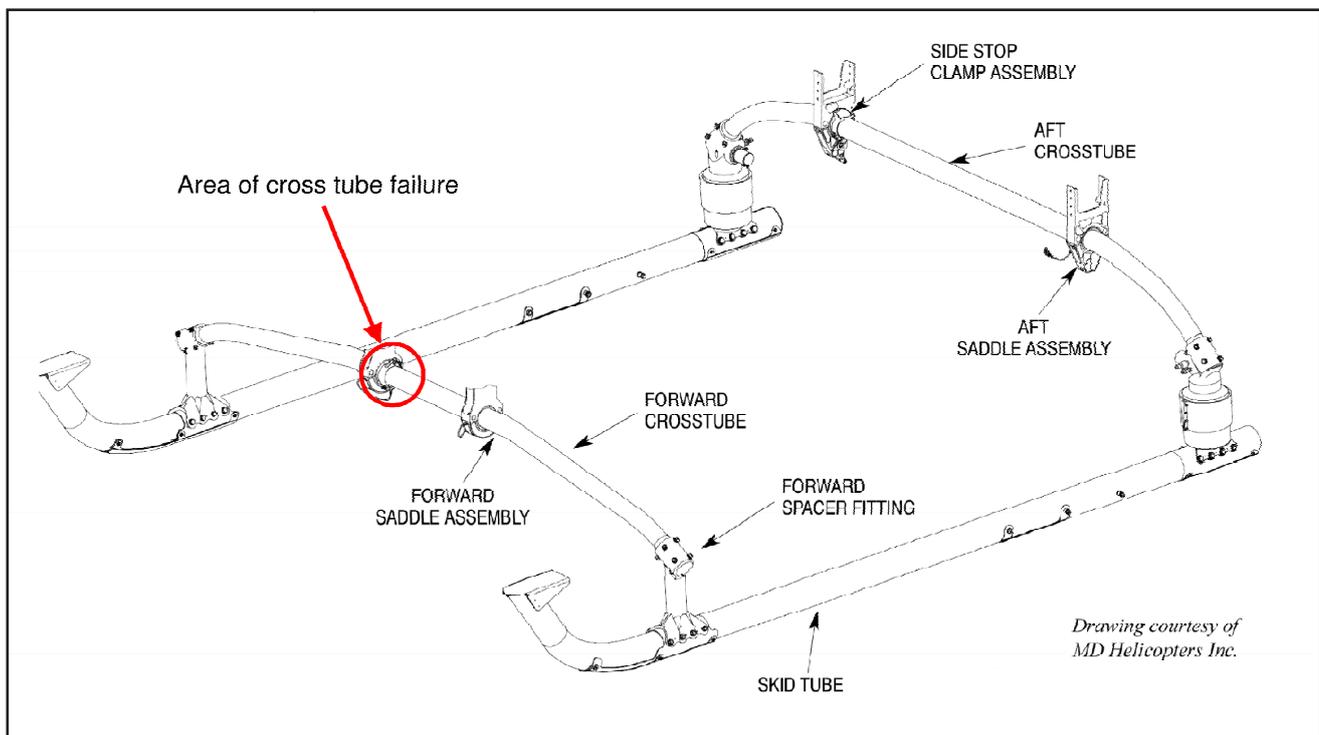
Figure 1
MD900 landing gear showing location of the forward cross tube failure

The forward cross tube had completely fractured immediately inboard of the right forward saddle assembly and the fracture originated at the lower surface of the cross tube, underneath the side stop clamp. The resulting contact between the helicopter's fuselage and the broken forward cross tube resulted in delamination of the fuselage skin and right keel beam, both of which are constructed from composite materials.

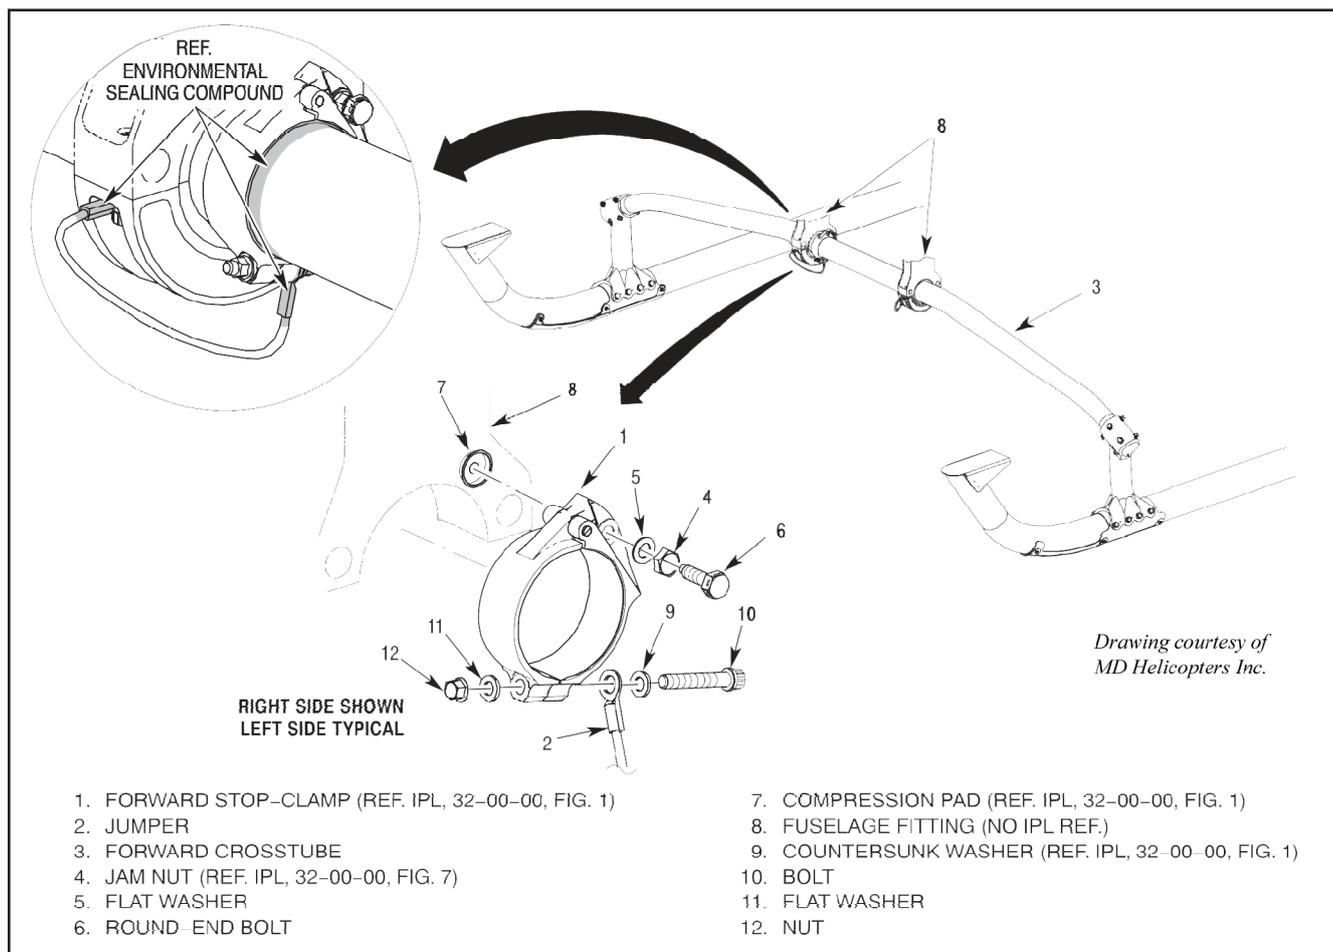
Figure 2

The MD900 helicopter is equipped with a tubular aluminium alloy landing gear, comprising left and right skid tubes that are supported by fore and aft cross tubes (Figure 1). The cross tubes provide elastic deformation during normal landings and are attached to fuselage fittings by means of four saddle clamp assemblies. The fore and aft cross tubes are restrained from moving laterally by four side stop clamp assemblies (Figure 2), that are attached immediately inboard of each saddle clamp. The internal face of the side stop clamps makes a metal-to-metal contact with the mating cross tube, allowing electrical current to flow in the event of a lightning strike. An electrical bonding strap is secured between the side-stop clamp and the saddle clamp assembly to provide electrical continuity.

Forward side stop clamp detail

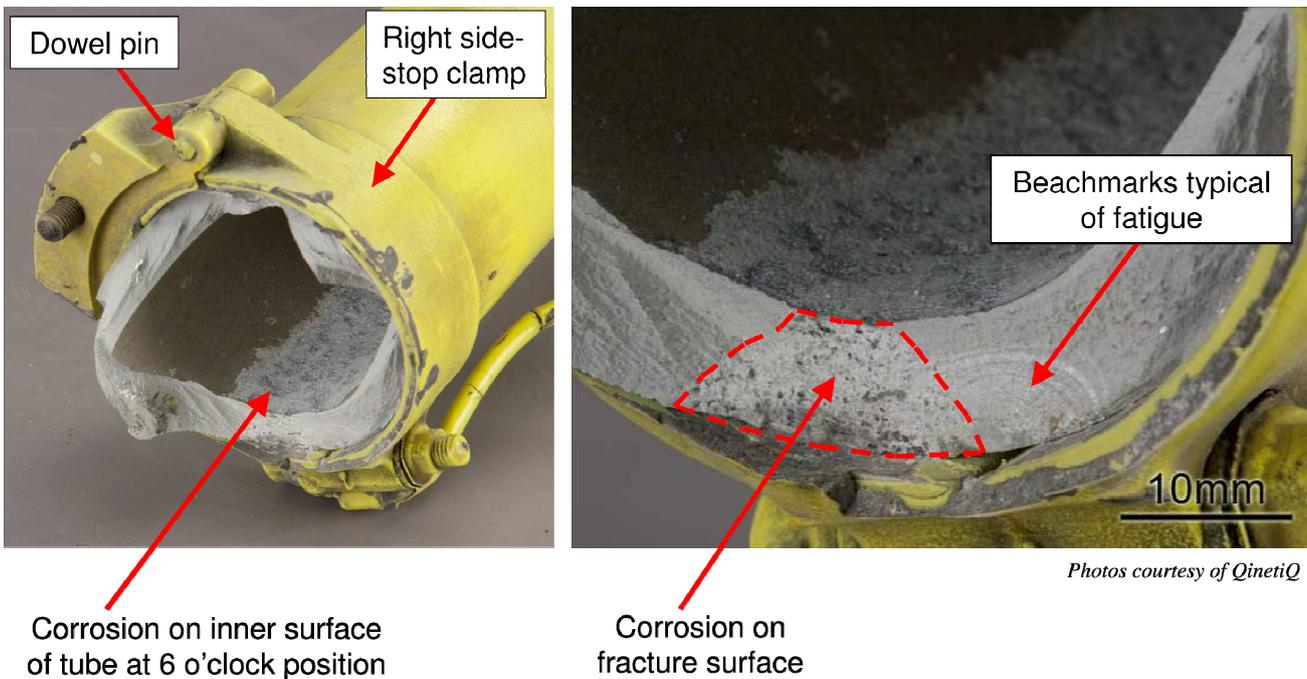
Figure 3

The forward cross tube, complete with the left and right side-stop clamp assemblies still attached, was sent to the AAIB for detailed examination. The inboard side of the fracture surface (Figure 3) exhibited a clear area of fatigue crack propagation, originating at the bottom of the cross tube, approximately 3 mm into the area covered by the side stop clamp. The circumferential length of the fatigue crack at the surface of the tube was 17 mm and the area of fracture surface away from the fatigue region had a dull grey appearance, indicative of tensile overload. The inside surface of the cross tube had not been painted with epoxy primer and was not in conformance with the

MD Helicopters production standard. The cross tube's inside lower surface was significantly corroded and the width of the corroded area decreased towards the outer ends of the cross tube, indicating that an accumulation of moisture had occurred inside the tube around a central low point. Some of the accumulated moisture had penetrated the fatigue fracture, causing a tapered area of corrosion on the fracture surface.

Visual examination of the inboard side of the fracture surface

It is recommended that the Federal Aviation Administration require MD Helicopters to determine a suitable inspection method and interval for periodic detailed examination of the landing gear cross tubes on the MD900 helicopter.

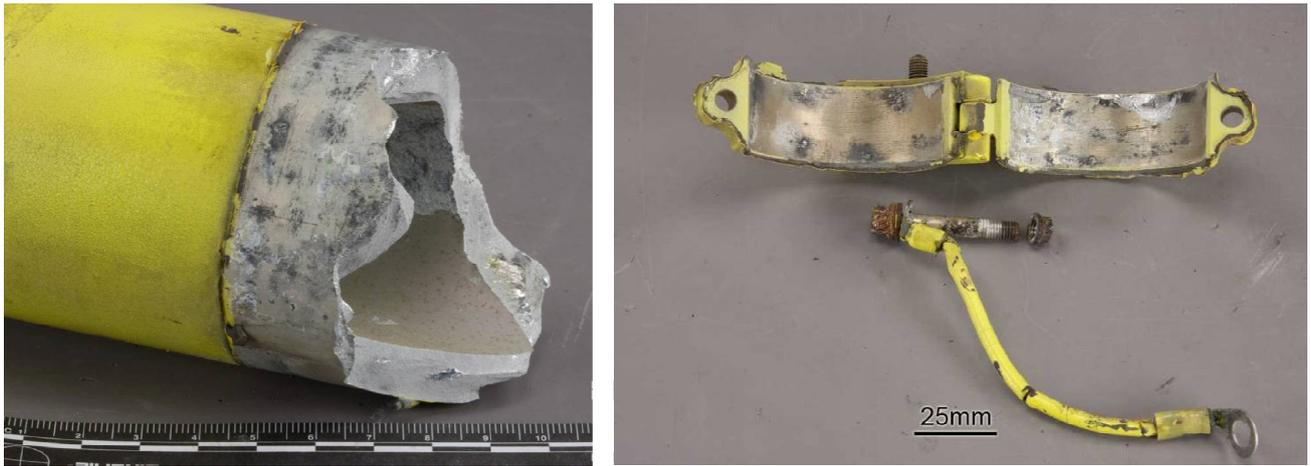
Figure 4

Both the forward cross tube side stop clamps had intact paint covering the environmental sealant around the circumferential joints between the clamp edge and the cross tube. Following removal of both clamps, the paint covering the sealant was examined in detail, revealing a lower layer of yellow paint, covered by an upper layer of lime green paint matching the helicopter's current paint scheme. The lower yellow paint finish was applied when the helicopter was manufactured in July 2001 and the intact paint layers demonstrate that the sealant on the side stop clamps had not been renewed since this date.

Removal of the clamps revealed significant surface corrosion on both the exposed area of the cross tube and on the mating clamp surfaces (Figure 4).

Surface corrosion beneath right side stop clamp

It is recommended that the Federal Aviation Administration require that MD Helicopters amend the MD900 Rotorcraft Maintenance Manual to require visual examination of the area of forward and aft cross tube, exposed when the forward and aft side stop clamps are removed, as part of the periodic maintenance schedule.

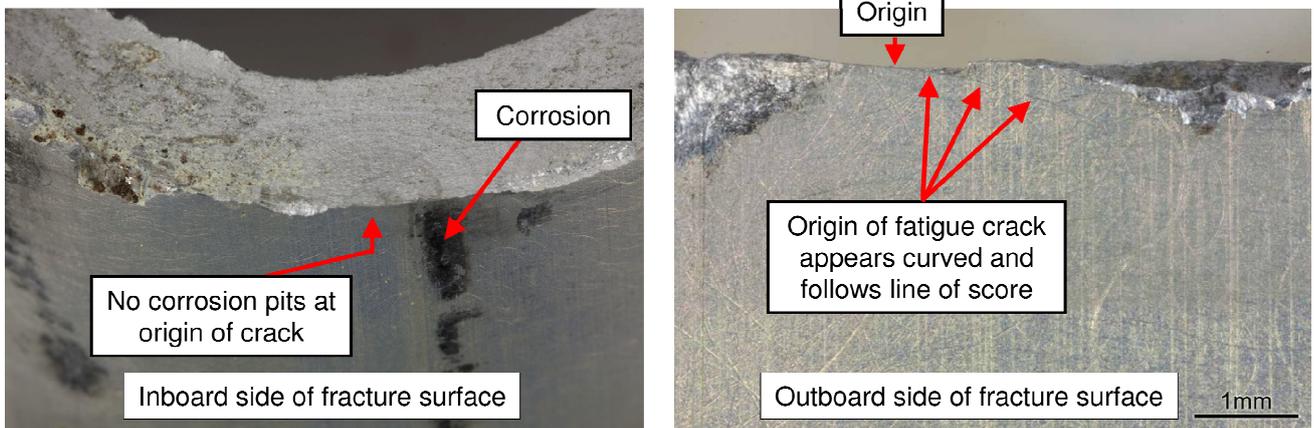
Figure 5

The fatigue crack origin was examined using both visual and scanning electron microscopy (SEM) which showed that, despite the presence of local corrosion pits, the fatigue crack had actually initiated from a shallow, curved machining mark in the tube's outer surface (Figure 5). The SEM analysis showed that the crack had initially propagated in fatigue, with at least 16 separate visible 'beachmarks', before subsequently progressing through a series of five 'static jumps' (Figure 6). A static jump is a ductile overload phenomenon in which a high load event causes a fatigue crack to propagate by localised tensile overload, before reverting back to progressive fatigue propagation under lower cyclical loading conditions. Analysis of the fracture surface away from the fatigue region revealed three 'arrest' marks within the overload failure surface.

Visual examination of the fatigue crack origin

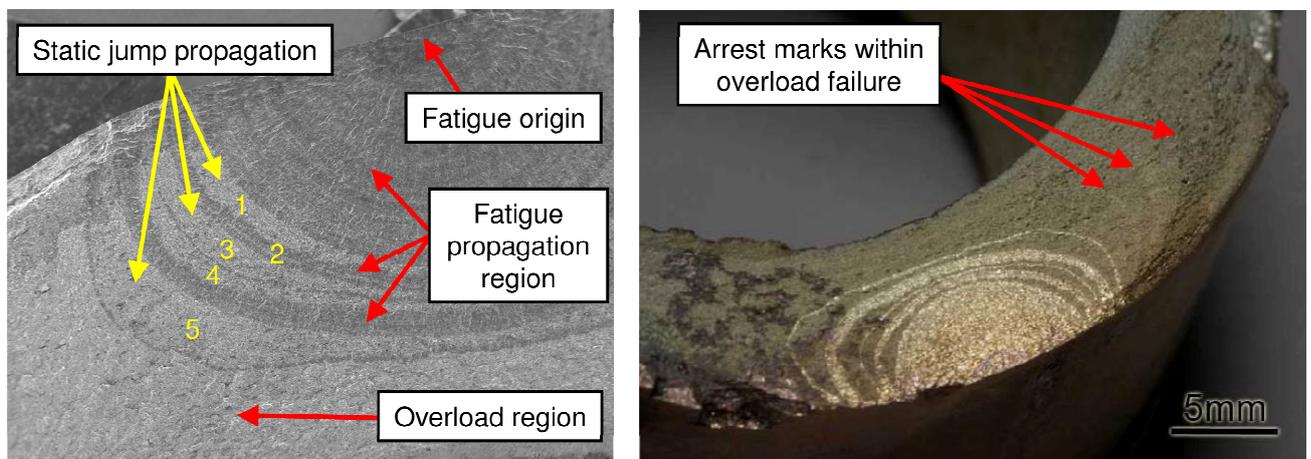
Figure 6

Propagation of the primary fatigue crack away from the crack origin

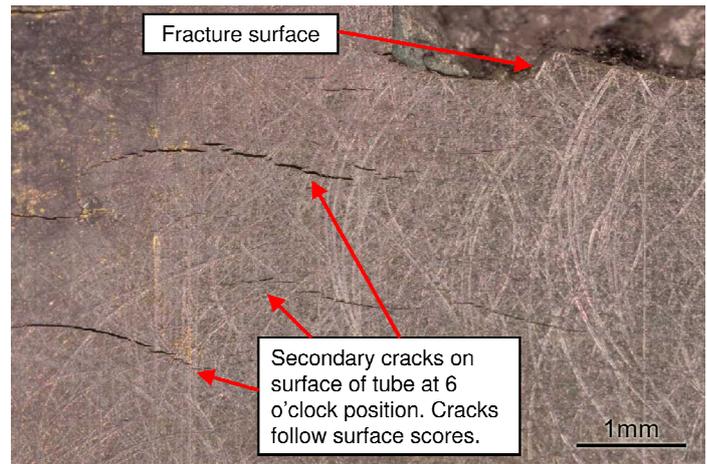
Figure 7

A significant number of secondary fatigue cracks were visible adjacent to the primary fatigue crack, with many of these originating from curved surface machining marks (Figure 7).

A 20 mm long section of the cross tube, immediately inboard of the primary fracture surface, was removed and polished to facilitate examination of the material's microstructure. A total of 64 secondary surface cracks were visible in this section, ranging in depth between 16 µm and 290 µm. The section's material characteristics were assessed by hardness testing and energy dispersive X-ray analysis and were determined to be within the 7075 T6 specification for hardness, chemical composition and electrical conductivity. The section exhibited extensive corrosion on the internal surface of the cross tube and in some areas this corrosion was intergranular, which is characteristic of exfoliation.

Secondary cracking of the cross tube
