Air Command 532 Elite, G-BOVP, 20 April 1996

AAIB Bulletin No: 7/96 Ref: EW/C96/4/7 Category: 1.3

Aircraft Type and Registration:Air Command 532 Elite, G-BOVP

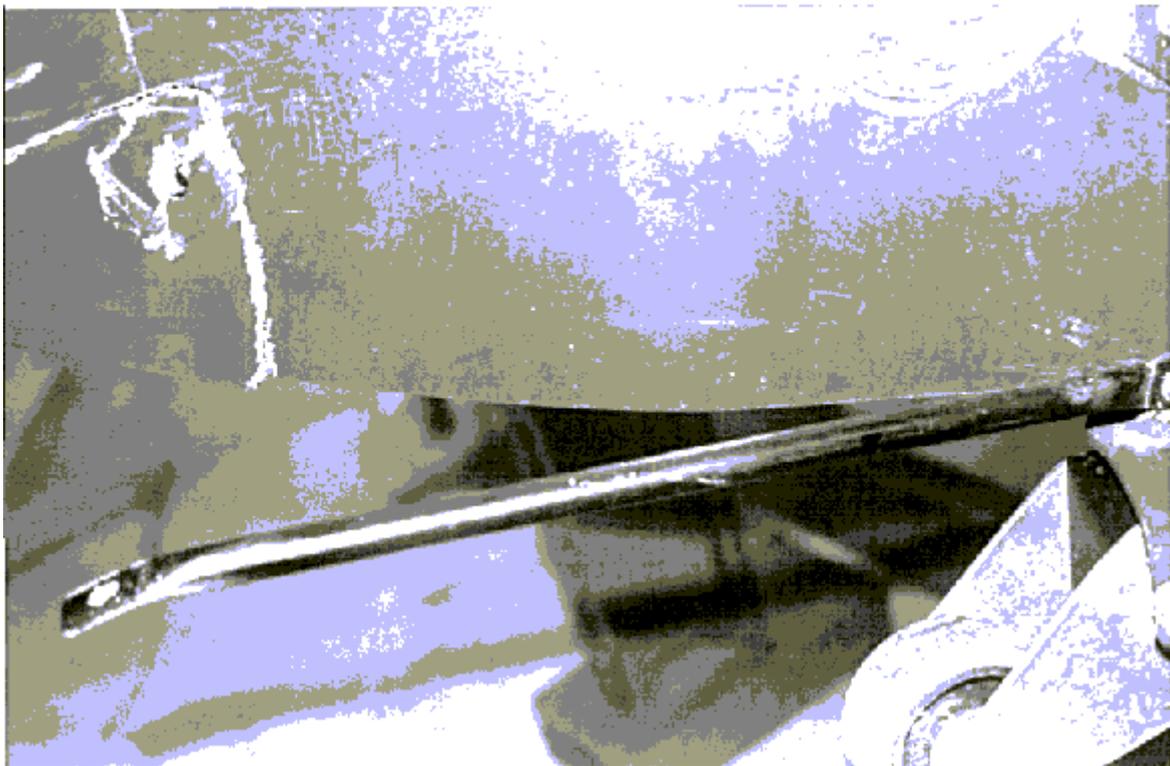
The right stabiliser was found to be broken in several pieces consistent with a ground impact. The two extruded light alloy brackets attaching the stabiliser to the rudder had failed in the right angle of the extrusion. Metallurgical examination of the failed brackets which had attached the right stabiliser to the rudder showed that they had failed in a single application of overload; this indicated that the stabiliser had been in place at impact. A strut, formed from a light alloy tube flattened at both ends to accommodate a bolt, was used to brace each stabiliser. The right strut was still attached to the base of the rudder, but the upper end had become detached from the right stabiliser, and although the bolt was missing, there was minimal damage to the bolt hole.

Photograph showing the rudder and right stabiliser bracing strut

This discrepancy was identified on receipt of the wreckage at Farnborough, and the bolt was found, loose *and without a nut*, amongst the debris collected from the site. Comparisons of lengths and gel coat traces confirmed that it had come from the right stabiliser. The bolt was 2BA and was worn and rusty, but otherwise undamaged. When the significance of the missing nut was realised, the accident site was searched again, this time using a sensitive metal detector, however the nut was not found.

Damage to the lower skin of the right stabiliser indicated that the bolt was still in place at impact - an area of the Glass-Reinforced Plastic (GRP) located under the strut end had been pushed through into the backing foam, and the displaced section of GRP contained a witness mark showing the outline of the strut end in the black paint used on the strut. However, the end of the strut

around the bolt hole showed insufficient signs of distress to account for the loss of the nut during the ground impact (see above photograph).

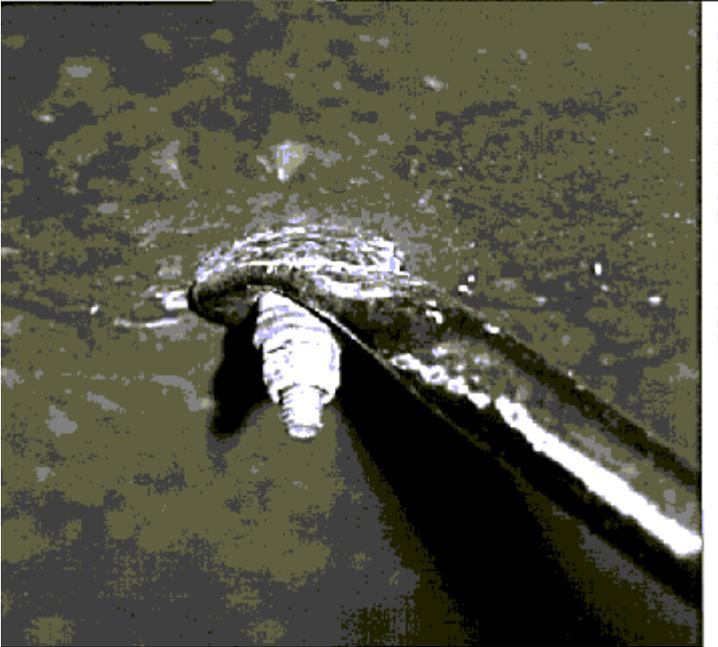
The length of the bolt (2BA) fastening the strut onto the left stabiliser was excessive, and extra washers were packed under the nut to prevent it bottoming on the unthreaded portion of the shank. The nut fitted to this bolt was cadmium plated, but two of the four lock nuts used on the 'L' shaped brackets between the rudder and the stabiliser were rusty. The source of the used nuts and bolts in this area was not established, but the modification kit containing the stabiliser was supplied with new (UNF) nuts and bolts, and these had reportedly been used in the original installation of the kit. The documentation covering the inspection of the aircraft before its test flight confirmed that the stabilisers had been '*properly installed and inspected*'. The 2BA bolts are a British design and would not be supplied with a kit assembled in the USA. The type and condition of the missing nut was not known, but it was noted that a plain (ie not self locking) UNF nut with 32 threads per inch (tpi) could be fitted to both 2BA bolts (31.4 tpi) recovered from the stabilisers, but that they made a very loose fit and could be spun off easily.
