## ACCIDENT

| <b>Aircraft Type and Registration:</b> | Cessna T303 Crusader, G-CYLS | |

## Synopsis

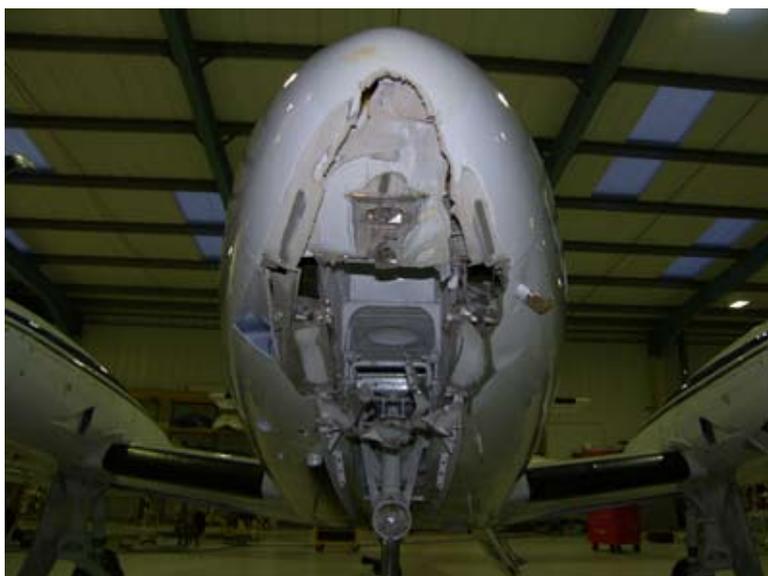
**Figure 1**

The aircraft sustained structural damage to its nose, which had buckled. It was also heavily abraded on its underside from sliding along the runway surface, Figure 1. The propellers were also badly damaged from striking the runway. Closer examination revealed that the locking lugs of the nose gear actuator had fractured, causing the gear to unlock and collapse forward as weight was applied to it on landing.

Photograph of G-CYLS showing damage to nose of aircraft

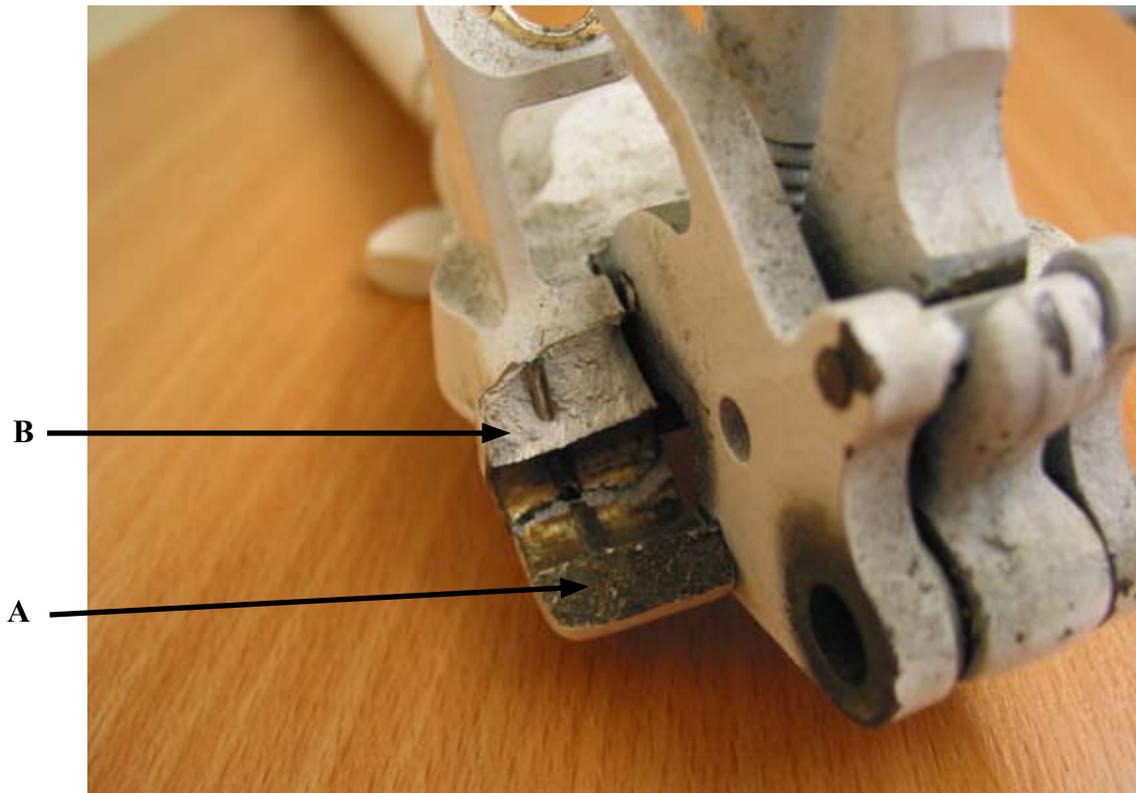
**Figure 3**

considerably more discoloured by corrosion products than the other, Figure 3. The other primary fracture differed in having a lesser degree of discoloration and a clearly visible region of ductile overload.

Detailed fractographic examination, using optical and scanning electron microscopy, showed the primary fractures to be generally intergranular in nature, with no evidence of fatigue propagation. It was not possible to state with any certainty what mechanism had caused the primary fractures.

The discoloration of the primary fractures of the actuator locking lugs is indicative that these had been present for some time, in contrast to the fresh appearance of the final ductile overload failures that resulted in the nose gear collapse. The cracks had therefore occurred over a period of time, but it was not clear what mechanism had caused the primary fractures. It is conceivable that

Photograph showing primary (A) and secondary (B) fractures of nose gear actuator locking lug

The unfavourable orientation of the grain boundaries at the ends of the lugs is likely to have had a significant influence on the local strength of the material, effectively providing planes of weakness for crack initiation and propagation.
