Air Accidents Investigation Branch

**Report on the accident to
Aerospatiale (Eurocopter) AS332 L2 Super Puma,
registration G-REDL
11 nm NE of Peterhead, Scotland
on 1 April 2009**

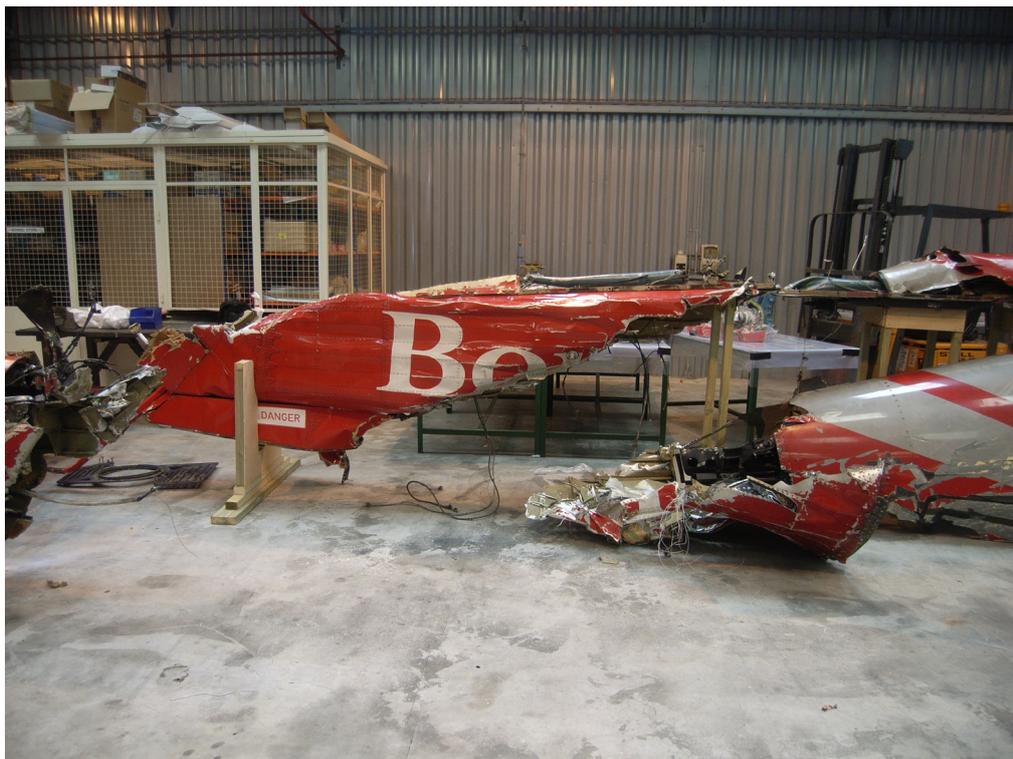
Figure 19

Damage to the tail boom of the helicopter confirmed that it had separated from the fuselage prior to the impact with the sea. It had suffered from multiple main rotor blade strikes on the boom and at the base of the fin, (see Figure 19). Damage to the tail rotor drive shaft was consistent with the shaft rotating when it was struck by the main rotor blades.

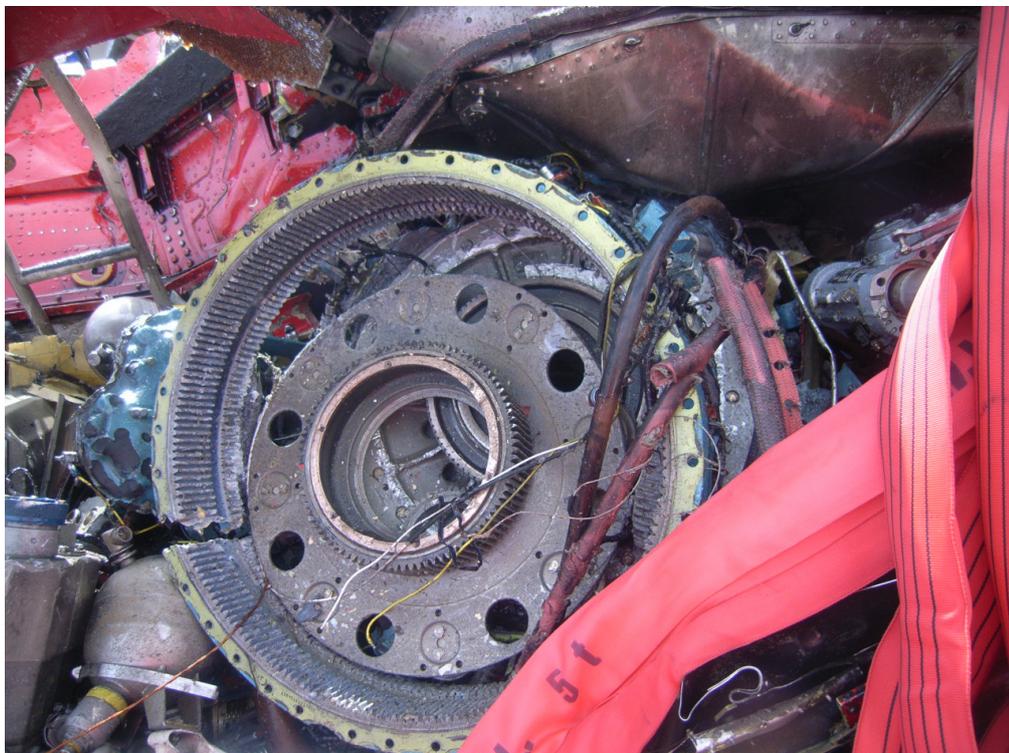
Figure 20

the remains of the main module and the remains of all eight first stage planet gears, together with pieces of a second stage planet gear, were recovered from within the MGB main module and its surrounding area.

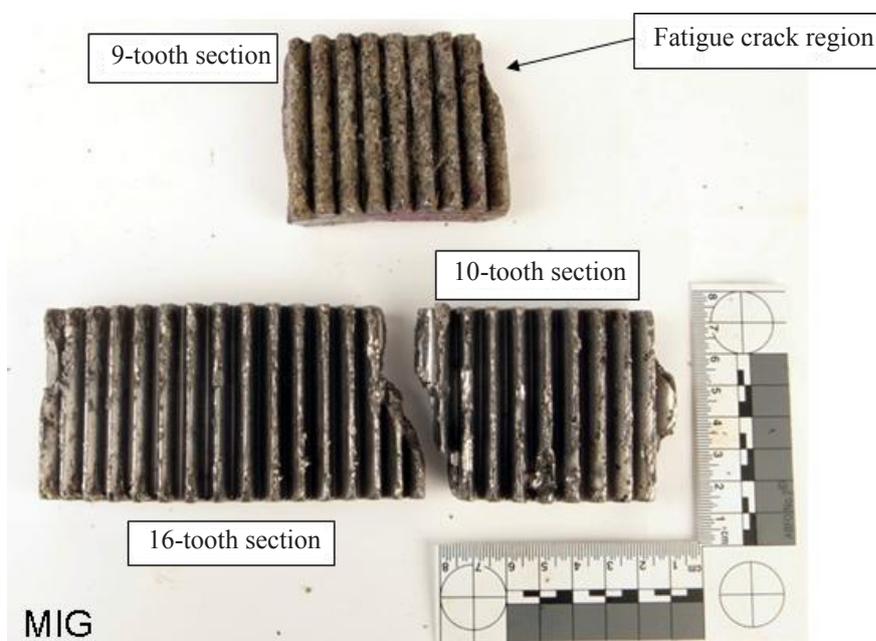
Figure 23

Initial inspection of the three recovered sections of the gear showed that the 9-tooth section did not fracture match with the other two sections. The 10-tooth and 16-tooth sections shared a common fracture face. In addition, the 9-tooth section exhibited a distinct ‘flattening’ of its curvature when compared with the other sections.

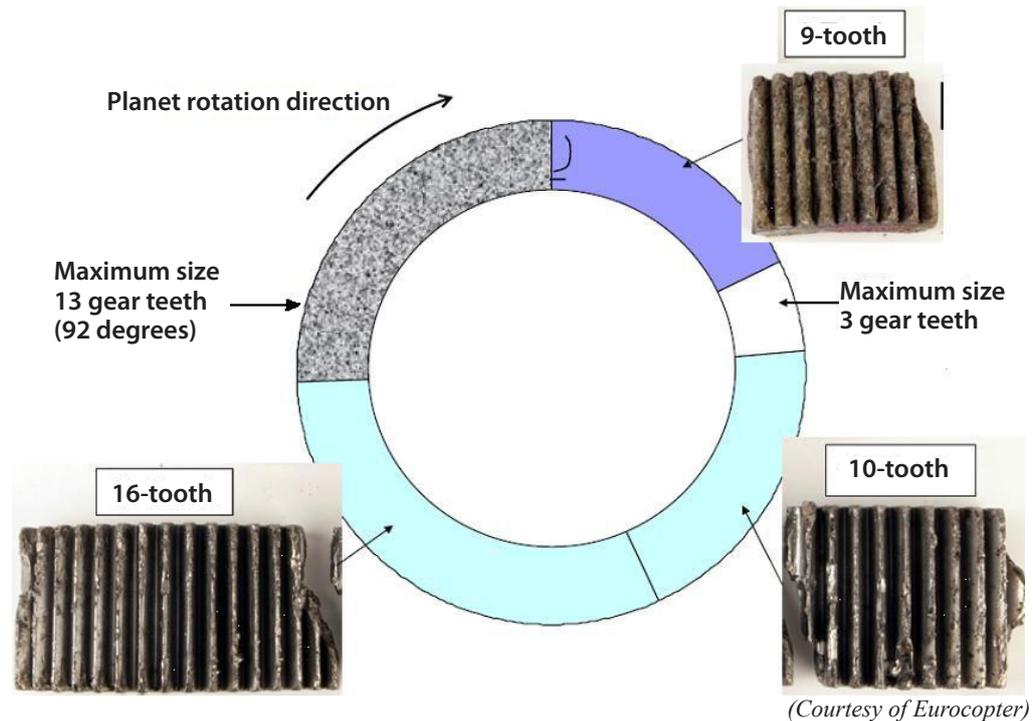
Figure 24

Examination of the recovered pieces allowed their relative positions around the circumference of the gear to be determined. The 16-tooth and 10-tooth sections comprised approximately one half of the gear, with the 9-tooth section being positioned somewhere in the remaining half. Stress analysis showed that the minimum separation of the 9-tooth section from the 16- and 10-tooth samples was equivalent to the span of three gear teeth, and the maximum separation was equivalent to 13 gear teeth, or approximately 25% of the circumference (see Figure 24).

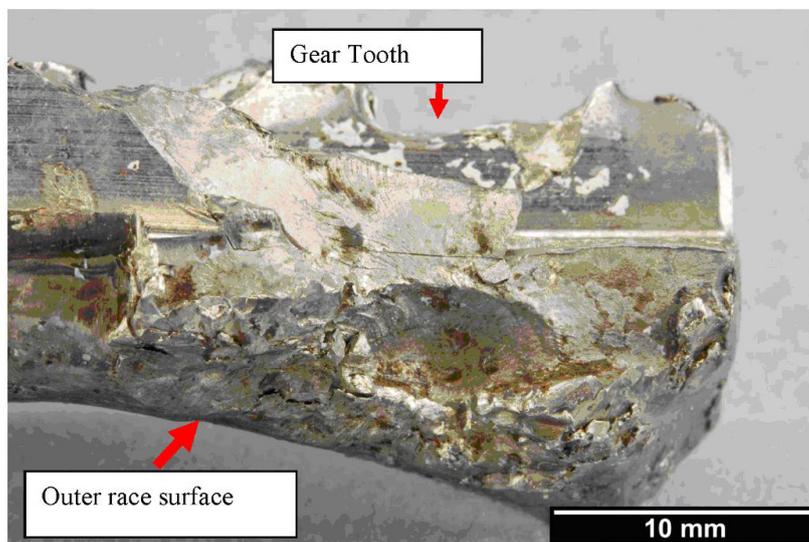
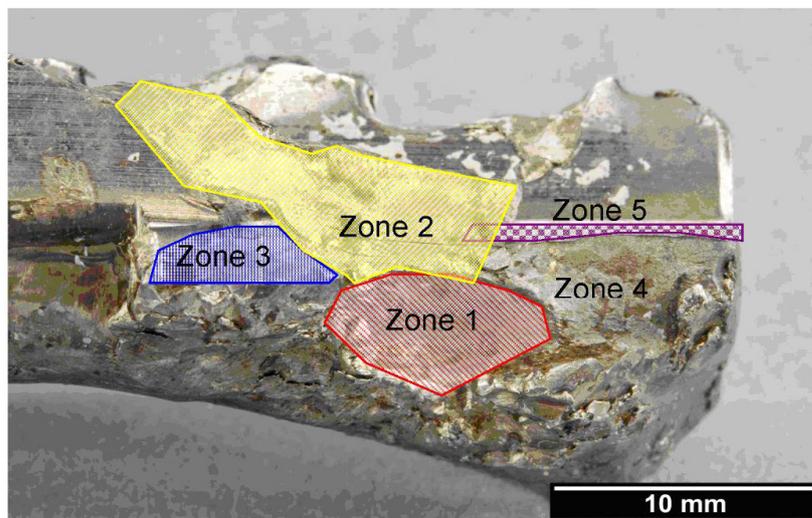
Figure 25

The Zone 4 fracture had originated on the outer edge of the Zone 1 fracture and progressed towards the edge of the gear. Zone 5 was a fatigue crack at right angles to the Zone 2 fracture face.

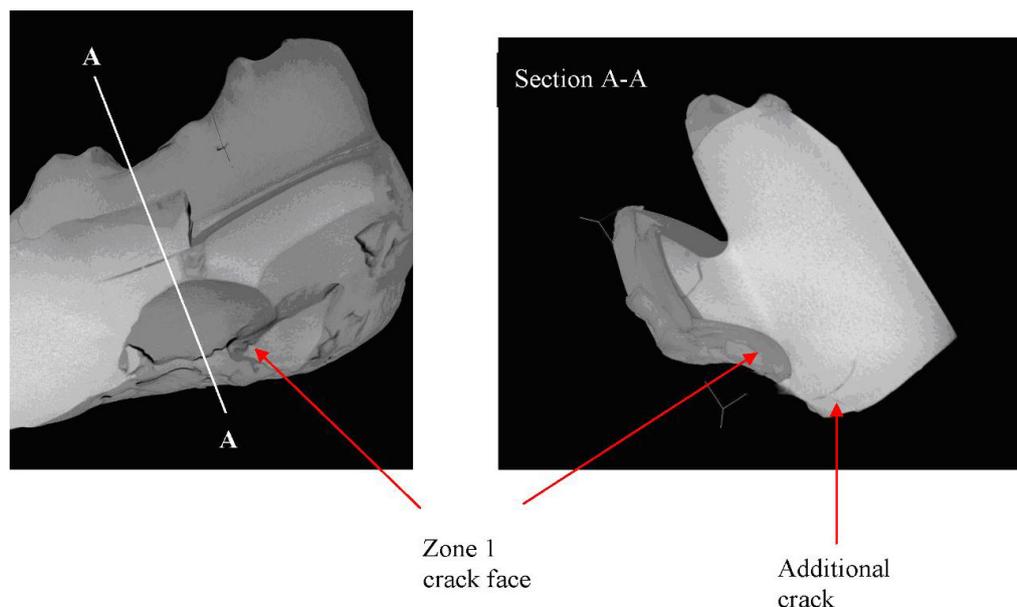
Figure 26

After examination, the 9-tooth sample was sectioned to allow detailed inspection of the fracture surfaces. Three dimensional tomographic images of the area surrounding the fracture faces showed the presence of an additional crack in the area of material immediately below the Zone 1 crack face, (see Figure 26), which was not apparent during the visual examination.

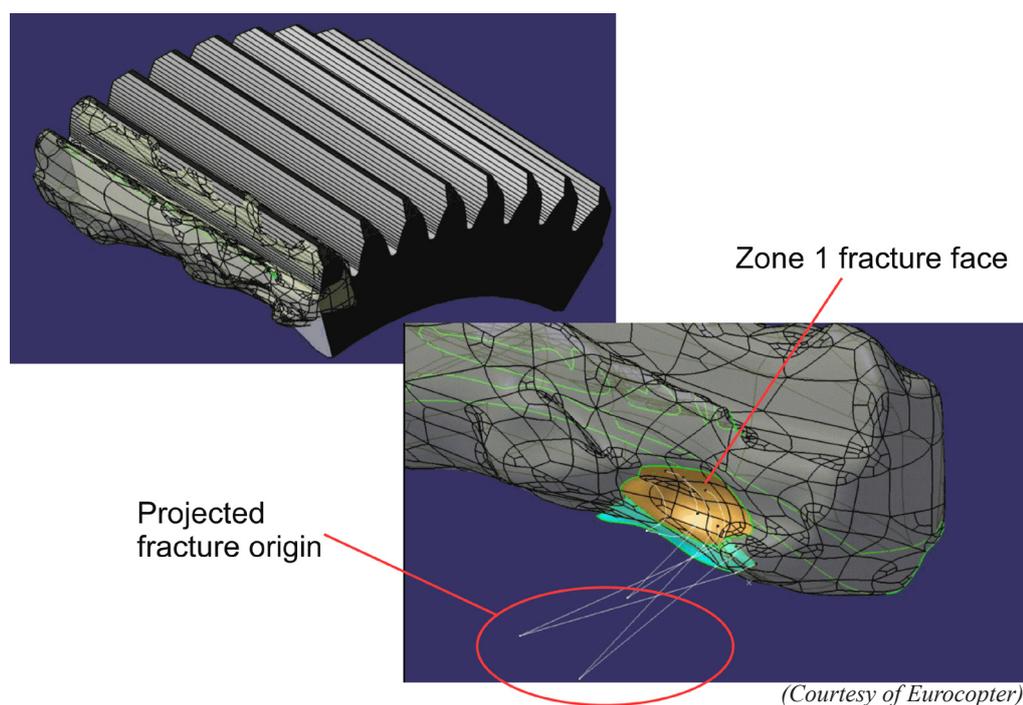
Figure 27

In order to determine the possible location of the origin of the Zone 1 crack, the dimensions of the fracture face were recorded and projected into a computer generated model of a second stage planet gear. The results showed that the origin of the Zone 1 fracture face was approximately 2.5 mm forward of the nine tooth sample, in a section of the gear which had not been recovered (see Figure 27).

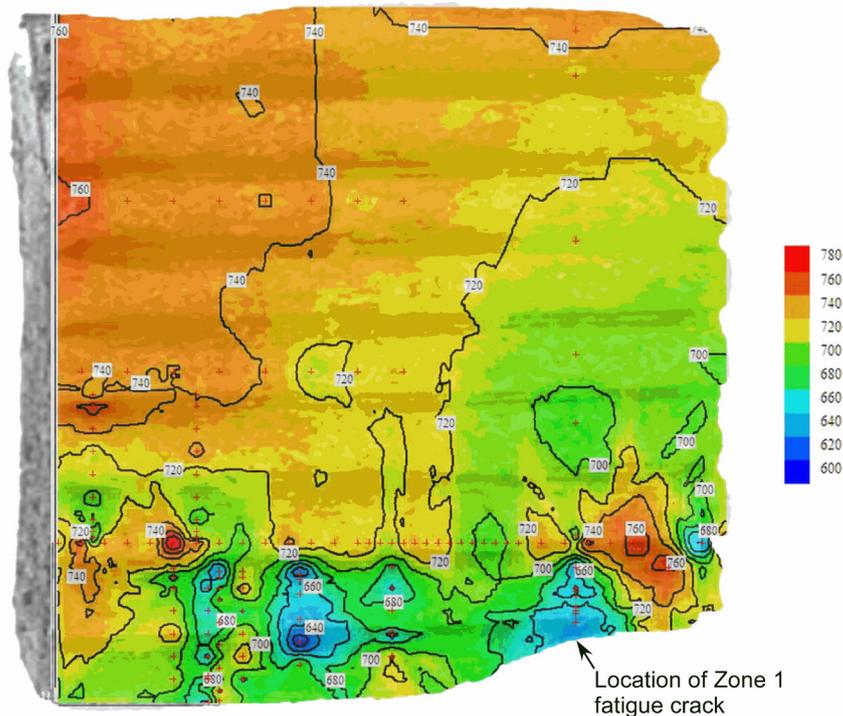
Figure 28

A detailed metallurgical examination of all the recovered sections of the failed gear confirmed that they complied with the material specification of 16NCD13 steel and no other abnormalities were identified during this examination. The hardness of the raceway of the 9-tooth section was also measured to identify any variation in the material hardness which may have contributed to the failure of the gear. These measurements were taken 0.15 mm below the surface of the raceway where the nominal material hardness, for a new second stage gear, was expected to be greater than 660 on the Vickers Hardness scale. The results were plotted onto an image of the 9-tooth section (see Figure 28). This showed that there appeared to be a relative hardening of the gear material throughout the bulk of the section.

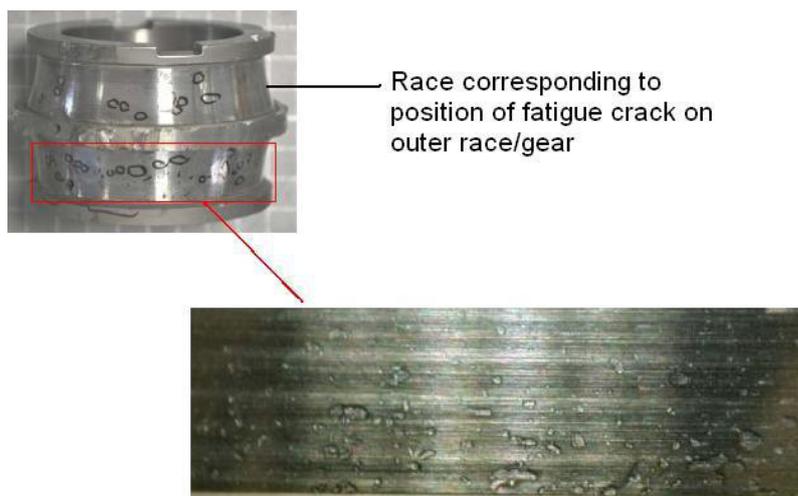
Figure 29

Examination of the inner race of the failed gear, which had remained attached to the second stage planet carrier, showed numerous small pits around the circumference of the race. This pitting was found predominantly on the highest loaded section of the inner race bearing tracks. The extent of this pitting was less evident on the bearing track corresponding to the position of the fatigue crack on the outer race/gear, (see Figure 29).

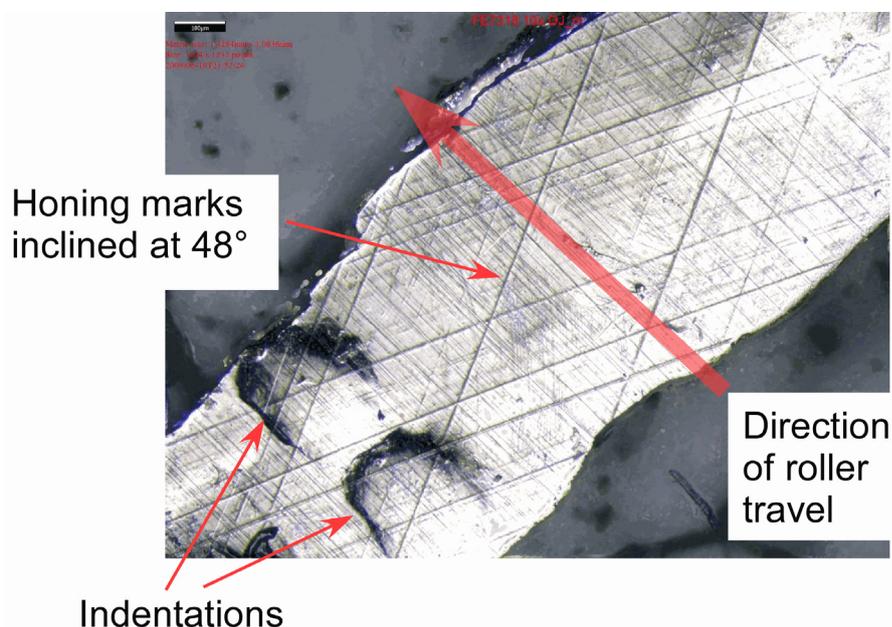
Figure 30

Detailed examination was performed on the metallic particle removed from the epicyclic module magnetic chip detector on 25 March 2009; 36 flying hours before the accident. The particle measured 2.88 mm by 0.8 mm. SEM analysis confirmed that the particle was 16NCD13 steel, planet gear outer race/gear material. On one side, the particle exhibited evidence of honing marks, a characteristic of the surface of the outer race of a second stage planet gear bearing. Comparison of these marks with an identical intact second stage planet gear established that it came from a location on the raceway in the wear track of one set of rollers. This was close to where the maximum surface loading from the rollers was to be expected, 14 mm from the edge of the gear, (see Figure 30).

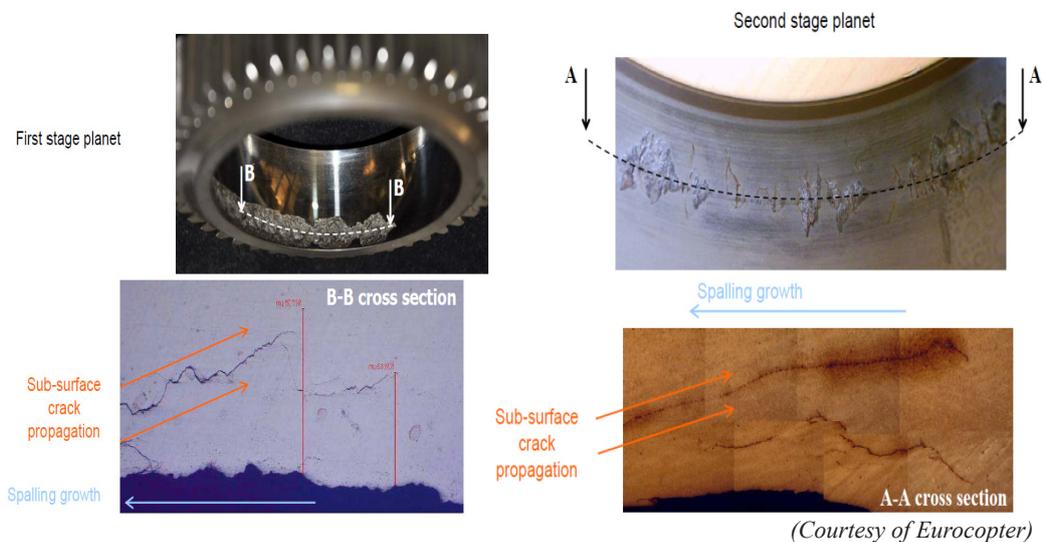
Figure 33

sub-surface cracks propagating tangentially inwards, extending beyond the carburised layer, in a manner which the stress analysis had suggested the crack path could follow in its early stages.

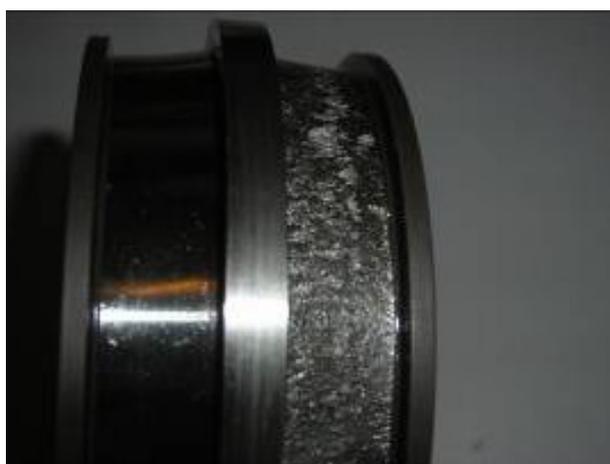
Figure 34

The inner raceway of the 2009 cracked first stage planet gear showed that the inner race roller track corresponding to the damage on the outer race had also suffered from significant amounts of spalling on the loaded arc, (see Figure 34). In addition a number of smaller ‘pits’ were present on the second bearing track of the inner race. Minor pitting was the only damage observed on either bearing track of the 2005 cracked second stage gear’s inner race. This pitting was consistent with the presence of particles within the planet gear bearing and was probably caused by spalled debris.

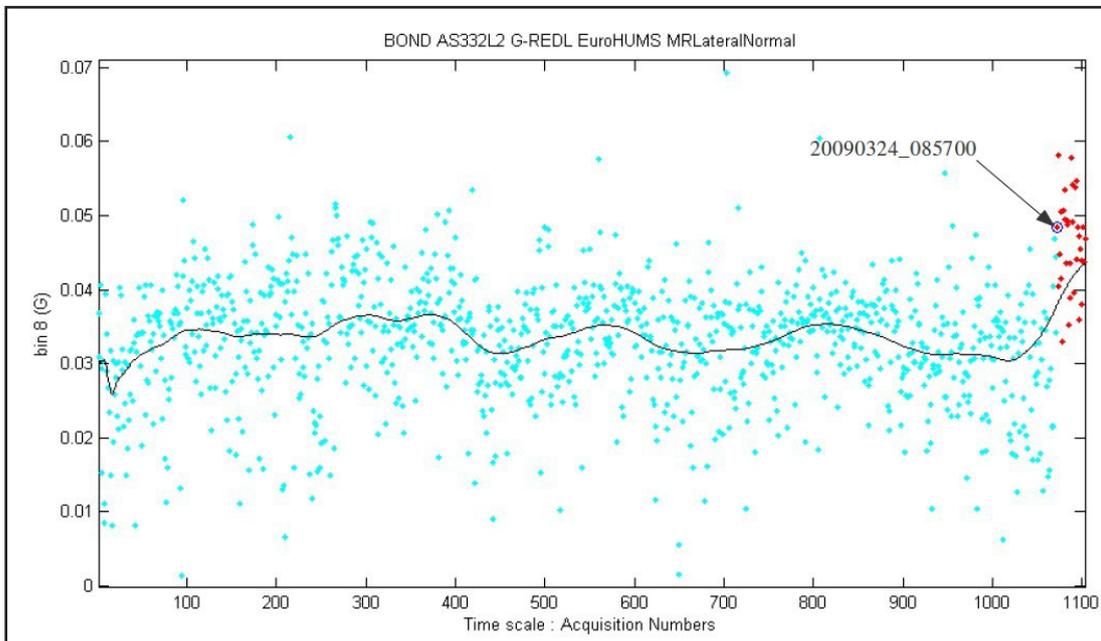
Figure H-1

Upper epicyclic ring gear eight-per-rev CI, calculated from the main rotor accelerometer Y-axis accelerometer measurements. Arrow points to operations of 24 March 09
 (Source: Eurocopter)
