ACCIDENT

Aircraft Type and Registration:	Cameron Z-250 Balloon, G-CDIN
No & Type of Engines:	3 Cameron Shadow burners
Category:	3
Year of Manufacture:	2005
Date & Time (UTC):	12 June 2005 at 0643 hrs
Location:	Dunkirk, near Faversham, Kent
Type of Flight:	Public Transport (Passenger)
Persons on Board:	Crew - 1 Passengers - 12
Injuries:	Crew - 1 (Serious) Passengers - 3 (Serious, 8 Minor)
Nature of Damage:	Distortion of basket and frame
Commander's Licence:	Commercial Pilot's Licence (Balloons)
Commander's Age:	47 years
Commander's Flying Experience:	392 hours Last 90 days - 8 hours Last 28 days - 5 hours
Information Source:	AAIB Field Investigation

Summary

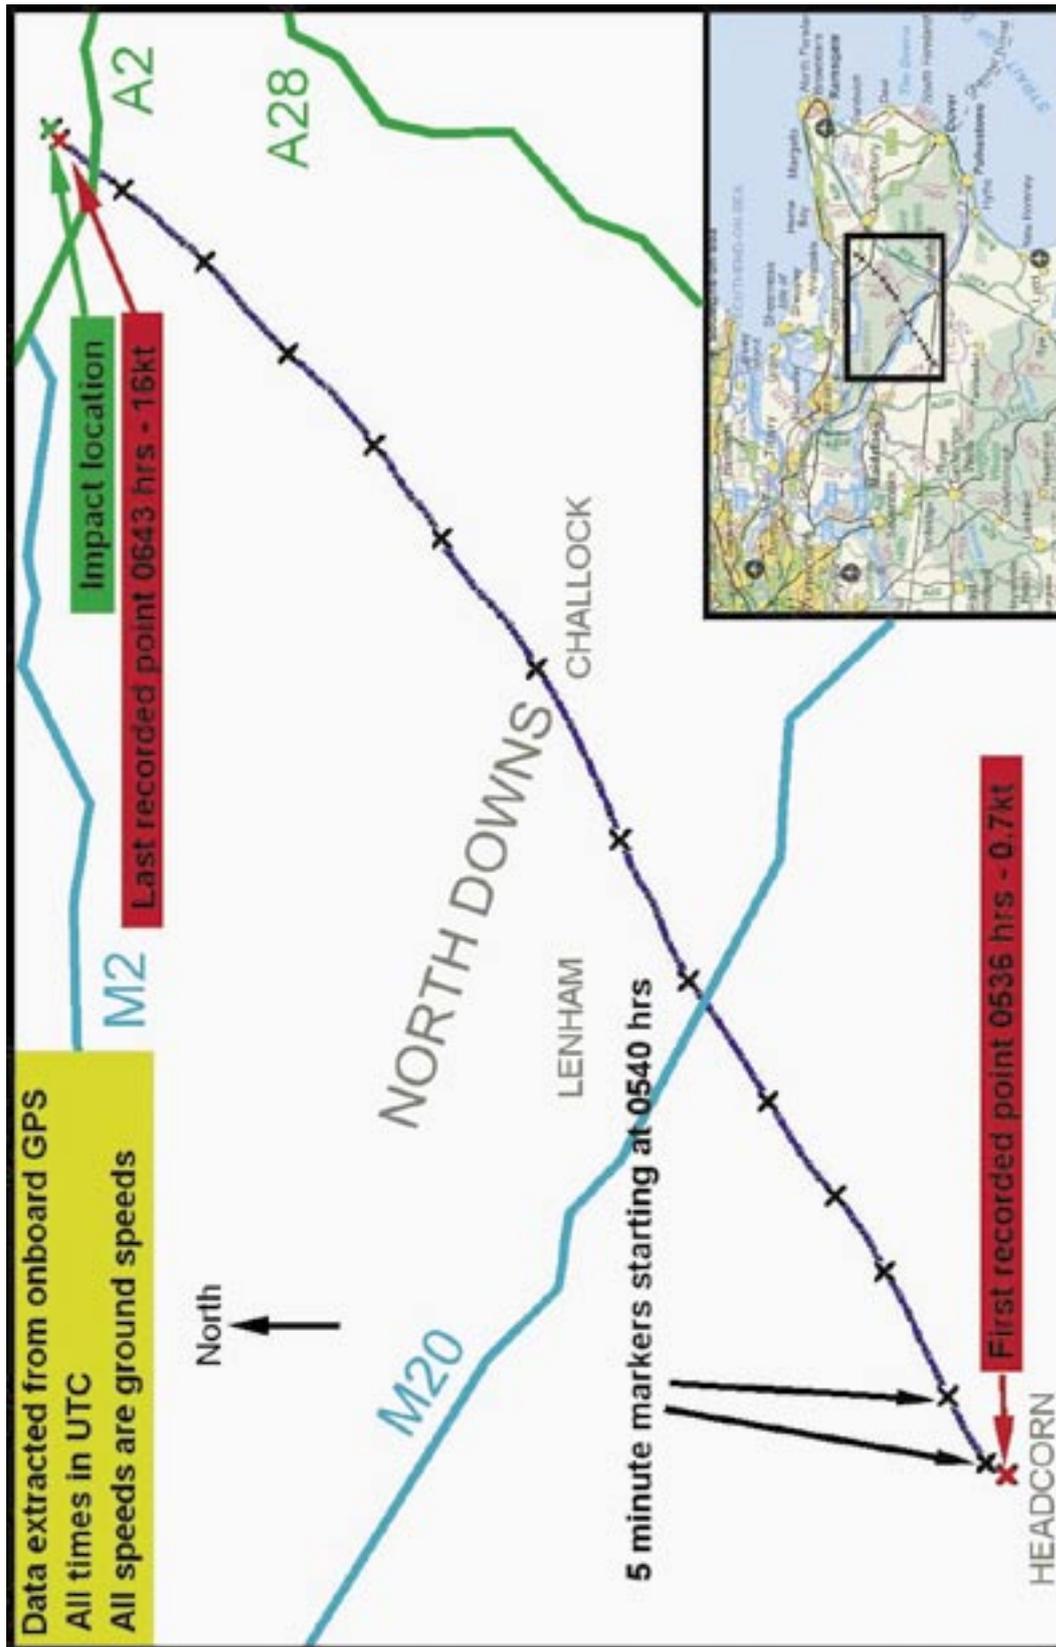
Figure 1

Data was recovered from the pilot's GPS which gave the time, speed and direction of flight until approximately the point of impact with the bunker, at which time the batteries appear to have run out. Altitude information was not recorded. The recorded data allowed the track of the flight to be overlaid on a map (see Figure 1).

GPS recorded ground track.
(Accident to G-CDIN on 12 June 2005 at Dunkirk)

The balloon's track, as shown in Figure 1, was initially about 060° and then later backed towards 040°. These tracks are not consistent with the commercial forecast issued the previous evening but they were reasonably consistent with the Met Office Ballooning forecast. They were also consistent with the observed northerly direction of travel of the weather balloons launched by the operator from Leeds Castle and Headcorn. However, the wind at 2,000 ft was stronger than any of the forecasts. The balloon was, therefore, taken more quickly than expected
