ACCIDENT

Aircraft Type and Registration:	Europa, G-PTAG	
No & Type of Engines:	1 Jabiru Aircraft PTY 3300A piston engine	
Year of Manufacture:	2000	
Date & Time (UTC):	27 May 2006 at 1545 hrs	
Location:	Wickenby, near Market Rasen, Lincolnshire	
Type of Flight:	Private	
Persons on Board:	Crew - 1	Passengers - 1
Injuries:	Crew - None	Passengers - None
Nature of Damage:	Damage to fuselage, nose gear leg, propeller and main gear fairings	
Commander's Licence:	Private Pilot's Licence	
Commander's Age:	66 years	
Commander's Flying Experience:	555 hours (of which 532 were on type) Last 90 days - 14 hours Last 28 days - 5 hours	
Information Source:	AAIB field investigation

Synopsis

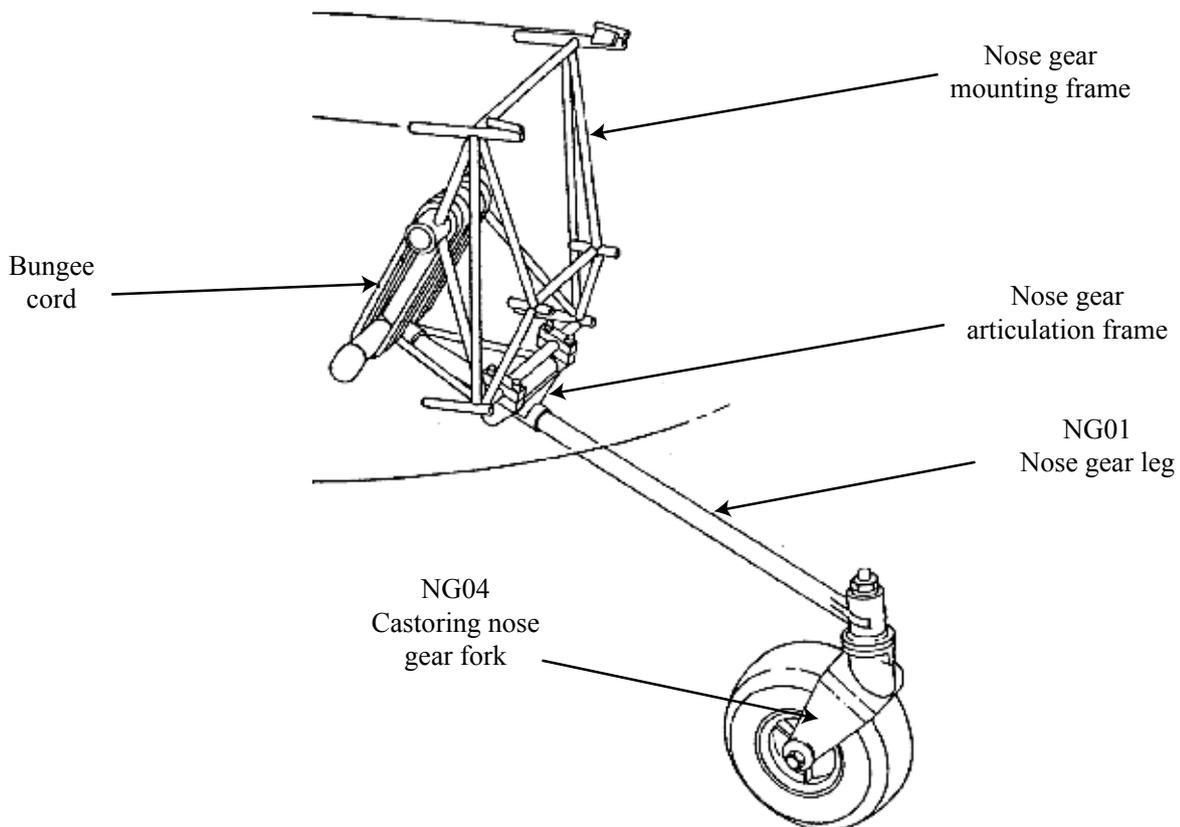
Figure 1
General arrangement of nose gear

The Europa is a two-seat aircraft sold in kit form. G-PTAG was a tri-gear version. The main component of the nose gear leg comprised a length of steel tube attached to the aircraft structure behind the engine compartment. The geometry was such that the leg was swept forward making an angle of approximately 30° to the horizontal, see Figure 1.

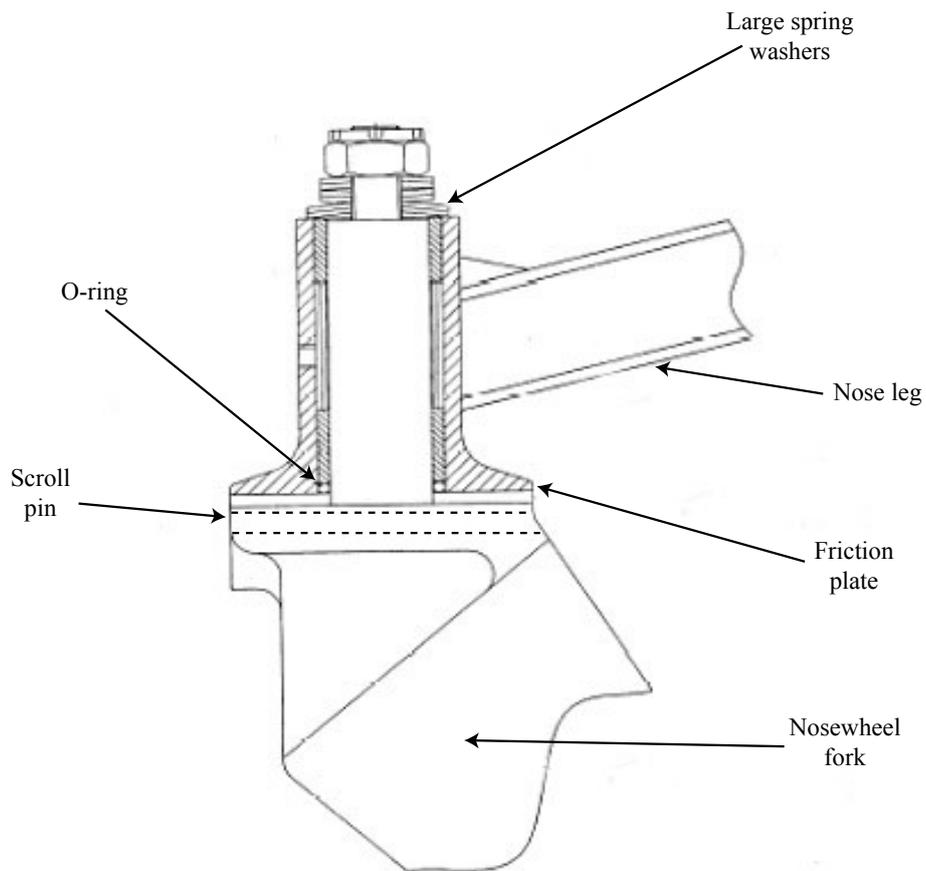
Figure 2

The nosewheel fork assembly was supplied as a pre-assembled unit and consisted of a pivot shaft and an aluminium alloy fork unit. The upper end of the pivot

shaft fitted into a cylindrical housing welded to the lower end of the nose gear leg, see Figure 2.

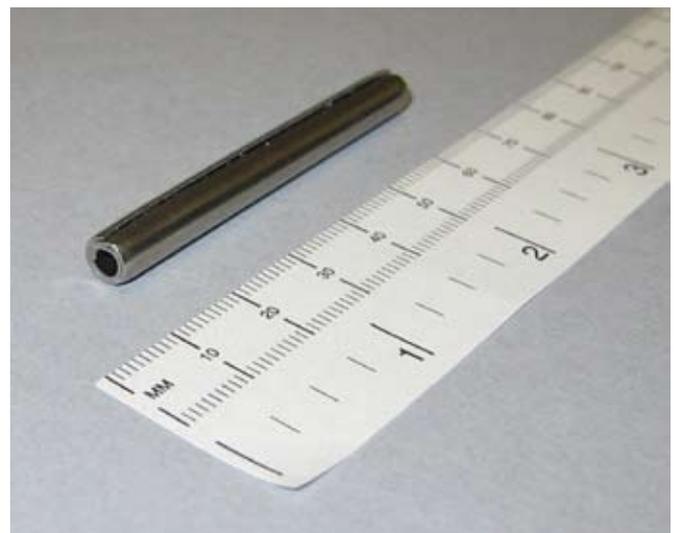
Figure 3

The lower end of the pivot shaft fitted into a hole in the fork unit. The tolerances on the pivot shaft and the hole in the fork were such that for within-tolerance components there could be, at one extreme, a gap of 0.0016", and at the other extreme 0.0002" interference. Loctite adhesive was used to bond the two components. A 6 mm diameter scroll pin¹ was inserted into a hole through both the fork and the lower portion of the pivot shaft to locate the components positively and to take the relatively small load from tightening the shimmy damper nut, see Figure 3.

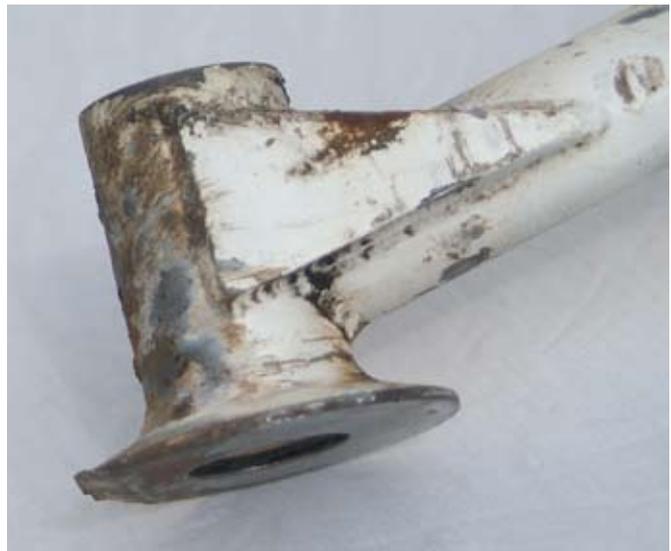
Figure 4

The underside of both the pivot shaft and the front of the pivot shaft housing had worn to a 'chisel edge', see Figure 4. This was consistent with the aircraft having rolled along the runway without the nosewheel and nosewheel fork, but with the gear leg swept forward in its normal position.

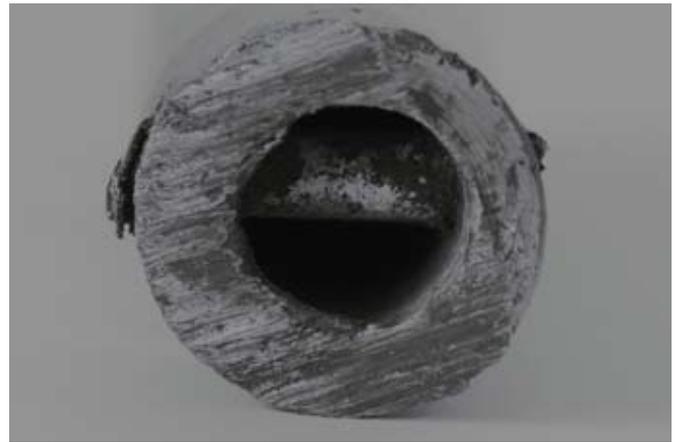
Figure 6
Detail of failed scroll pin in pivot shaft

The scroll pin in the pivot shaft had failed in shear due to overload, see Figure 5. The hole in the pivot shaft for the scroll pin had not been drilled accurately across a diameter, see Figure 6. There were also burrs present on the internal surface of the pivot shaft next to the hole for the scroll pin. The hole was not perpendicular to the axis of the pivot shaft, hence the scroll pin was aligned slightly nose down. The off-centre and

non-perpendicular hole for the scroll pin, and possibly the presence of the burrs, would have compromised the effective strength of the scroll pin.

It is recommended that Europa Aircraft Limited review the design, manufacture and recommended maintenance of the nose gear fork assembly of the tri-gear Europa to improve the integrity of the nosewheel fork attachment.

Prior to finalising this report for publication, and following the distribution of a draft to various parties, including Europa, for comment, Europa has advised the AAIB that the design of the pivot shaft has been revised. It has been modified to increase the length of insertion in the casting and thereby reduce the load on the scroll pin. Also, the tolerances of the shaft and casting bore will be reviewed, and a new material has been specified for the casting. No change to the maintenance requirements was considered necessary by Europa.
