**Air Accidents Investigation Branch**

**Report on the serious incident to  
British Aerospace ATP, G-JEMC  
10 nm southeast of Isle of Man (Ronaldsway) Airport  
on 23 May 2005**

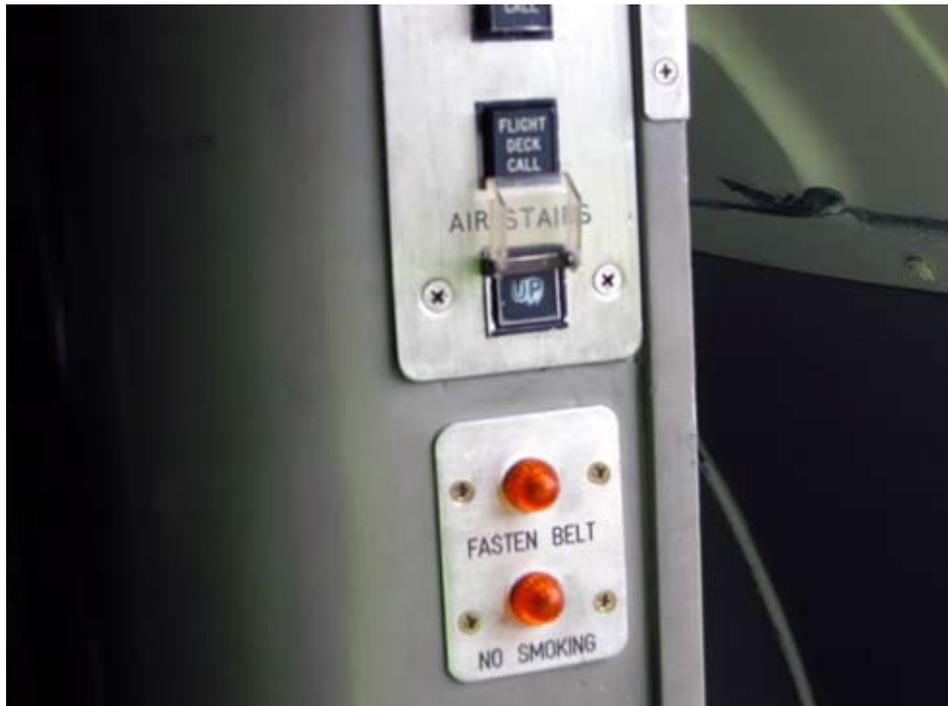
**Figure 11**

On inspection of the switch panel at the Flight Attendant's call station, it was immediately apparent that the airstairs UP switch was being held in the depressed position by the plastic flip-guard. This had been lifted beyond its usual 90° position such that it was lying against the switch panel, Figure 11. Lying thus, the switch button had become trapped behind the upper edge of the guard, preventing the switch spring from returning the switch to the OFF position.

Examination of the guard on a similar aircraft revealed the presence of a baulk strip, bonded to the outer face of the guard, close to its upper edge. Rotation of the guard significantly beyond the 90° position caused the baulk strip to make contact with the surface of the switch panel and this served to discourage attempts to rotate it further, Figure 12. The presence of the baulk strip identified the flip-guard as a 'Korry' type, which was introduced following an earlier incident (see Section 1.18.1). Additional examination of the flip-guard from G-JEMC revealed traces of adhesive, showing that a baulk strip had been present at some stage, and that this had most probably been broken off as a result of the guard being forced beyond the 90° position.

‘As-found’ position of airstairs retraction switch flip-guard, holding switch in

The missing baulk strip on the flip-guard had enabled it to be rotated into a position such that it had trapped the airstairs UP switch in its depressed position. Whilst it is possible that this had occurred on previous occasions, a concomitant sticking door microswitch plunger would not have presented a problem so long as the hydraulic seals remained intact. If cabin crews have at any time noticed the absence of the baulk strip on the flip-guard, it is possible that they could have considered it a trivial matter and unworthy of a report. Moreover, the UP switch has to be fully depressed before the flip-guard can be moved to a position to jam the switch, and thus be immediately apparent to the attendant on releasing the switch.

- During any smoke/fumes event it is vital that flight deck crew follow the appropriate emergency checklist in its entirety.
- On any guarded switch throughout the aircraft, check the integrity of the guards for wear and also for missing parts such as guard baulk strips.
- Check the integrity of the airstairs safety microswitch door hinge plunger to ensure it is operating satisfactorily. Refer to AMM Task 52-60-00-820-830.

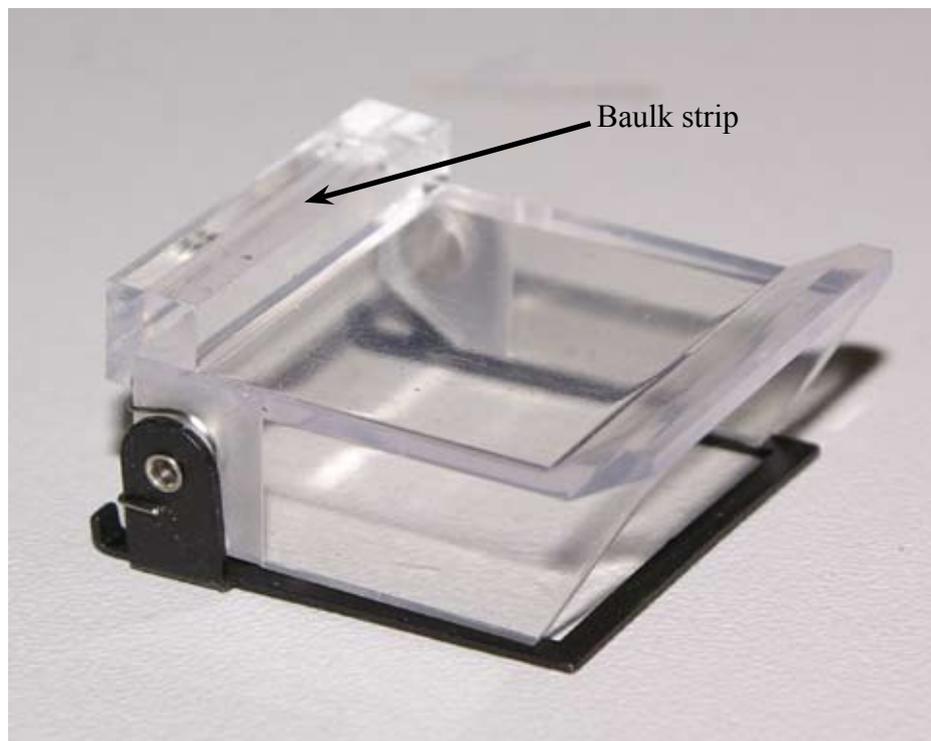
**Figure 12**

New flip-guard showing baulk strip, which prevents guard from being rotated beyond 90° position

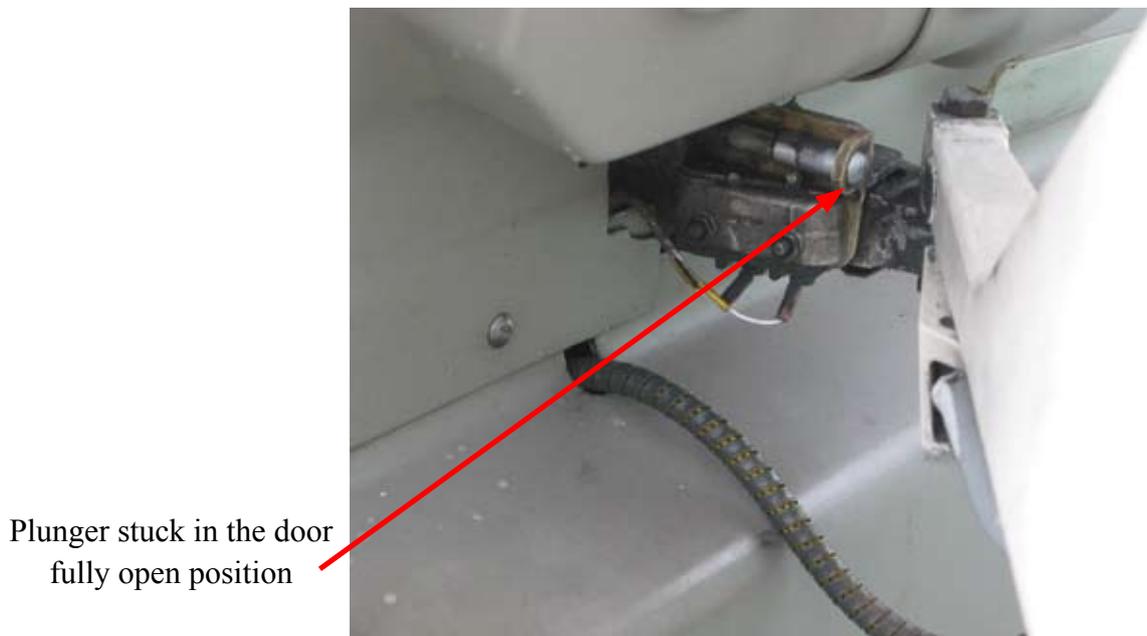
**Figure 13**

Figure 13 shows a photograph of the safety microswitch and its associated plunger, as it was found immediately after the incident. The plunger had remained in its depressed state, despite the fact that the door had been moved away from its fully open position<sup>7</sup>. The reason for this was not clear: it appeared that the contact force between the roller and plunger may have exceeded the ability of the spring to move the plunger. This in turn implied that the axis of the plunger may not have been exactly parallel to its line of travel, so that the contact force between the roller and plunger increased with distance travelled. When finger pressure was applied to the end of the plunger, it was found that it could be encouraged to stick in the depressed position if it was pushed, against spring pressure, to its full limit of travel. This raised the possibility that the door may have over-travelled at some stage, which would have had the effect of extending the plunger travel beyond normal.

‘As found’ stuck switch condition of the door safety switch

The general appearance of the microswitch and plunger assembly was slightly grimy, with a sheen of grease, although the latter may have originated from nearby hinge components. The microswitch was subsequently cleaned and adjusted in accordance with the Aircraft Maintenance Manual (AMM), following which it operated normally; it could not be encouraged to stick. It was noted that

the Aircraft Maintenance Manual did not specify any lubrication to be applied, and neither the operator nor the aircraft manufacturer specified any periodic inspection of the microswitch and plunger assembly. No record was found of the last time that this component had been inspected, adjusted or refitted.

The sticking door microswitch plunger represented a dormant failure; it could not be established how long this condition had existed or whether it was intermittent in nature. Previous incidents involving the airstairs hydraulic system suggest that a similar situation had occurred on at least one other occasion. In the absence of any requirement for a periodic inspection or maintenance of the plunger mechanism, it is possible that other aircraft in the fleet could be similarly affected due to the accumulation of grease and dirt. It would therefore seem logical for the Maintenance Schedule to be amended to introduce periodic checks and maintenance of the microswitch assembly.

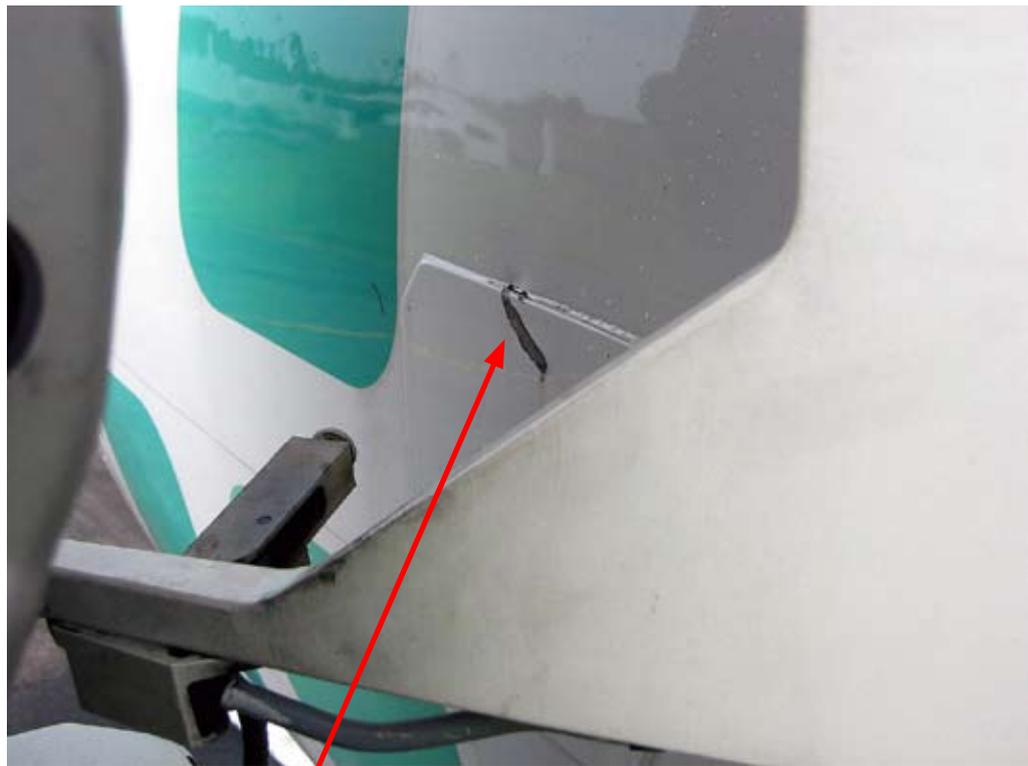
**Figure 14**

The door was fitted with a stop, comprising a plastic strut with an adjustable pad at its end. With the door fully open, the pad came in to contact with a reinforcing plate attached to the fuselage but, when the door was forced further open, the strut could be made to deflect, causing the pad to slide off the edge of the reinforcing plate. This had caused a significant dent in the fuselage skin. The presence of a scar on the surface of the plate indicated that this had occurred in the recent past, Figure 14. Examination of another aircraft revealed no evidence of such a scar and that the strut appeared to be more rigidly attached than on G-JEMC. However, it was noted that the reinforcing plate on the other aircraft was positioned lower on the side of the fuselage than on G-JEMC, resulting in a significant dent being made in the fuselage skin.

Scar on fuselage reinforcing plate caused by door stop deflection

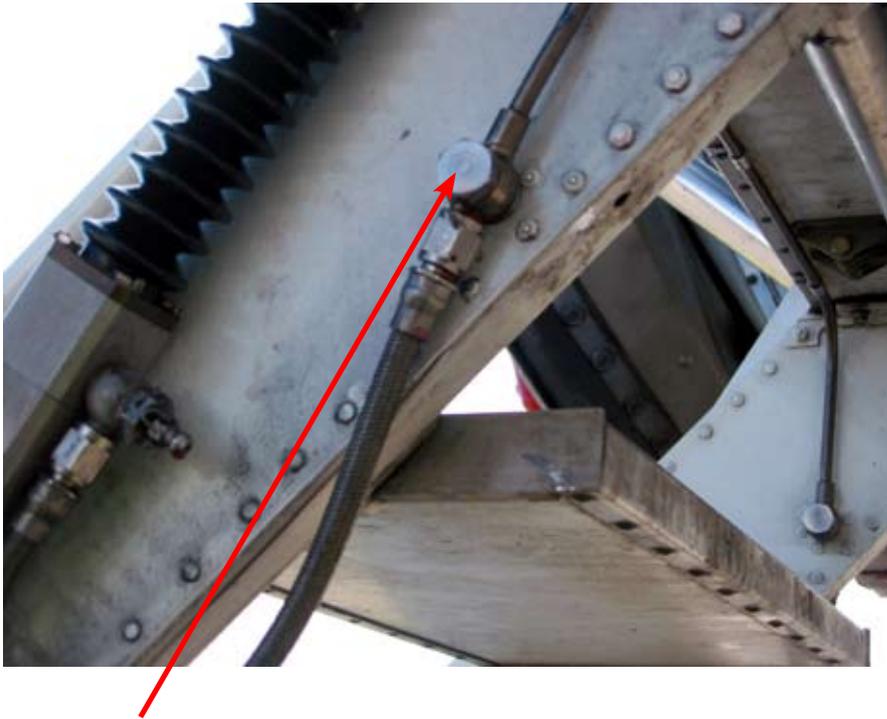
**Figure 15**

Hydraulic fluid was found to be leaking from the banjo fitting on the right side of the airstairs, when viewed from outside the aircraft. The fitting marked the point where the hydraulic pressure supply pipe bifurcated, with one (flexible) pipe leading to the actuator mounted nearby, the other routing underneath one of the airstairs rungs to the actuator on the opposite side, Figure 15.

Banjo fitting associated with the hydraulic fluid leak

The reason for the failure of the seal was not established, but could have been the result of, for example, insufficient assembly torque or degradation of the seal material. Should the banjo connector seal have failed as the retraction sequence was initiated, in the absence of the other failure events, any hydraulic mist/spray would largely have occurred outside the aircraft during retraction of the airstairs after the passengers had boarded. This would not have presented a significant operating hazard and would have afforded an opportunity for detection and rectification prior to flight. The combination of the stuck door safety switch and defective seal resulted in the continued pressurisation of the only part of the aircraft's hydraulic system that was contained within the cabin. The result of the seal failure, apart from producing the mist which was perceived as smoke, was a rapid exhaustion of the contents of the main system hydraulic reservoir. However, the ATP has no hydraulically operated primary flight controls - it has electrically powered flaps - and the braking system is protected by accumulators. Thus the ability of the crew to operate the flight controls normally was not compromised.

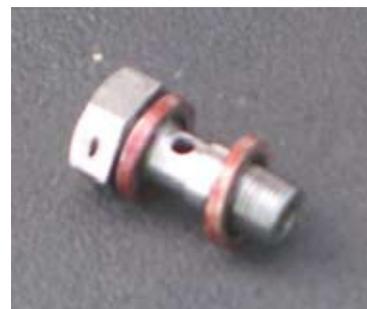
**Figure 16**

The part number of the seal from the banjo fitting associated with the leak was 300-202-1911-02, with the last two numerical groups referring to the rubber material from which the seal was made and the metal outer ring respectively. According to the manufacturer's data sheet, the seal burst pressure is 1,270 bar, or approximately 18,500 psi, ie well in excess of the aircraft's main hydraulic system operating pressure of 2,450 psi. The seals had not burst and appeared intact, Figure 16.

Banjo bolt with 'intact' seals

31. The cause of the hydraulic leak was not identified by the investigation; the seal appeared to be undamaged but had been installed for a considerable period of time.
