**No: 9/91**

**Ref: EW/G91/06/16**

**Aircraft Type and Registration:** Boeing A75L3 Stearman, G-BPMD

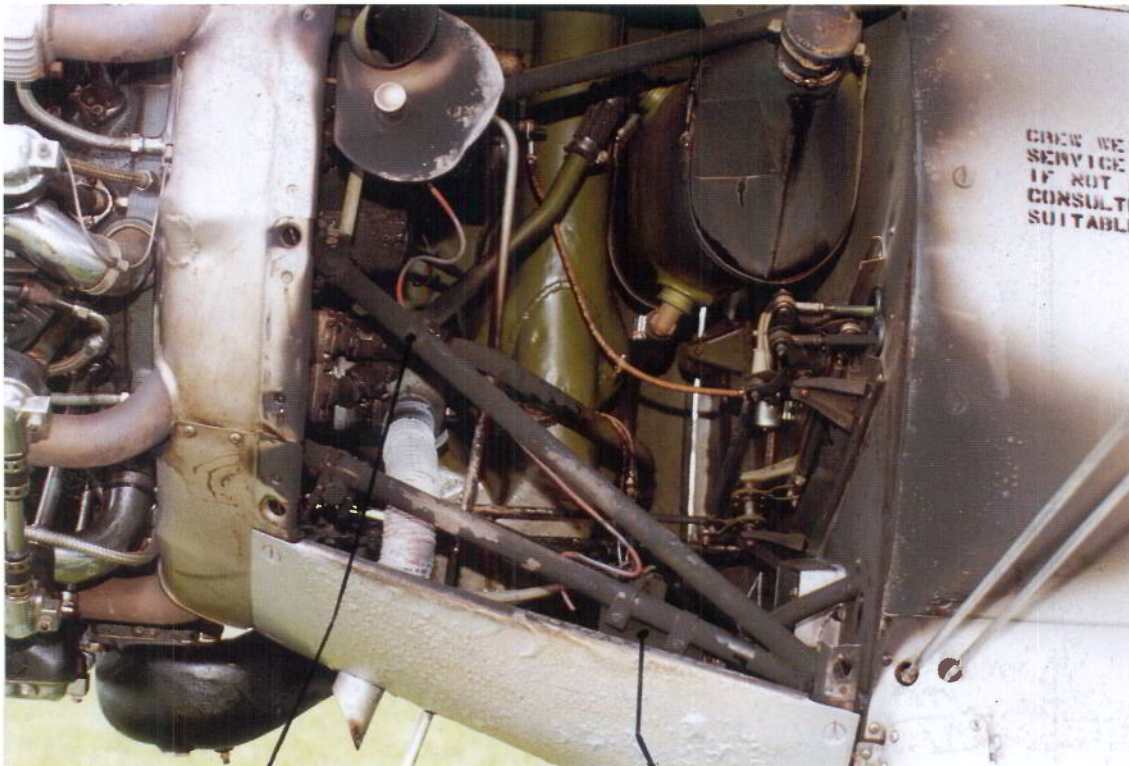
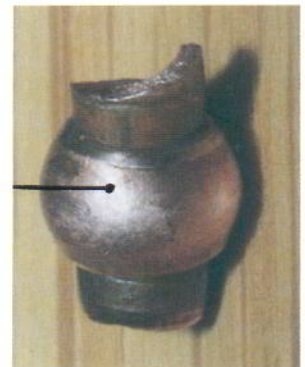
It was established that a fuel leak had occurred as a result of fracture of the small bore copper priming pipe which connected the fuel strainer to the priming pump, at a position where it attached to the top of the strainer housing. The pipe end was secured to the strainer outlet by a compression type of fitting where a small sealing olive had been swaged onto the end of the pipe by the action of tightening the associated nut. A detailed examination of this pipe showed that it had failed in fatigue. The failure had occurred at a bend in the pipe and the diameter of this pipe (4.75 mm) was found to be approximately twice that of pipes fitted to other aircraft examined. On the other Stearman aircraft inspected, this pipe, which is approximately 60 cm in length, was invariably found to be clipped at its mid position to one of the engine support tubes in order to minimise the effects of vibration. When this aircraft was first examined after the fire the pipe was observed to be secured, near its top end, to an engine support tube, leaving the relatively long unsupported length of pipe to the strainer free to vibrate. The accompanying photographs show the fractured pipe, olive-end and fire damage.

PIPE CLIPPED TO THIS TUBE

FUEL STRAINER

BROKEN PIPE END c.w. OLIVE

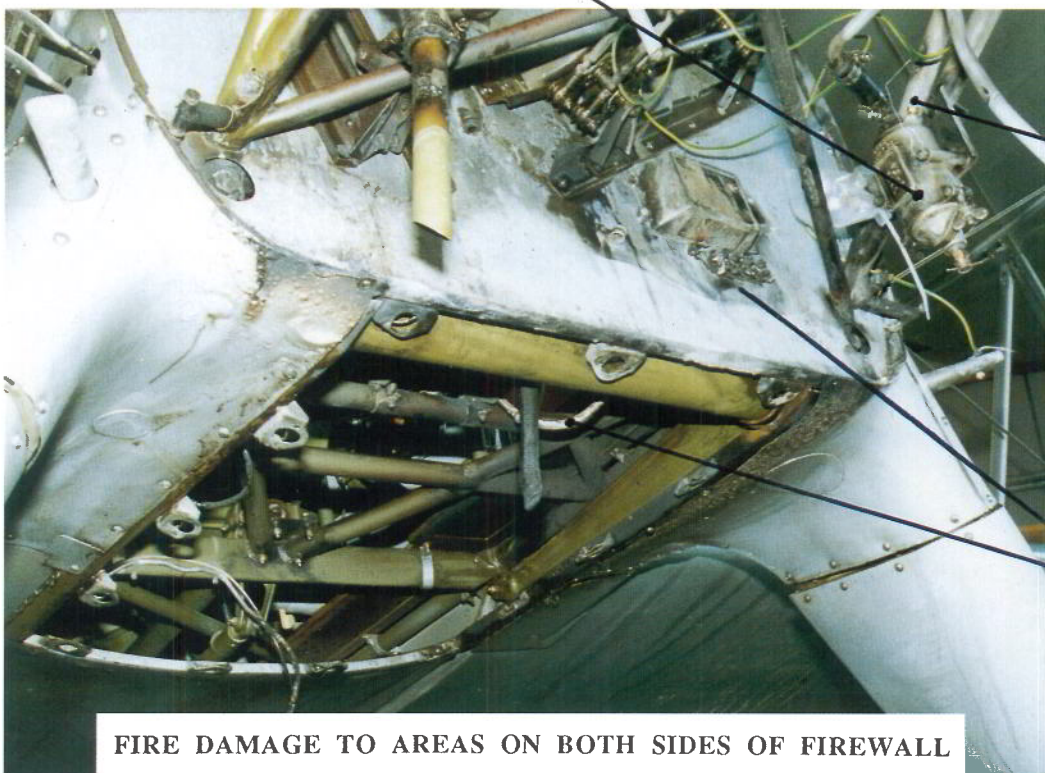
Subsequent examination of the aircraft showed that the fire had damaged the lower and left side engine cowlings, the aluminum skin beneath the front cockpit and most of the equipment and wiring between the firewall and the rear of the engine. In addition there was heat damage to the battery box and its feeder cables, which were situated in the front cockpit between the rudder pedals. It was evident that although the firewall had not been directly penetrated by the fire, hot gases and/or flames had flowed around its lower edge and entered the front cockpit, after burning through the leading edge of the skin

PIPE FAILURE LOCATION

BURNT WIRES

FIRE DAMAGE TO AREAS ON BOTH SIDES OF FIREWALL
