ACCIDENT

Aircraft Type and Registration:	Beech 200 Super Kingair, G-BGRE	
No & Type of Engines:	2 Pratt & Whitney Canada PT6A-61 turboprop engines	
Year of Manufacture:	1979	
Date & Time (UTC):	23 November 2009 at 1308 hrs	
Location:	Chalgrove Airfield, Oxfordshire	
Type of Flight:	Private	
Persons on Board:	Crew - 2	Passengers - None
Injuries:	Crew - None	Passengers - N/A
Nature of Damage:	Aircraft nose and propellers damaged	
Commander's Licence:	Airline Transport Pilot's Licence	
Commander's Age:	47 years	
Commander's Flying Experience:	7,000 hours (of which 600 were on type) Last 90 days - 60 hours Last 28 days - 22 hours	
Information Source:	Aircraft Accident Report Form submitted by the pilot, operator's investigation report and metallurgy report

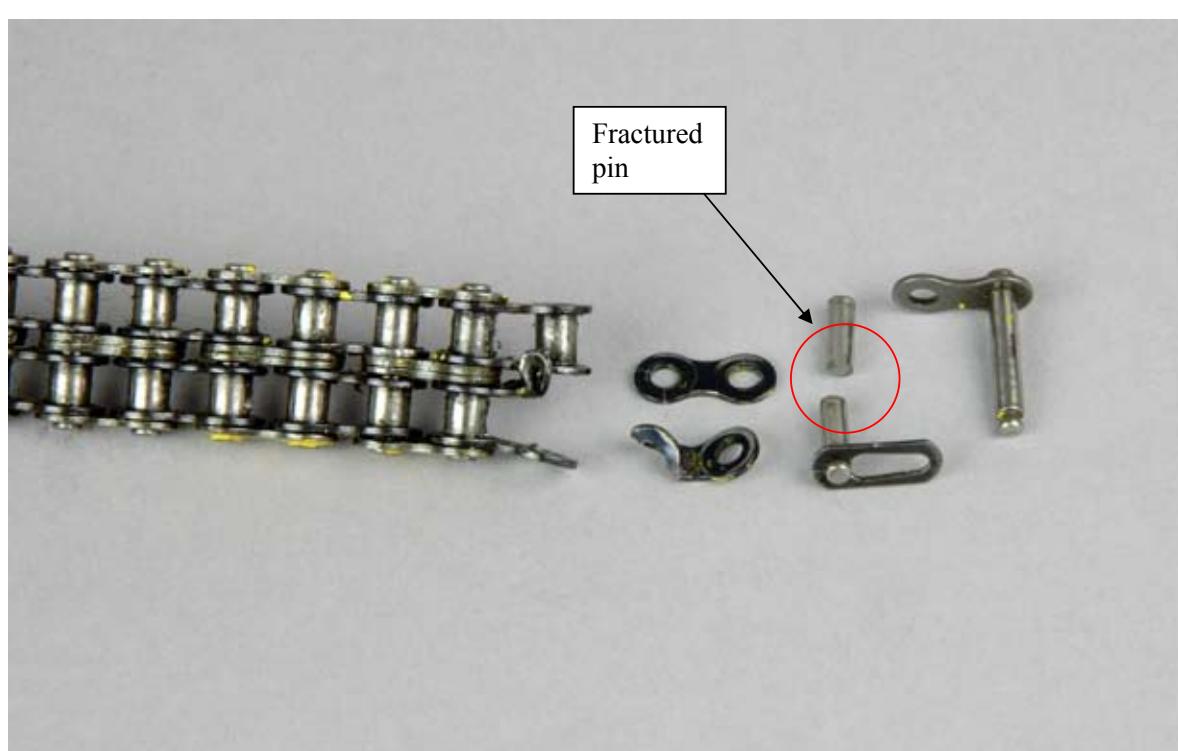
Figure 1
Failed chain link

After removing the cabin floor to access the gearbox, it became evident that the nose gear chain had separated. The point of separation was a connecting master link used to remove the chain for maintenance. The pins, plates and the spring clip which made up this link had detached, but the parts were recovered from the aircraft. The chain was visually inspected in accordance with the manufacturer's Aircraft Maintenance Manual (AMM) and the general condition was considered to be within limits. Detailed inspection of the detached parts showed that one of the pins had fractured at its mid point and two of the connecting plates were distorted upwards, with a third plate distorted outwards (Figure 1).

The failed pin was sent for metallurgical analysis. Inspection of the pin, under a scanning electron microscope, showed evidence on the fracture surface that the failure was due to overload. No evidence of fatigue was identified. Several other cracks, which had not propagated to failure, were also identified when the pin was sectioned. The pin material composition and hardness were also tested and met the required specification.

subsequent failure of the nose gear to extend fully when selected. The damage identified to the chain plates is likely to have been caused by the sprocket teeth as the failed link travelled around the gearbox sprocket.

It was not possible to determine whether the lack of a 'press-fit' front cover plate may have contributed to the failure of the pin. However, fully inserting the pins into the rear cover plate and fitting a front 'press-fit' cover plate as defined in Model Communiqué No 16 would most likely have prevented the failed link becoming completely detached after the pin fractured. This may have allowed the gear system to continue to operate until the nose gear had fully extended. With a failure of the drive chain in this manner, the emergency extension system is rendered ineffective as it requires the nose gear drive chain to be serviceable to lower the nose gear leg.

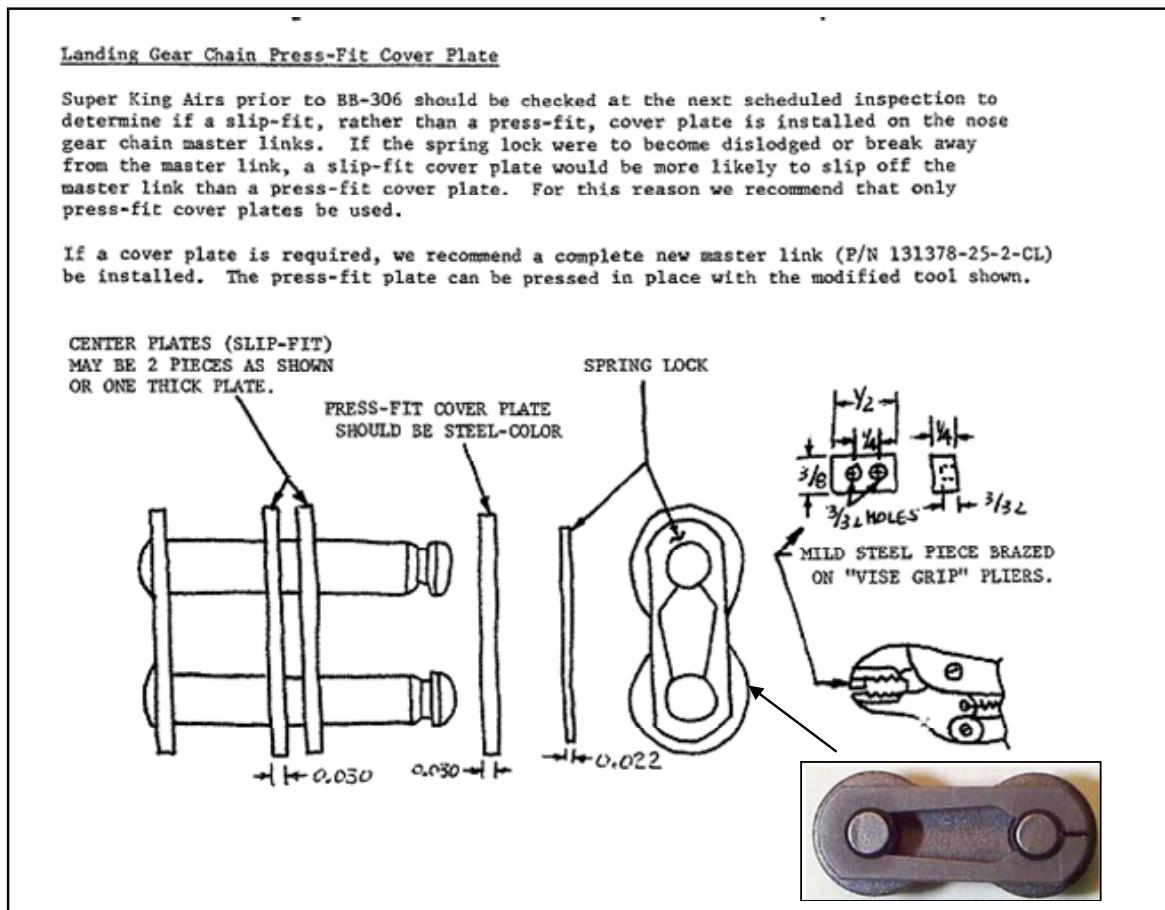
**Figure 2**

Model Communiqué No 16, dated 13 January 1978 was issued by the aircraft manufacturer advising replacement of a 'slip-fit' plate on the master link, with a 'press-fit' plate to retain the master link in the event of the spring lock becoming detached. This communiqué was applicable to aircraft serial numbers prior to BB-306. The accident aircraft serial number was BB-568, suggesting that the chain master link should be the same as the arrangement shown in Figure 2. Examination of the recovered parts of the chain indicated that the pins may not have been pressed through the rear cover plate to the full extent; as such there was insufficient gap remaining for the front 'press-fit' cover plate to be fitted underneath the spring clip. A front cover plate was not recovered from the aircraft following the accident (Figures 1 and 2).

The operator's maintenance staff were unaware that a 'press-fit' cover plate should have been fitted in this position on the chain. They reported that as the AMM did not provide any detail regarding the assembly/disassembly of the master link during removal/installation of the gearbox and did not refer to Model Communiqué No 16, it is possible that a 'press-fit' cover plate may not have been fitted to the chain for some time.
