ACCIDENT

Aircraft Type and Registration:	Boeing 737-800, EI-DYM
No & Type of Engines:	2 CFM 56-7B26 turbofan engines
Year of Manufacture:	2008
Date & Time (UTC):	12 May 2011 at 0815 hrs
Location:	Liverpool John Lennon Airport
Type of Flight:	Commercial Air Transport (Passenger)
Persons on Board:	Crew - 6 Passengers - 169
Injuries:	Crew - None Passengers - None
Nature of Damage:	Damage to aircraft's nosewheel tyre and left main undercarriage assembly, and substantial damage to ground towing equipment
Commander's Licence:	Airline Transport Pilot's Licence
Commander's Age:	48 years
Commander's Flying Experience:	14,266 hours (of which 11,283 were on type) Last 90 days - 180 hours Last 28 days - 64 hours
Information Source:	Aircraft Accident Report Form submitted by the pilot, and reports from the airport authority, ground handling company and Air Traffic Control

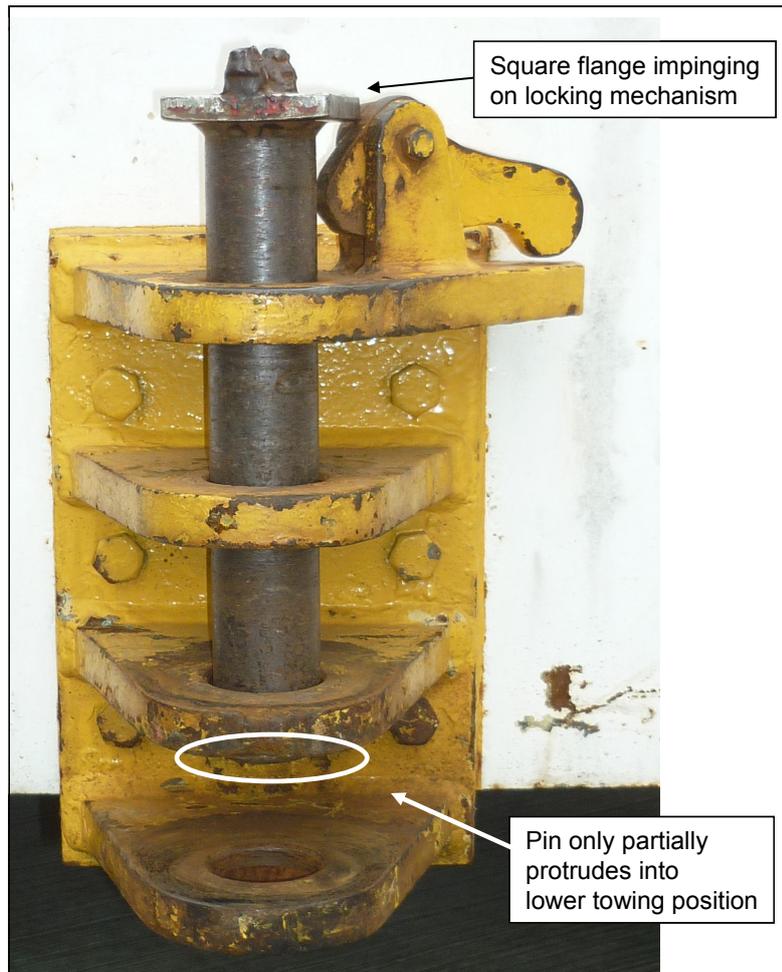
Figure 1

The pushback tug was found to have a towbar locking pin that was not fitted to the vehicle and was apparently not the original pin supplied with the vehicle. The history of the pin was not established but it was confirmed that the tug driver had used it before on two occasions.

From photographs supplied to the AAIB, the locking pin was seen to be fitted with a square flange at one end to which was attached the remnants of a handle, which had broken off a considerable time beforehand. The pin was photographed with the square flange resting on top of a locking mechanism, which was intended to prevent a correctly fitted pin from jumping out of the towing bracket whilst the tug was in motion (Figure 1). In the photographed position, the pin would only partially engage the towbar eye-end fitting if the fitting was inserted into the lower of the three available positions, and would not be mechanically prevented from lifting the small amount required to release the towbar.

Tug vehicle's rear towing bracket with locking pin

Disciplinary actions were taken against the two ground crewmen. The tug concerned was removed from service pending the installation of a radio and all tugs were inspected to ensure that correct towbar locking pins were fitted. Additionally, a programme of daily ramp inspections was initiated to ensure correct pushback procedures were being followed.
