**ACCIDENT**

<b>Aircraft Type and Registration:</b>	Jabiru UL-450 Jabiru, G-CEKM	
<b>No &amp; Type of Engines:</b>	1 Jabiru Aircraft PTY 2200A piston engine	
<b>Year of Manufacture:</b>	2007	
<b>Date &amp; Time (UTC):</b>	29 March 2009 at 1600 hrs	
<b>Location:</b>	Close to Headon, near Retford, Nottinghamshire	
<b>Type of Flight:</b>	Private	
<b>Persons on Board:</b>	Crew - 2	Passengers - None
<b>Injuries:</b>	Crew - None	Passengers - N/A
<b>Nature of Damage:</b>	Substantial damage	
<b>Commander's Licence:</b>	National Private Pilot's Licence	
<b>Commander's Age:</b>	46 years	
<b>Commander's Flying Experience:</b>	255 hours (of which 82 were on type) Last 90 days - 12 hours Last 28 days - 7 hours	
<b>Information Source:</b>	Aircraft Accident Report Form submitted by the pilot

**Synopsis**

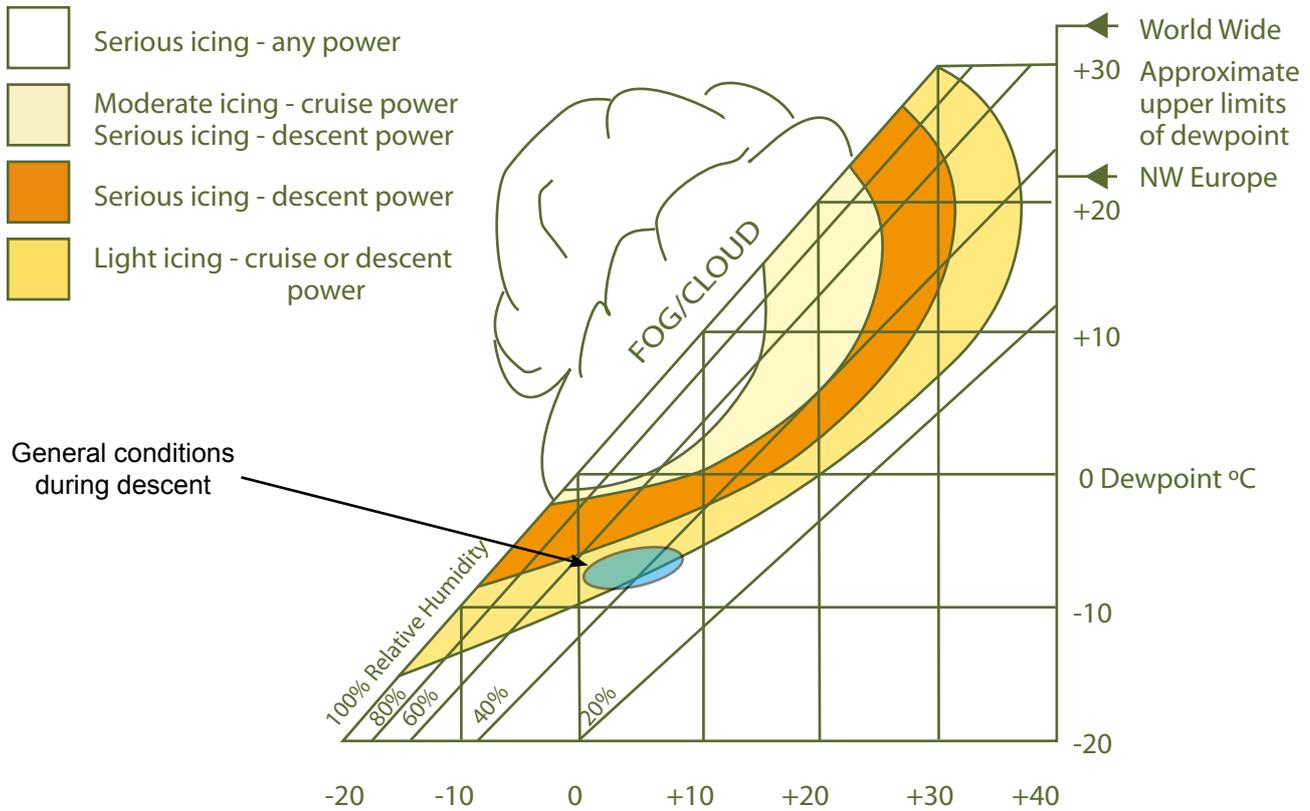
**Figure 1**

From the chart in Figure 1 it can be seen that the general conditions were favourable for ‘light icing - cruise or descent power’.

As reported in AAIB Bulletin 4/2003, in which a Jabiru UL-450 G-TYKE suffered a loss of power after being flown close to a power station, the humidity of the air can be significantly raised over a considerable distance (possibly some miles) from cooling towers, depending on the wind speed and level of turbulence. This can create local conditions more favourable for serious carburettor icing.
