BAe 146-200, G-JEAJ

AAIB Bulletin No: 10/2000 Ref: EW/C2000/6/2 Category: 1.1

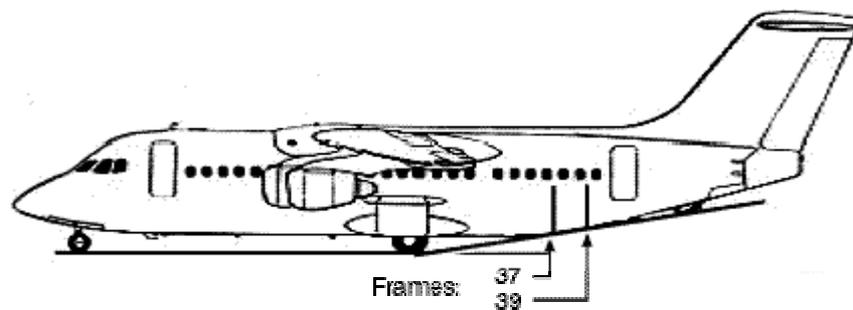
It was apparent that light scrape 1.57 metres long and approximately 0.27 metres wide had occurred on the underside of the rear fuselage. The damaged area extended from just ahead of Frame 37 to the forward face of Frame 39. Frame 37 was close to the aft edge of the baggage door on the left side of the fuselage, with the rear pressure bulkhead being joined to the fuselage skin at Frame 45. Additionally, there had been a light strike on the tail bumper, which is attached to the air conditioning equipment bay door aft of the rear pressure bulkhead. The area of damage is indicated on the sketch below.

Apart from the loss of paint, the skin had suffered light abrasion but had not been penetrated. Some dimpling had occurred in the areas between the stringers and frames in the centre of the panel. After removing the floor panels in the baggage area the dimpled areas of skin could be inspected. No cracking had occurred and the frames and stringers were undamaged. The subsequent inspection at the operator's maintenance base revealed no additional damage, and the aircraft was returned to service following replacement of the skin panel.

and the aircraft touched down early in a nose high landing attitude leading to the fuselage scraping the ground.
