ACCIDENT

Aircraft Type and Registration:	Boeing 777-222, N786UA	
No & Type of Engines:	2 Pratt & Whitney PW4090 series turbofan engines	
Year of Manufacture:	1997	
Date & Time (UTC):	26 February 2007 at 1000 hrs	
Location:	London (Heathrow) Airport	
Type of Flight:	Commercial Air Transport (Passenger)	
Persons on Board:	Crew - 20	Passengers - 185
Injuries:	Crew - None	Passengers - None
Nature of Damage:	Heat and fire damage to the right main power distribution panel, surrounding structure and components inside the Main Equipment Centre	
Commander's Licence:	Airline Transport Pilot's Licence	
Commander's Age:	52 years	
Commander's Flying Experience: (Hours all approximate)	18,000 hours (of which 2,800 hours were on type) Last 90 days - 215 hours Last 28 days - 65 hours	
Information Source:	AAIB Field Investigation

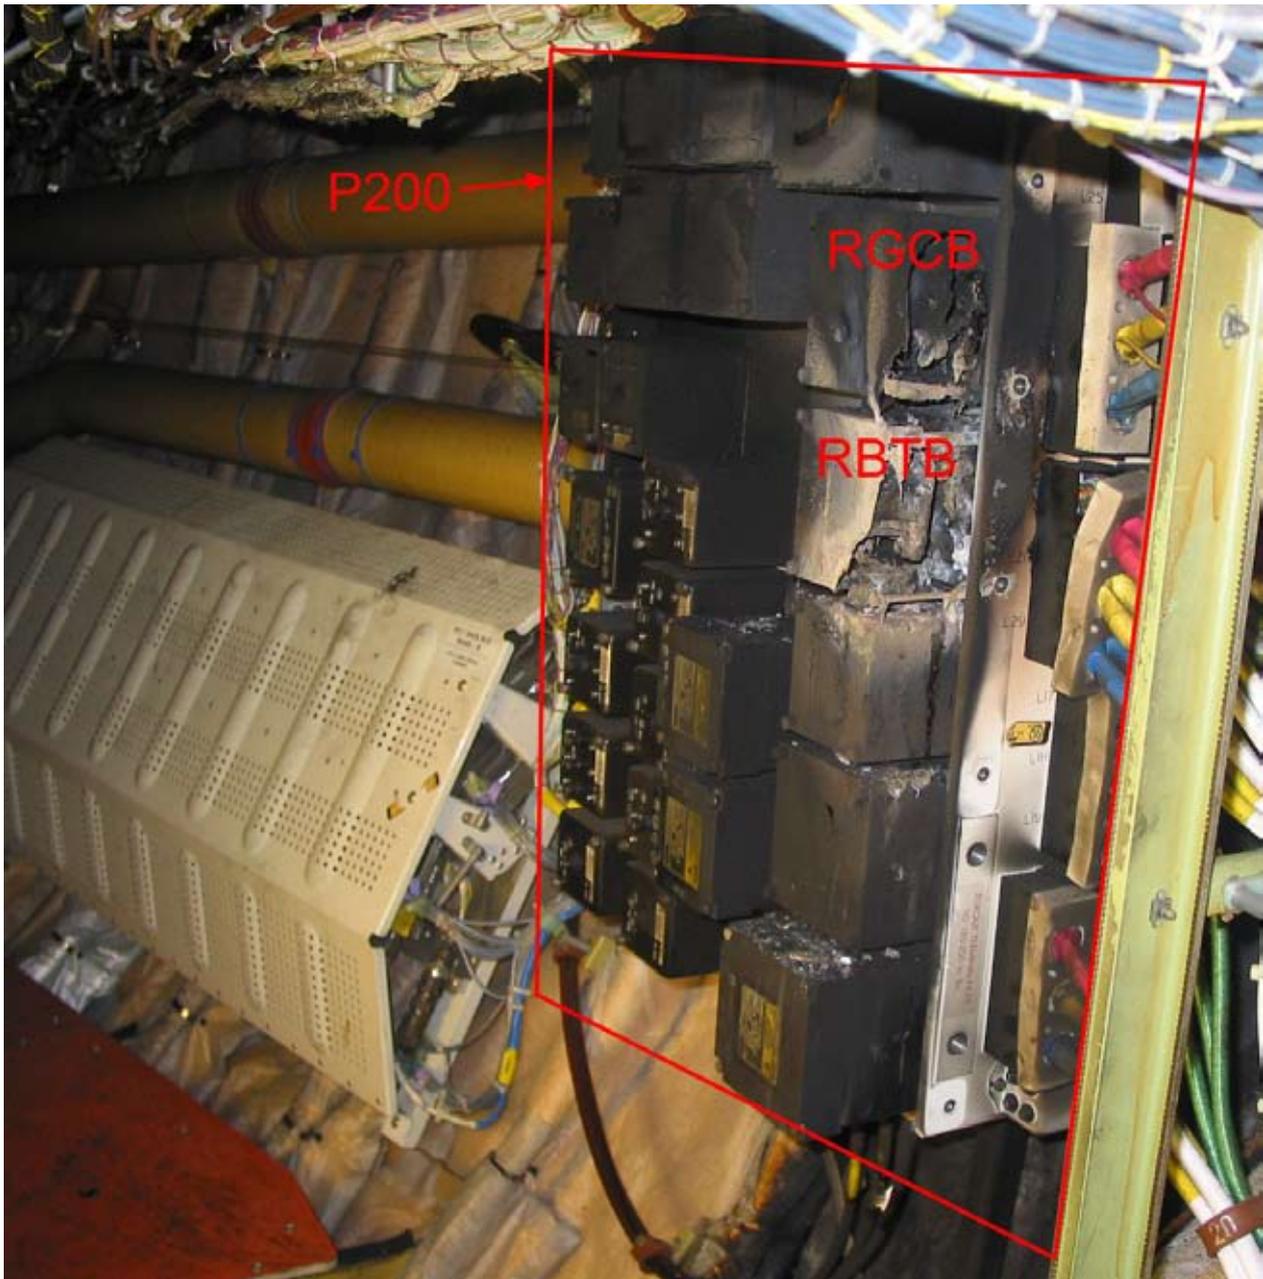
Figure 2

An inspection inside the MEC after the accident revealed extensive heat and fire damage to the P200 power panel as shown in Figure 2. The worst affected components of the power panel were the RGCB and RBTB contactors, parts of which had melted and vaporised. There was evidence that molten metal had dripped down onto the insulation blankets beneath this panel. Extensive fire damage to the fire-retardant insulation blankets located behind and beneath the power panel under the floor, had occurred as shown in Figure 3. Nearby components including a floor panel, equipment cooling system ducting, other wire bundles and some structural frames and stringers in the vicinity were later determined to have suffered sufficient heat damage to require replacement.

revealed that both the RBTB and RGCB had suffered from extreme heating and electrical arcing. The main moveable contacts within both contactors were destroyed. There was some insulation damage to the bus bars within the panel in the vicinity of the RBTB. The damage to the surrounding components of the power panel appeared to be a consequence of a failure within either the RBTB or RGCB.

Fire damage to P200 panel, showing burnt-out RGCB and RBTB contactors
(panel cover has been removed in this photograph)
