SERIOUS INCIDENT

Aircraft Type and Registration:	Airbus A320-214, EI-EZV
No & Type of Engines:	2 CFM 56-5-B4/P turbofan engines
Year of Manufacture:	2003 (Serial no: 2001)
Date & Time (UTC):	16 January 2014 at 1505 hrs
Location:	London Heathrow Airport
Type of Flight:	Commercial Air Transport (Passenger)
Persons on Board:	Crew - 6 Passengers - 41
Injuries:	Crew - 4 (Minor) Passengers - None
Nature of Damage:	None reported
Commander's Licence:	Airline Transport Pilot's Licence
Commander's Age:	34 years
Commander's Flying Experience:	7,272 hours (of which 6,878 were on type) Last 90 days - 96 hours Last 28 days - 19 hours
Information Source:	Aircraft Accident Report Form submitted by the pilot

Synopsis

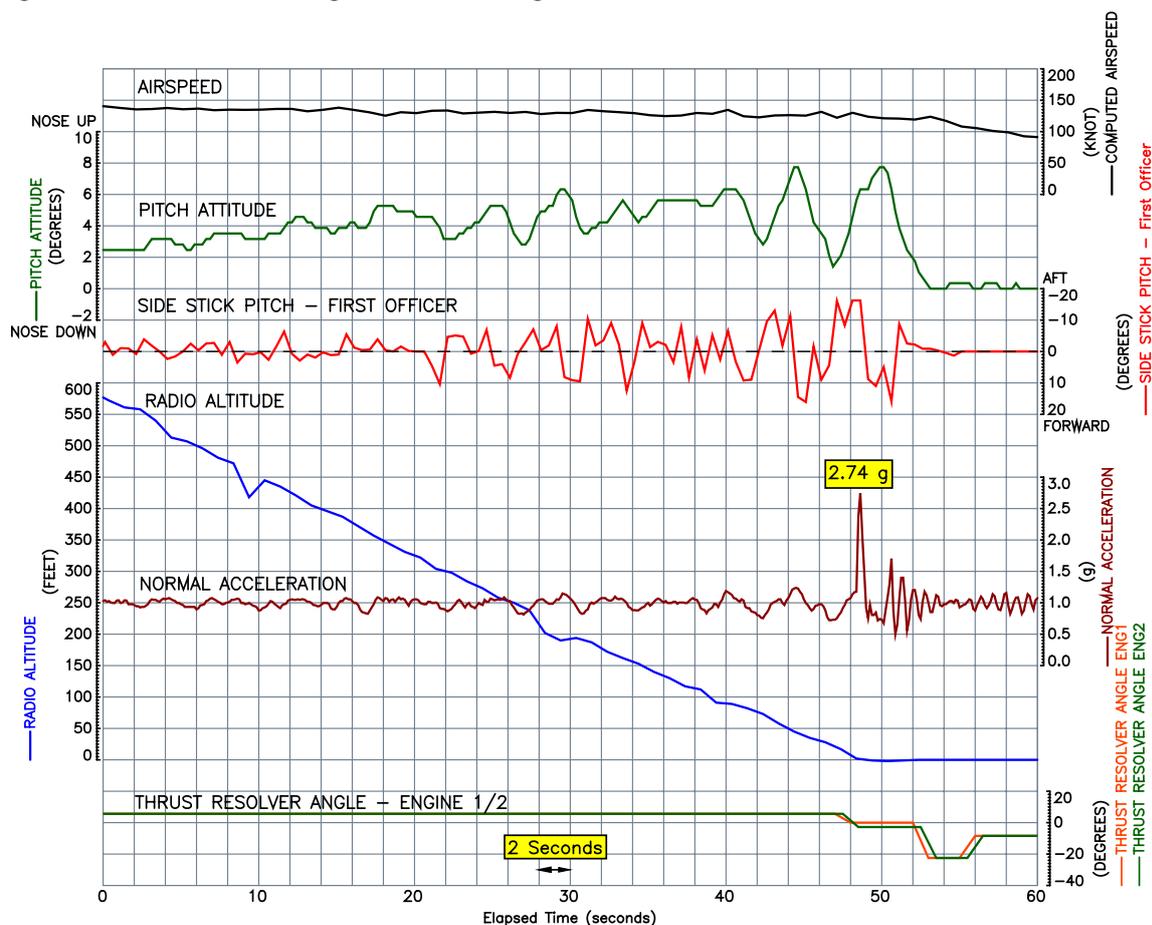
Flight data from the landing

The computed airspeed at touchdown (equivalent to groundspeed in the absence of headwind) was approximately 130 kt. The thrust levers were retarded over approximately 1.5 seconds to reach idle at touchdown. The average rate of terrain closure was 706 fpm during the descent from 500 ft radio altitude to touchdown. This approximates to the aircraft's rate of descent given the flat and level ground over which the aircraft was flying during the final approach. The ILS 27L page in the UK AIP entry for London Heathrow Airport shows that a rate of descent of 690 fpm is required to maintain the ILS glideslope at 130 kt groundspeed.

In the final 28 seconds before touchdown, the amplitude of sidestick input slowly increased but, although the pitch attitude varied, the average rate of descent remained constant. In the two seconds before touchdown, the pitch attitude changed from approximately 1.5° to 6.5° nose-up.

During the final 28 seconds of flight, the high rate at which the pitch inputs were made and reversed meant that the pitch attitude did not always change in response. The pitch inputs also had little effect on the flight path and rate of descent. The pitch attitude varied significantly during the six seconds before touchdown, including a 5° nose-up pitch change in the final two seconds. However, the final increase in pitch attitude came too late to arrest the rate of descent leading to the hard landing.

The scale for the parameter SIDE STICK PITCH – First Officer in Figure 1 is incorrectly labelled. The scale should read that positive values greater than zero indicate that the side stick has been moved forward and that negative values of less than zero indicate that the side stick has been moved aft. The revised plot has been inserted into the above report. The analysis remains unchanged.
