**AAIB Bulletin No: 1/2003**

**Ref: EW/A2001/6/10**

<b>Aircraft Type and Registration:</b>	Lockheed L188C, G-FIZU	
<b>No &amp; Type of Engines:</b>	4 Allison 501-D13 turboprop engines	
<b>Year of Manufacture:</b>	1960	
<b>Date &amp; Time (UTC):</b>	7 June 2001 at 1715 hrs	
<b>Location:</b>	Approximately 10 nm south of Rennes, France	
<b>Type of Flight:</b>	Public Transport	
<b>Persons on Board:</b>	Crew - 4	Passengers - 1
<b>Injuries:</b>	Crew - None	Passengers - None
<b>Nature of Damage:</b>	Crew Emergency Exit Door missing and hinge mechanism damaged	
<b>Commander's Licence:</b>	Airline Transport Pilot's Licence	
<b>Commander's Age:</b>	43 years	
<b>Commander's Flying Experience:</b>	5,525 hours (of which 1,300 were on type) Last 90 days - 98 hours Last 28 days - 27 hours	
<b>Information Source:</b>	AAIB Field Investigation

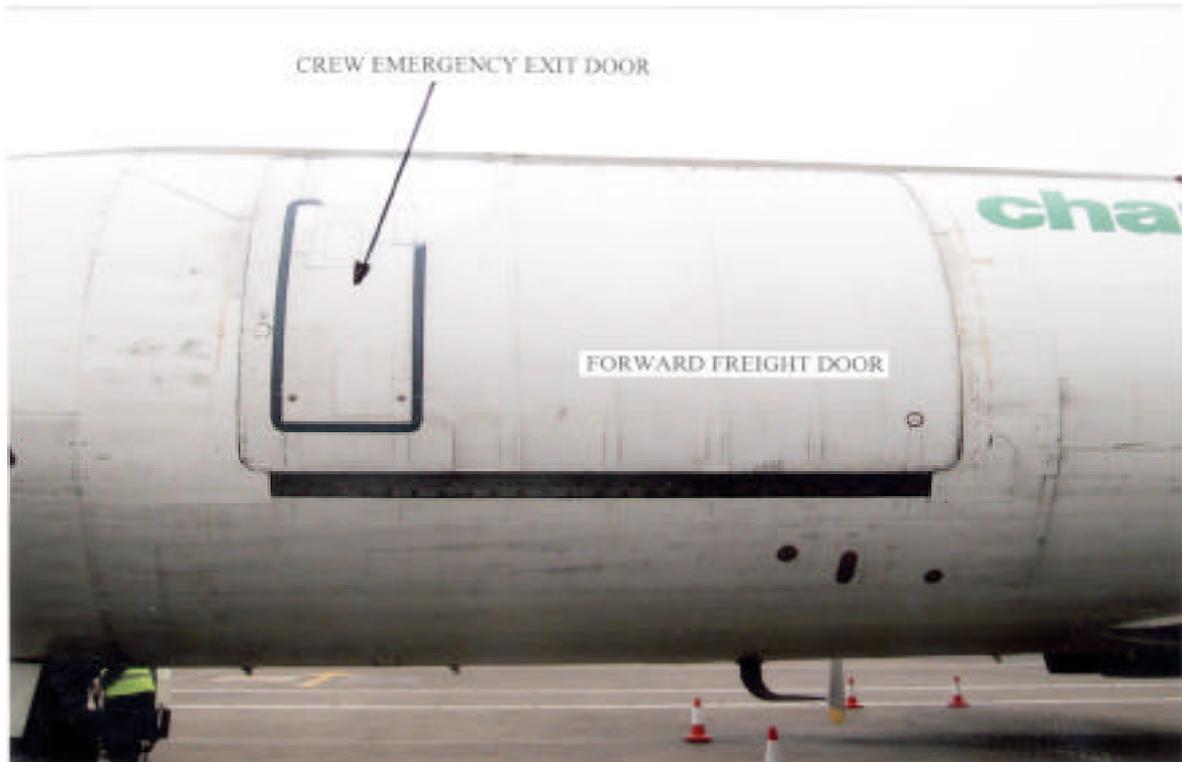
This aircraft, along with many others, was converted from the passenger to freighter role in accordance with a Supplemental Type Certificate (STC), issued by the aircraft manufacturer, and approved by the FAA. The CEED is a small door, approximately 2 feet x 6 feet in size, located within the Forward Freight Door, photograph 1. It is hinged along its top edge and opens outwards. The door is held in the closed position by two latches. Two manually operated Latch Handles which, when pushed down, each cause a claw mechanism to grab an airframe mounted spigot. These claws are in turn locked by the operation of a Door Lock/Hook Tensioning Handle. When this handle is placed in the LOCKED/CLOSED position a mechanism within the door draws the tops of the Latch Handles into the bottom of the door structure, which both draws the door tight shut and physically prevents the latches from opening, photographs 2 & 3.

Photograph 1  
Crew Emergency Exit Door set into the Forward Freight Door

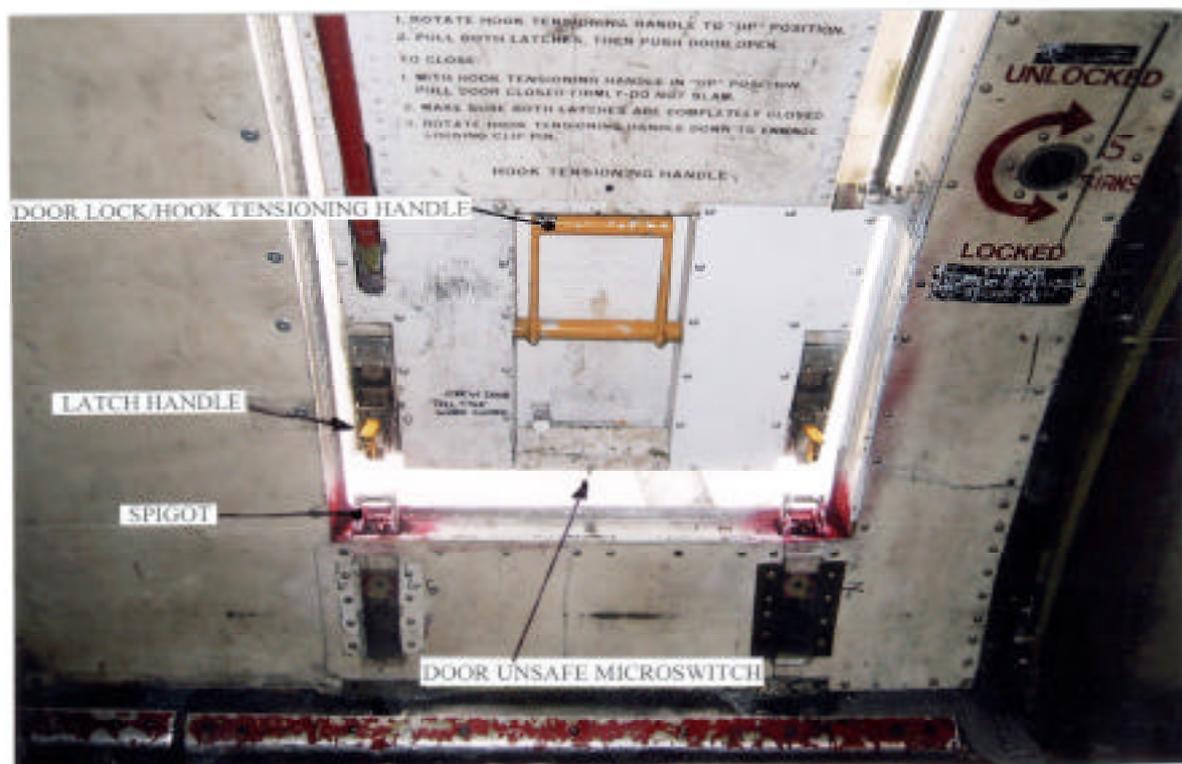
On the door which departed the aircraft, it was reported that there were no placards or markings on either the Door Lock/Hook Tensioning Handle or the door itself, to indicate the LOCK/CLOSED and UNLOCK/OPEN positions of the handle. A similar door is shown in photograph 2.

Photograph 2  
Replacement Crew Emergency Exit Door fitted to G-FIZU in the UNLOCKED/OPEN position

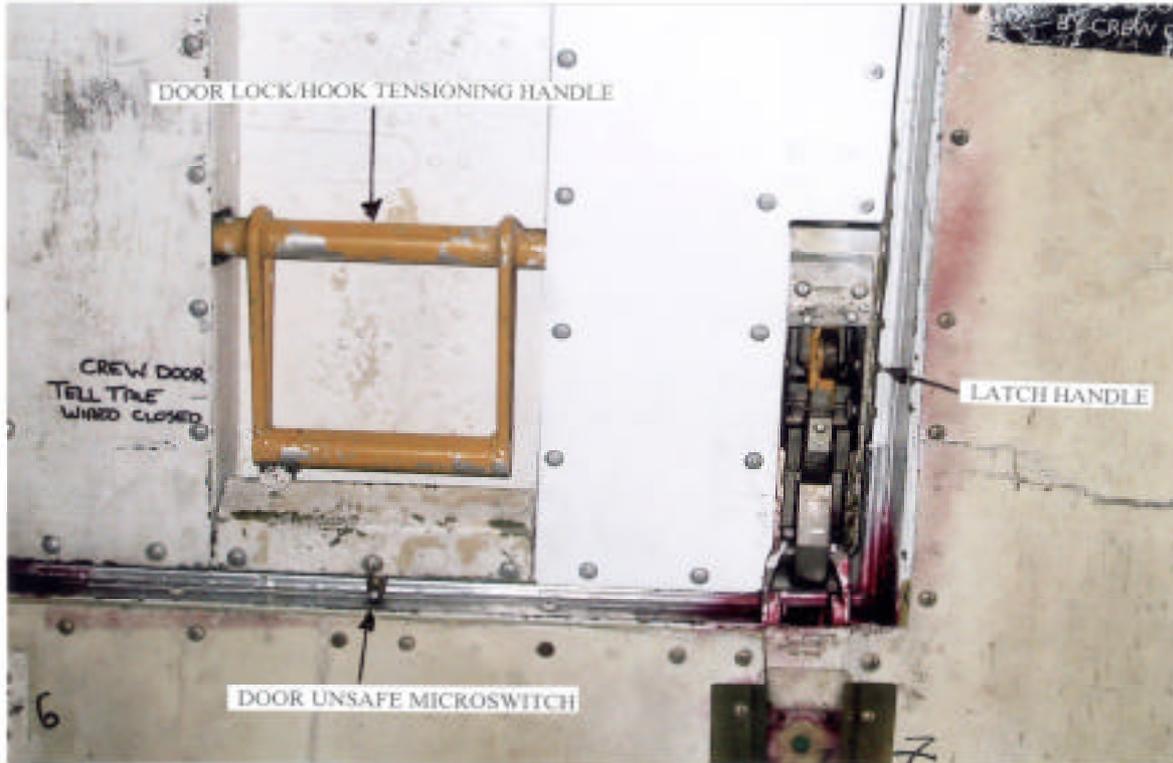
Photograph 3  
Replacement Crew Emergency Exit Door fitted to G-FIZU in the  
LOCKED/CLOSED position

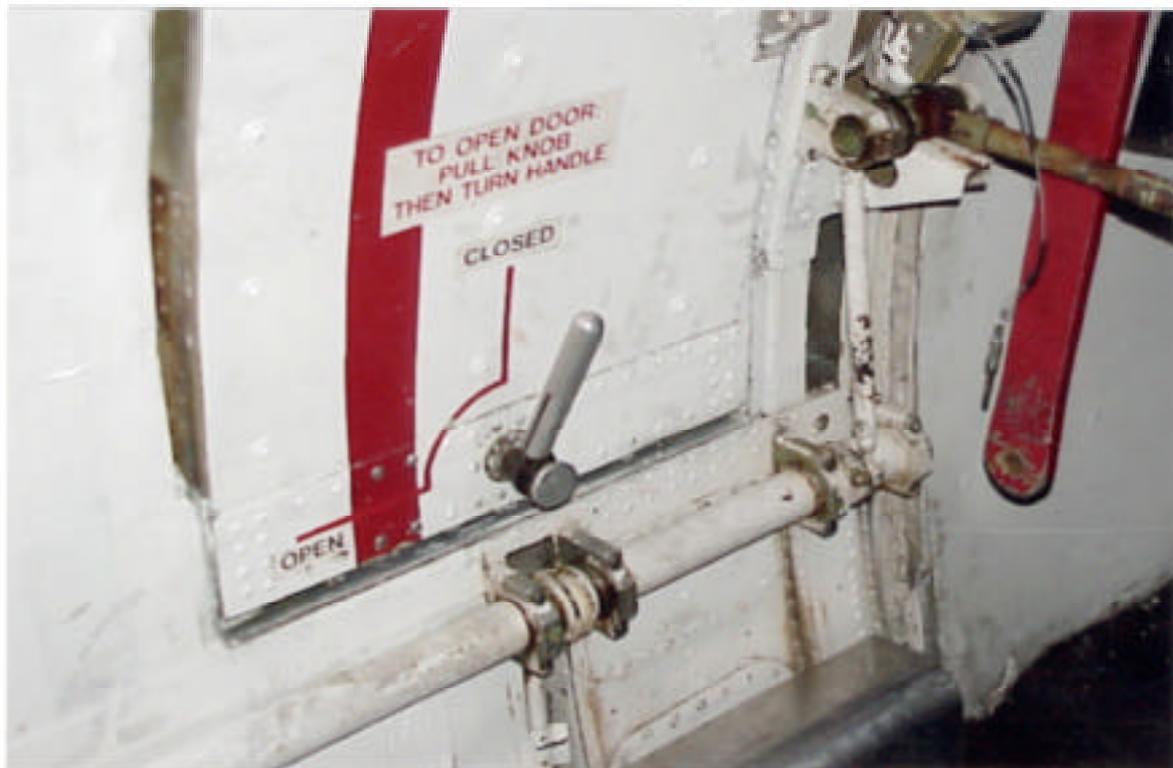
The flight crew of the accident aircraft were operating an aircraft that was on loan from another UK company whilst the aircraft they normally operated was in maintenance. The aircraft that the crew normally operated had been converted from a passenger to a freighter aircraft in accordance with an STC that had been approved by the FAA, but which had been issued by an organisation other than the aircraft manufacturer. The DOOR UNSAFE indication system on this aircraft was significantly different to that of the accident aircraft, in that the latch handle/claw/spigot arrangement was not employed. On the crews' normal aircraft, a Door Lock Handle, which rotates through 90°, extends two 'shoot' bolts into receptacles in the door frame. A micro-switch, also mounted in the door frame, is operated when one of the shoot bolts becomes fully extended and this removes the DOOR UNSAFE signal from the door. In addition, this Door Lock Handle is clearly marked to indicate the door LOCKED/CLOSED and UNLOCKED/OPEN positions, photograph 4.

Photograph 4  
Crew Emergency Exit Door fitted to the aircraft normally  
operated by the accident flight crew

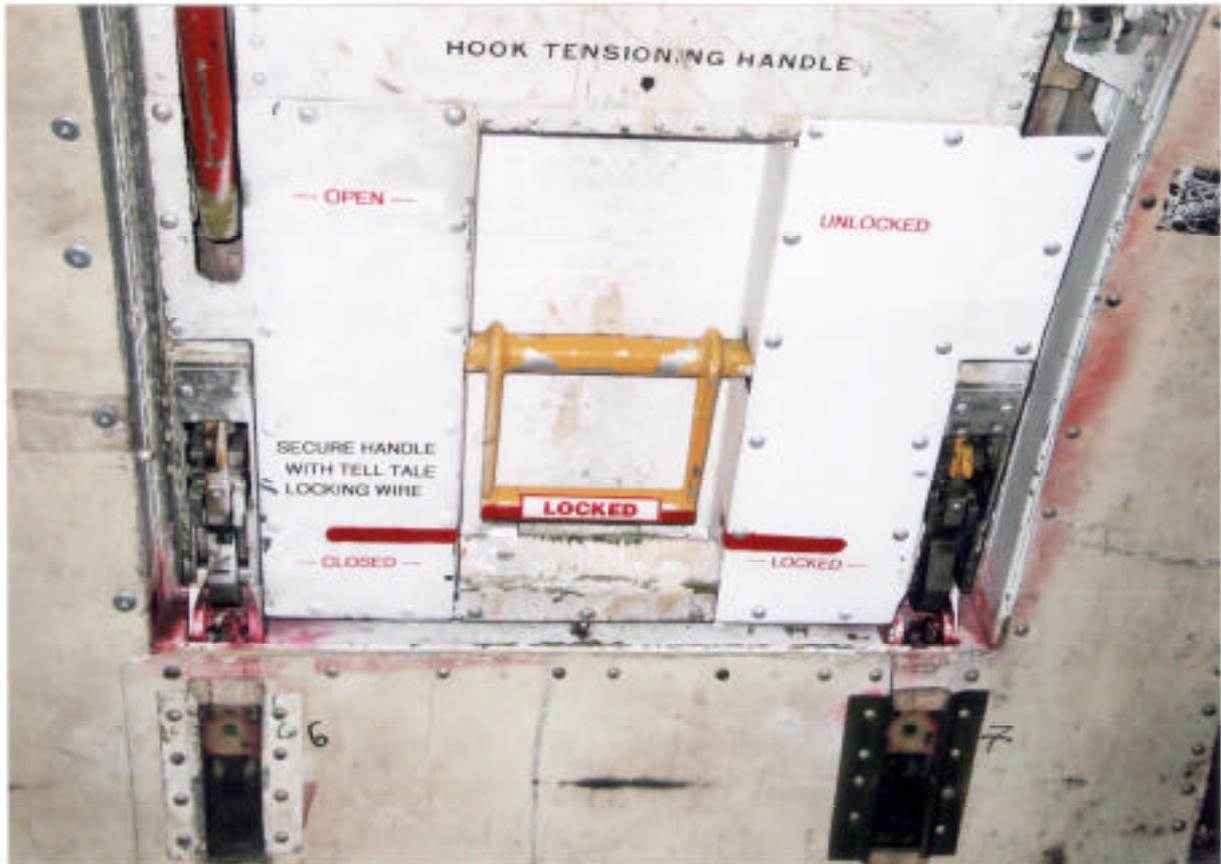
Photograph 5  
Placards applied to the Crew Emergency Exit Door by the  
maintenance organisation

1. Placards have been applied to the Door Lock/Hook Tensioning Handle to highlight the LOCKED/CLOSED and UNLOCKED/OPEN positions of the handle, photograph 5.
1. The Door Lock/Hook Tensioning Handle has been safety wired to indicate movement of the door handle.
1. The Pre-Flight Check has been amended with an additional item which calls for a physical check of the Door Lock/Hook Tensioning Handle and Latch Handles, to ensure that they are in their LOCKED/CLOSED positions.
1. A Notice to Crews concerning the correct operation of the CEED has been published.
1. The possibility of modification action to eliminate the CEED on aircraft not requiring this door as an emergency exit is being investigated.
