ACCIDENT

Aircraft Type and Registration:	Schweizer 269C-1, G-CEAW	
No & Type of Engines:	1 Lycoming HIO-360-G1A piston engine	
Year of Manufacture:	2006	
Date & Time (UTC):	22 May 2010 at 1150 hrs	
Location:	Liverpool Airport, Merseyside	
Type of Flight:	Private	
Persons on Board:	Crew - 1	Passengers - None
Injuries:	Crew - 1 (Minor)	Passengers - N/A
Nature of Damage:	Extensive	
Commander's Licence:	Commercial Pilot's Licence	
Commander's Age:	51 years	
Commander's Flying Experience:	370 hours (of which 230 were on type) Last 90 days - 1 hour Last 28 days - 1 hour	
Information Source:	AAIB Field Investigation

Synopsis

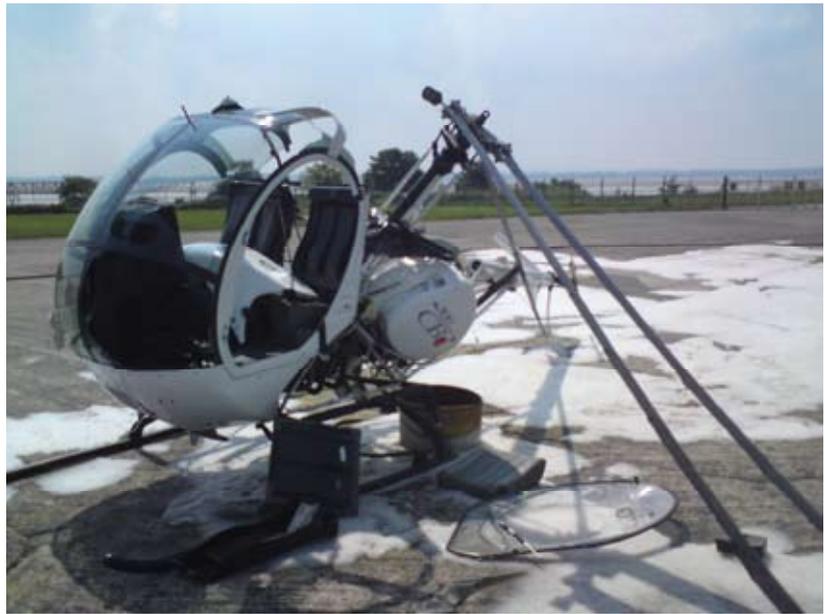
Figure 1

This was the pilot's last recollection. The next thing he remembered was sitting on the ground, approximately 40 m from the helicopter, being treated by the emergency services. The pilot was taken to the local hospital where he received 20 stitches to the back of his head. The aircraft was damaged beyond economic repair but there was no fire (Figure 1).

The manufacturer examined photographs of the helicopter and of relevant components, which were taken after the accident and confirmed that the damage to the aircraft was consistent with ground resonance.
