ACCIDENT

Aircraft Type and Registration:	Raj Hamsa X'Air 133(1), G-CDHO	
No & type of Engines:	1 Verner 133M piston engine	
Year of Manufacture:	2005	
Date & Time (UTC):	17 June 2006 at 1500 hrs	
Location:	Near Tilbury Docks, Essex	
Type of Flight:	Training	
Persons on Board:	Crew - 2	Passengers - None
Injuries:	Crew - None	Passengers - N/A
Nature of Damage:	Engine magneto failure and damage to propeller	
Commander's Licence:	Private Pilot's Licence	
Commander's Age:	37 years	
Commander's Flying Experience:	275 hours (of which 33 were on type) Last 90 days - 21 hours Last 28 days - 4 hours	
Information Source:	Aircraft Accident Report Form submitted by the pilot and follow-up AAIB investigation

Synopsis

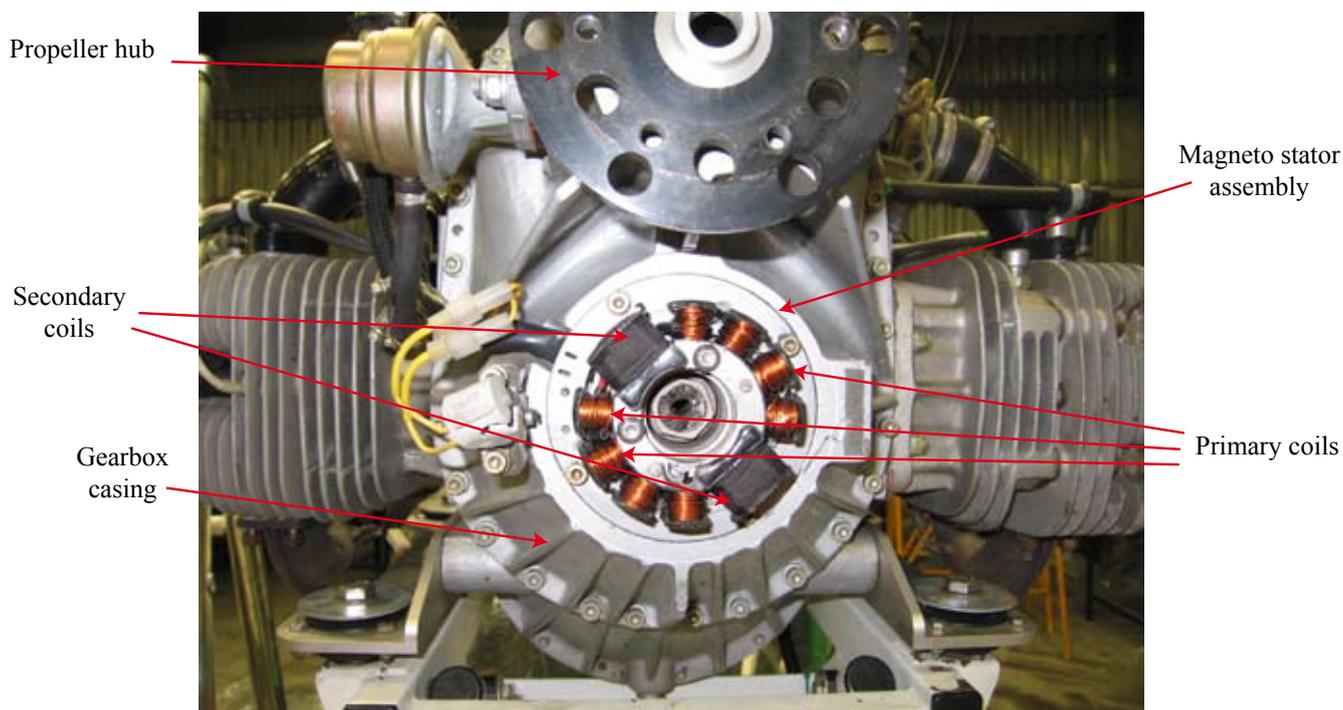
Figure 1

The magneto on the Verner 133M engine is located on the front of the engine, immediately below the propeller shaft. It consists of eight primary and two secondary coils secured to the front of the gearbox casing (Figure 1). Magnets are secured to the inside of a rotating casing which covers the entire assembly. The casing is bolted to a steel stub shaft, pressed into the forward end of the crankshaft, which passes through the centre of the coils, (Figure 2).
