ACCIDENT

Aircraft Type and Registration:	Boeing 737-45D, SP-LLB	
No & Type of Engines:	2 CFM56-3C1 turbofan engines	
Year of Manufacture:	1993	
Date & Time (UTC):	20 February 2006 at 1140 hrs	
Location:	Stand 114, London Heathrow Airport	
Type of Flight:	Public Transport (Passenger)	
Persons on Board:	Crew - 6	Passengers - 89
Injuries:	Crew - None	Passengers - None
Nature of Damage:	Wing tip light and some structural damage to wing tip	
Commander's Licence:	Airline Transport Pilot's Licence	
Commander's Age:	59 years	
Commander's Flying Experience:	11,725 hours (of which 7,680 were on type) Last 90 days - 160 hours Last 28 days - 65 hours	
Information Source:	AAIB Field Investigation

Synopsis

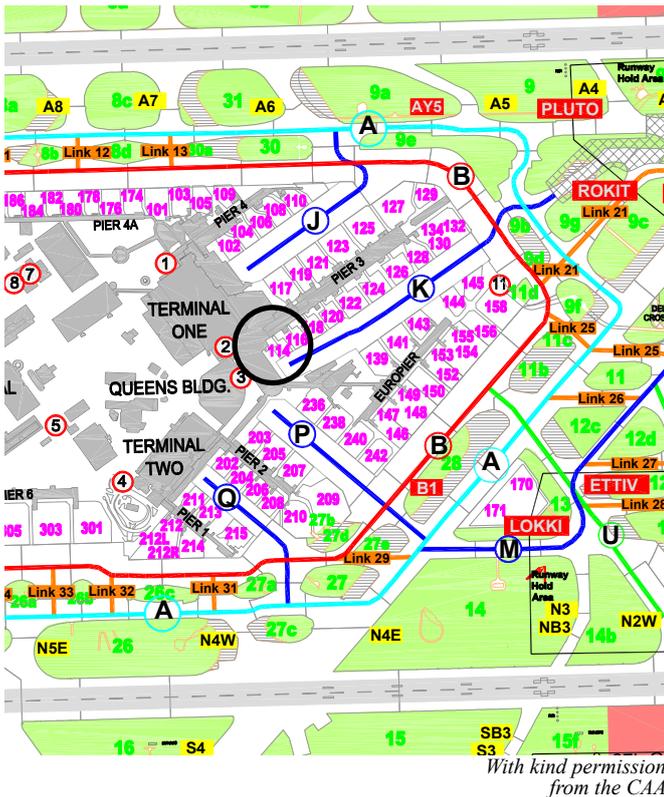
Figure 1
Location of Stand 114 (in black circle)

Stand 114 is located at the end of a cul-de-sac, between Pier 3 and the 'Europier' of Terminal 1 (Figure 1). To its left is a baggage storage area adjacent to a part of the terminal building which forms the cul-de-sac, and to its right is another stand of similar dimensions. Due to the confined nature of its location it is restricted to the operation of Boeing 737 or smaller aircraft. A yellow lead-in line, painted on the taxiway leading to the stand, is intended to indicate to pilots the safe approach course to the stand centreline. The history of successful manoeuvring on to this stand demonstrates that a safe approach will result if the nose wheel of the aircraft is steered over this lead-in line.

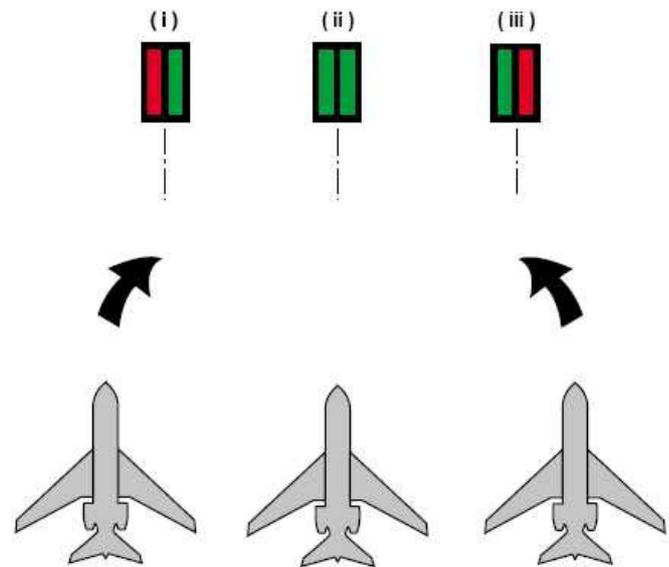
Figure 2
AGNIS

Guidance along the centreline of the stand is provided by an Azimuth Guidance for Nose-In Stands (AGNIS) system. The system is designed to be viewed from the left pilot's seat and displays two closely spaced vertical light bars mounted in a box, as illustrated in Figure 2. The light bars display one red bar and one green bar as illustrated in Figure 2 (i) & (iii), indicating that the pilot should steer away from the red towards the green bar, or two green bars, indicating correct alignment, as illustrated in Figure 2 (ii).

position, nor had it gained the stand centreline, when it struck the van. When viewed from the commander’s seat in the cockpit immediately after the incident, the AGNIS indicated that the aircraft was right of the centreline.

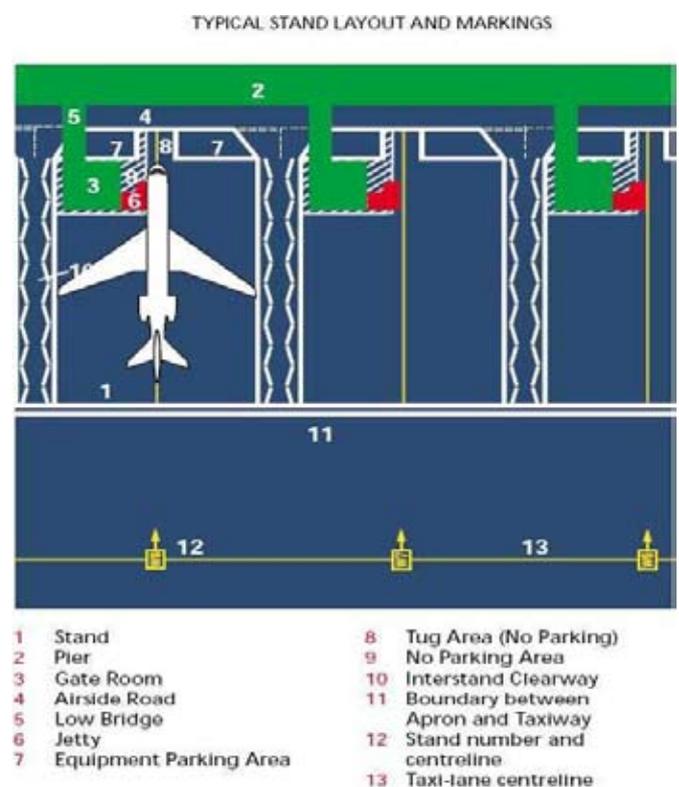
Figure 3

Diagrams explaining stand markings, produced in CAP 637 and the *Airside Safety and Driving Code* handbook, showed hatched areas associated with the jetty manoeuvring area only and it was not clear from these diagrams or related text that hatched areas were

also to be found in the interstand clearways, as in the case of Stand 114. Consequently, it was not clear that parking might be prohibited altogether in some parts of an interstand clearway. Therefore, the following two recommendations are made.

Safety Recommendation 2006–138

It is recommended that the Civil Aviation Authority should amend CAP 637 – *Visual Aids Handbook*, to clarify those areas where parking is prohibited.

Safety Recommendation 2006–139

It is recommended that Aviance UK should amend the *Airside Safety and Driving Code* handbook to clarify those areas where parking is prohibited.
